DOT HS 813 300

**Special Crash Investigations:
On-Site Air Bag Non-Deployment
Crash Investigation;
Vehicle: 2008 Chevrolet Malibu;
Location: New York;
Crash Date: September 2017**

Special Crash Investigations
On-Site Air Bag Non-Deployment Crash Investigation
Office of Defects Investigation
Case Number: CR18019
Vehicle: 2008 Chevrolet Malibu
Location: New York
Crash Date: September 2017

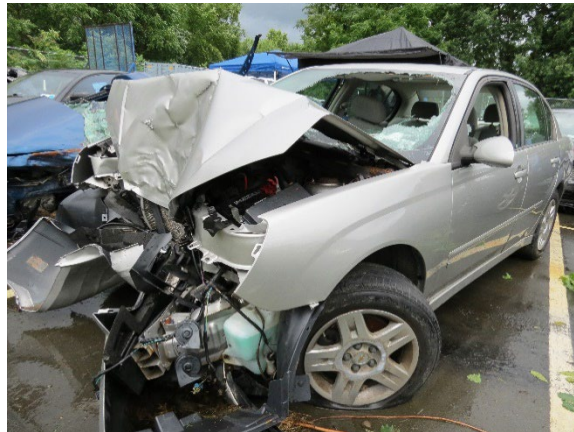
This on-site investigation documents the non-deployment of the air bag systems in a 2008 Chevrolet Malibu (Figure 1) that was involved in a road departure/fixed object crash. The Chevrolet had a certified advanced 208-compliant (CAC) frontal air bag system, inflatable curtain (IC) air bags, and front-seat belt retractor pretensioners. Driven by an unbelted 36-year-old female, the Chevrolet traveled on a straight trajectory through a slight right curve. The vehicle departed the left road edge, struck a small bush (Event 1), gouged the ground with its undercarriage (Event 2), and then struck a large-diameter tree (Event 3). The Chevrolet sustained significant front plane damage, but no air bags deployed. The driver was transported by ambulance to a Level II trauma center and died 35 hours post-crash.

Figure 1. Left-front oblique view of the 2008 Chevrolet Malibu at the time of the SCI inspection

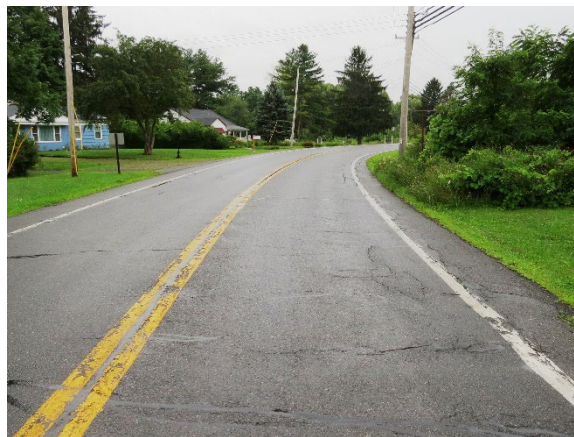
Figure 2. Southbound view of the Chevrolet's pre-crash approach to the crash site

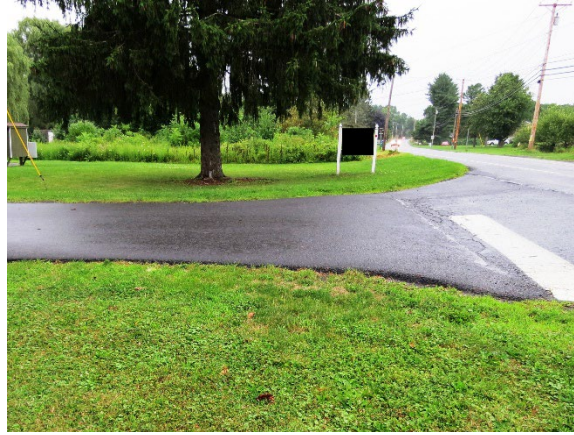
Figure 3. Southerly view of the intersecting roadway and large-diameter coniferous tree

A private driveway and a local roadway intersected the two-lane roadway from the east. The private drive measured 4.0 m (13.1 ft) wide, and the local roadway measured 7.0 m (23.0 ft) wide. A stop bar and stop sign controlled westbound traffic approaching the north/south two-lane roadway. Located 8.5 m (27.9 ft) east of the east road edge and 6.5 m (21.3 ft) south of the intersecting roadway edge was a 102 cm (40.0 in) diameter coniferous tree. A crash diagram is included at the end of this report.

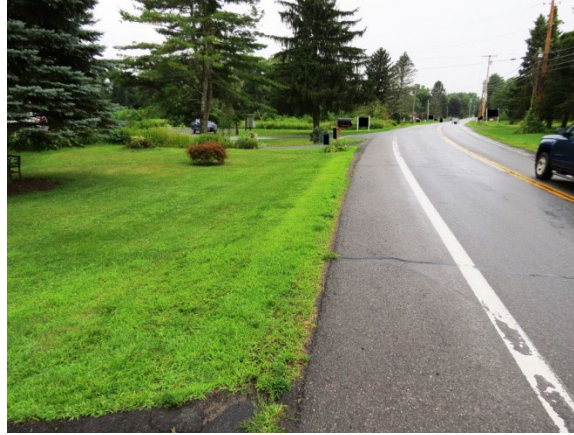
The Chevrolet continued from the straight section of the roadway and entered the right curve, but it kept going straight (Figure 4). This suggests the driver was possibly distracted or fell asleep (specifics unknown). The vehicle crossed the double-solid yellow centerline, crossed the northbound travel lane and east shoulder, then departed the east road edge and entered the grass roadside.

Figure 4. Southbound view of the Chevrolet's roadside departure trajectory at the time of the SCI inspection

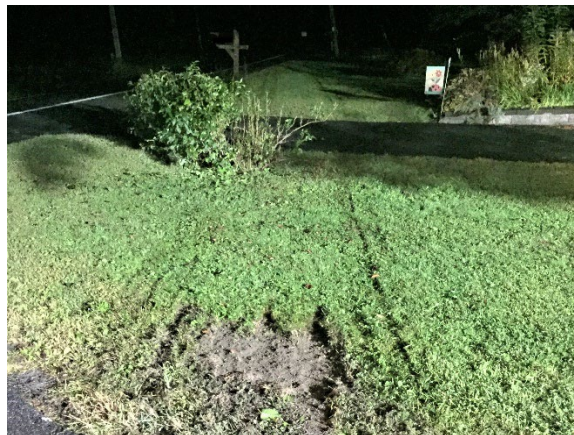
This errant trajectory alerted the driver, who made a right steering input in an attempt to regain the roadway. At the 3-second interval prior to AE, the EDR-recorded speed of the Chevrolet was 97 km/h (60 mph). Recorded steering wheel angle data indicated a right steering input by the driver at this time interval. Due to the wet conditions, the Chevrolet initiated a slight clockwise yaw (approximately 5 degrees) as it continued southbound. On-scene images obtained from the investigating law enforcement agency showed these dynamics, as four distinct tire marks were visible in the grass roadside (Figure 5).

Figure 5. Northbound lookback view of the Chevrolet's trajectory (on-scene law enforcement image)

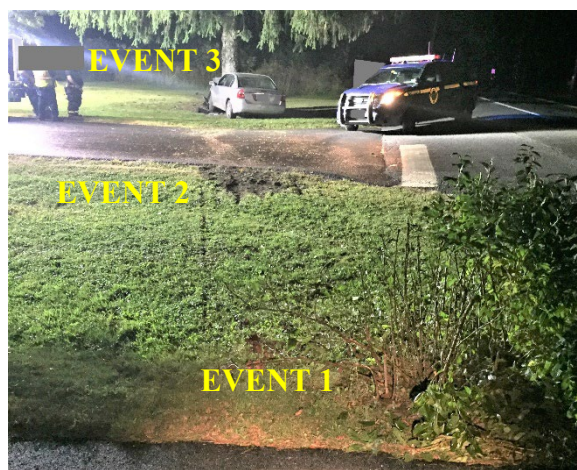
Compression of the Chevrolet's suspension occurred relative to the uneven roadside/grass surface and varying elevation with respect to the surface of the intersecting local roadway. This caused the vehicle to bound across the intersecting local roadway and through the grass as it approached the large-diameter tree. The distance between the gouge marks and the tree measured 13.5 m (44.3 ft). At the EDR-reported pre-crash speed of 97 km/h (60 mph), the vehicle would have traveled this short distance in approximately 0.5 seconds. The front plane, center aspect of the Chevrolet then struck the large-diameter tree (Event 3). As the front structure began to crush, the left and right aspects of the front plane engaged the tree, resulting in a direct contact width of 90 cm (35.4 in) across the front plane that had a concave profile that matched the circumferential dimension of the 102 cm (40.0 in) overall diameter tree. Directions of force were within the 12 o'clock sector for the Chevrolet. The vehicle rotated 10 degrees counterclockwise during the engagement before it came to final rest with its front plane engaged against the trunk of the tree (Figure 6).

Figure 6. South-facing view of the Chevrolet's trajectory and the three impact events (on-scene law enforcement image)

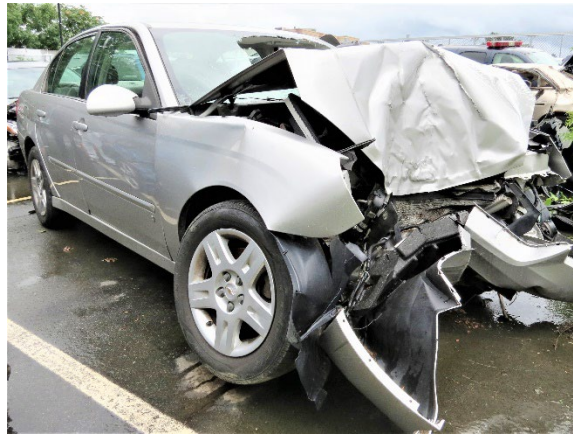
Figure 7. Right-front oblique view of the 2008 Chevrolet Malibu at the time of the SCI inspection

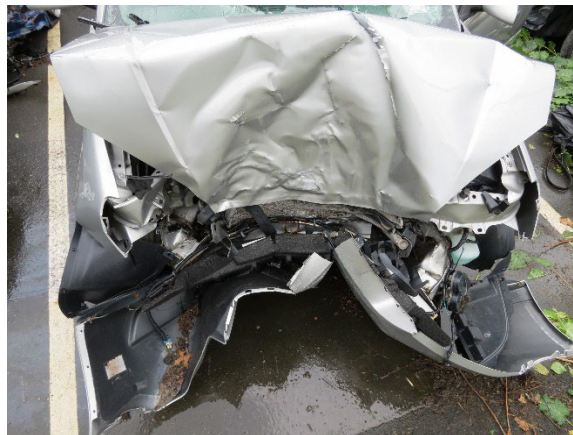
The front plane of the Chevrolet struck the 102 cm (40.0 in) diameter tree (Event 3). The initial contact involved the center aspect; however, as the frontal structure began to crush, the left and right aspects also became involved due to the wide diameter of the tree trunk. Direct contact damage measured 90 cm (35.4 in) wide and spanned the three zones of the end plane. Involved components included the bumper fascia and bumper beam, both front frame rails, the hood, the upper radiator support, the air conditioner condenser and radiator, the engine, and both headlight assemblies.

Figure 8. Front-plane damage profile to the Chevrolet

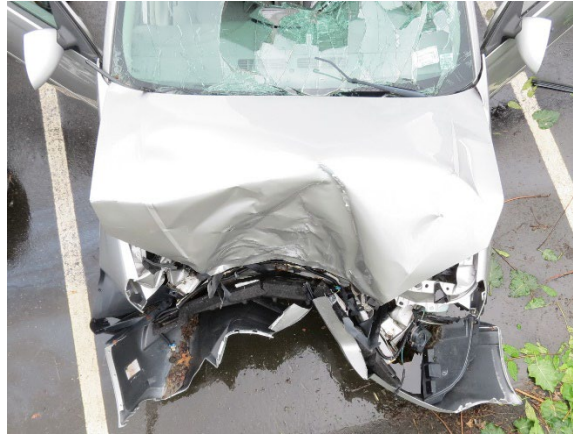
Induced damage involved both front fenders and their support structures, as well as the windshield glazing. The combined direct and induced damage length spanned the entire front-end width of the Chevrolet. Figures 8 and 9 depict the front plane damage to the Chevrolet.

Figure 9. Overhead perspective of the damage profile

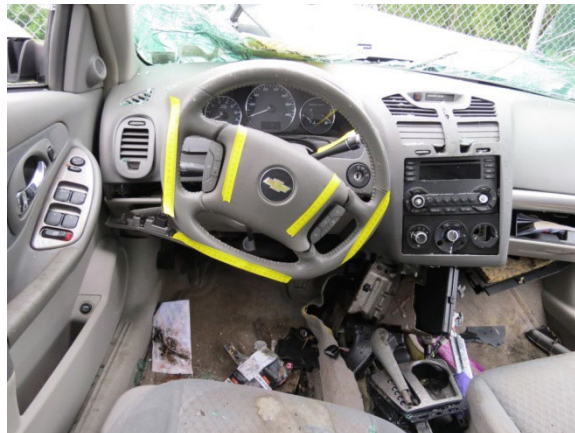
The driver initiated a forward trajectory in response to the crash forces. She was subjected to unrestricted movement about the vehicle's interior during the crash due to her unbelted status. She therefore was displaced from the driver's seat into the frontal components. Her left knee contacted and loaded the lower left instrument panel, which deformed the polymer component as evidenced by tensile stress discoloration. Her abdomen and torso struck the steering wheel rim and the non-deployed air bag module, which bent the wheel rim forward at the four spoke locations and deformed the lower aspect of the wheel rim (Figure 10). The estimated wheel rim deformation was 4 cm (1.6 in).

Figure 10. Driver trajectory and loading damage to the steering assembly and the lower instrument panel

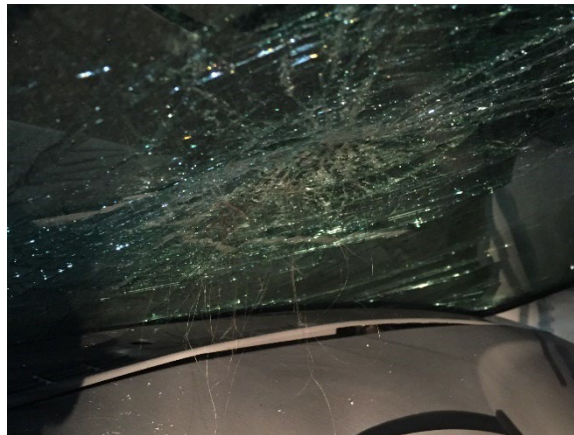
Driver contact to the windshield glazing was evident in several law enforcement images. Contortion of the driver's body over the compressed steering wheel/column during the crash allowed her head to strike the windshield immediately above and to the right of the steering assembly. The driver's head fractured the laminated glazing and embedded strands of the driver's hair into the fracture site (Figure 11, an on-scene law enforcement image categorized in the on-scene images of the Crash Viewer application). A second windshield fracture site was located adjacent to the left upper A-pillar, attributed to contact from the driver's left hand/forearm. Induced deformation fractures to the glazing were apparent around the windshield's outer edges. The tempered left-front door glazing was shattered by the first arriving law enforcement officer. All other door glazing (closed) and the backlight glazing remained intact and were not damaged or contacted relative to the crash or occupant.

Figure 11. Law enforcement image of the vehicle's windshield and driver contact damage

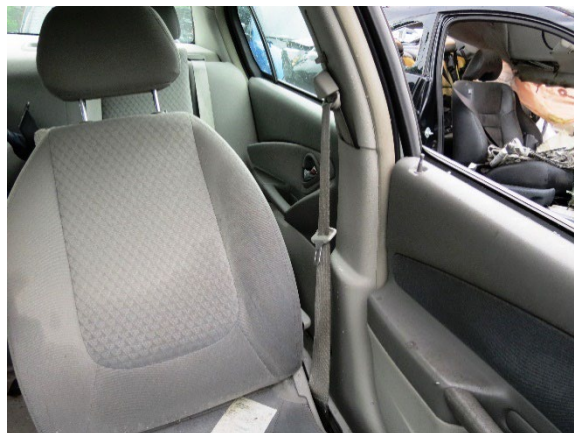
At the time of the SCI vehicle inspection, the driver's D-ring was adjusted to the full-down position. The seat belt was stowed against the B-pillar, and the webbing spooled freely from/retracted to the ELR retractor. There was no occupant loading evidence and/or damage discernable on the driver's seat belt system, and the retractor pretensioner was not actuated.

Figure 12 shows the driver's seat belt system at the time of the SCI vehicle inspection. Based on the post-crash condition of the system and the contact evidence in the vehicle as observed by the SCI investigator during the inspection, and in conjunction with the data imaged from the Chevrolet's EDR, it was apparent that the driver was not belted at the time of the crash.

Figure 12. View of the driver's seat belt system at the time of the SCI vehicle inspection

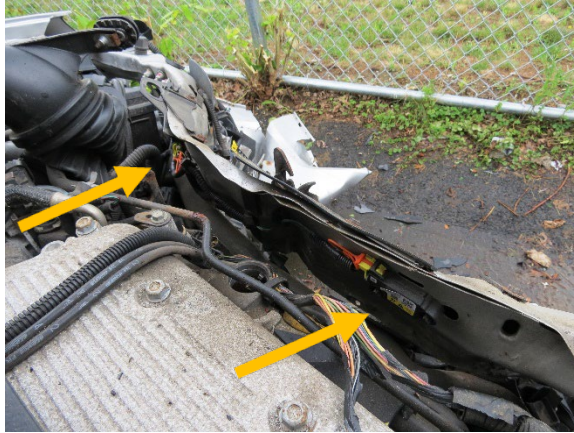
Two remote satellite sensors for the frontal air bag system were mounted to the aft side of the upper radiator support (identified by the arrows in Figure 13). The satellite sensors were identified by the following nomenclature: Left – AD1097R00TBA, 5WK4384901, and 15821097; Right – AD1097R00NHS, 5WK438901, and 15821097. The upper radiator support was deformed by the exterior crush, and, although the sensors were rotated from their original mounted positions, they were not physically damaged.

Figure 13. Satellite crash sensors mounted to the radiator support
