DOT HS 813 330

**Special Crash Investigations:
On-Site Air Bag Non-Deployment
Crash Investigation;
Vehicle: 2012 Honda Accord;
Location: North Carolina;
Crash Date: September 2019**

**Special Crash Investigations
On-Site Air Bag Non-Deployment Crash Investigation
Office of Defects Investigation
Case Number: CR19005
Vehicle: 2012 Honda Accord
Location: North Carolina
Crash Date: September 2019**

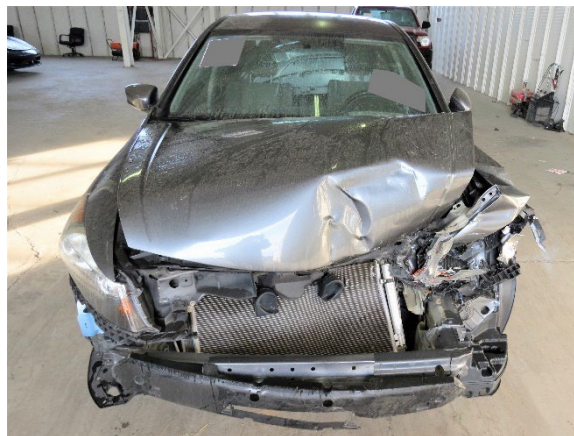
This crash involved the Honda's front plane, and the damage pattern resembled an underride profile. This damage profile resulted from the forward pitch of the Honda immediately prior to impact caused by the driver's panic braking avoidance attempt. Combined with the higher profile of the vehicle it struck, the front plane of the Honda submarined under the rear plane of the Dodge.

Direct contact damage began on the left front bumper corner of the Honda and extended 80 cm (31.5 in) rightward to 24 cm (9.4 in) right of center. The direct contact damage on the Honda's hood began on the left leading edge and extended right to the vehicle's centerline. Within the damage pattern was longitudinal deformation to the left-front fender, hood, upper radiator support, radiator, and underhood components. There was minimal deformation to the bumper beam (Figure 4). The left-front headlight assembly was disintegrated, and the bumper fascia assembly was separated from the front plane. A rectangular impression was discernable in the hood immediately left of the Honda's centerline, which resembled the rear license plate of the struck vehicle and was evidentiary of the vehicles' alignment at impact.

Figure 4. Front-plane damage profile to the Honda

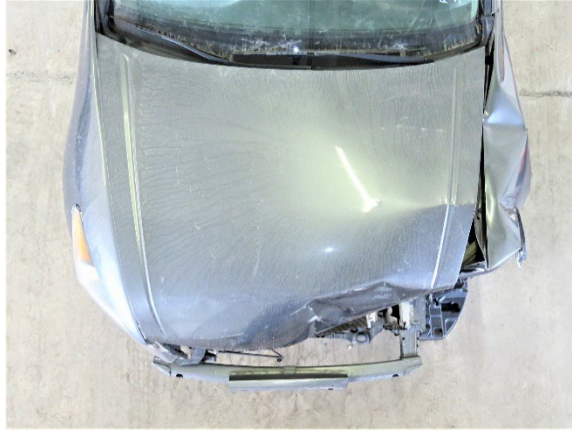
Figure 5. Overhead perspective of the damage profile

A residual crush profile was documented to the bumper beam and upper radiator support of the Honda using a Field-L width of 112 cm (44.1 in). The resultant underride crush profile produced the following averaged measurements: C1 = 14 cm (5.5 in), C2 = 11 cm (4.3 in), C3 = 9 cm (3.5 in), and C4 – C6 = 0 cm (0 in). Maximum crush was 26 cm (10.2 in), observed to the upper radiator support above the vehicle's left front bumper corner (Figure 5). A corresponding collision deformation classification (CDC) of 12FYEW2 was assigned to the Honda's crash damage profile.

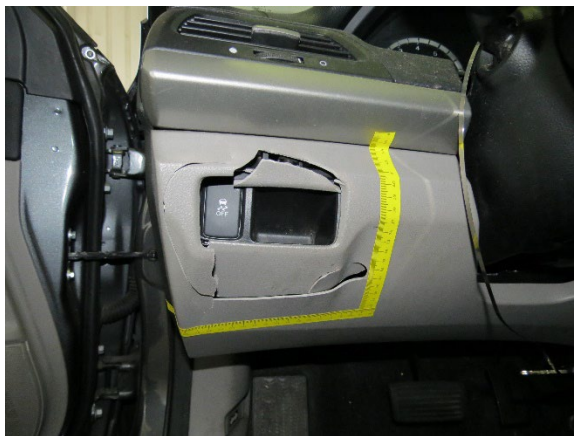
Interior inspection of the Honda revealed that there was no intrusion into the occupant compartment of the vehicle and no loss of integrity. Historical wear-and-tear to the vehicle was evident, with discoloration to frequently touched/contacted surfaces such as the door panels, left B-pillar, steering wheel, seats, and vehicle controls. One area of occupant contact was identified, located on the left aspect of the Honda's left instrument panel. The driver's left knee had contacted and engaged the instrument panel during the crash, fracturing and deforming the plastic molded surface and panel surrounding an electronic switch for the vehicle's electronic traction control and a small storage compartment (Figure 6). This contact had resulted in corresponding soft tissue injuries to the driver's left knee. No other occupant contact evidence or damage related to the crash was found during the SCI vehicle inspection.

Figure 6. Driver's left knee contact damage to the left aspect of the Honda's left instrument panel

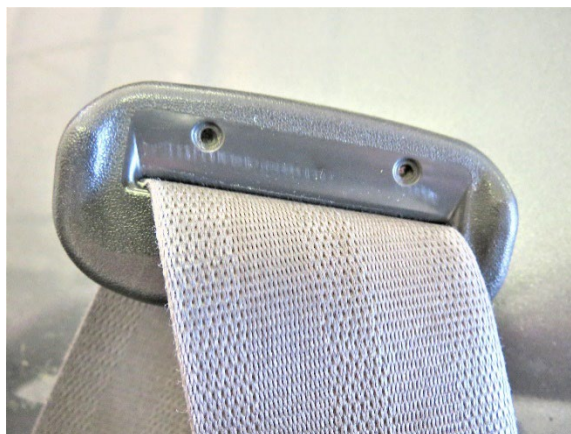
At the time of the SCI vehicle inspection, the driver's D-ring was adjusted full-down, and 167 cm (65.7 in) of webbing was extended from the retractor. There was significant historical wear on components of the driver's seat belt system. A distinct loading abrasion was visible in the belt path on the latch plate (Figure 7). The retractor was locked in position, related to the actuation of the retractor pretensioner. It was apparent to the SCI investigator that the driver used the Honda's seat belt system for manual restraint at the time of the crash.

Figure 7. Loading abrasion in the belt path on the latch plate of the Honda's driver seat belt system
