DOT HS 813 349

**Special Crash Investigations:  
On-Site Reported Driver Manual  
Restraint System Malfunction  
Crash Investigation;  
Vehicle: 2018 Honda Civic EX;  
Location: Florida;  
Crash Date: January 2020**

**Special Crash Investigations  
On-Site Reported Driver Manual Restraint System  
Malfunction Crash Investigation  
Office of Defects Investigation  
Case Number: CR20008  
Vehicle: 2018 Honda Civic EX  
Location: Florida  
Crash Date: January 2020**

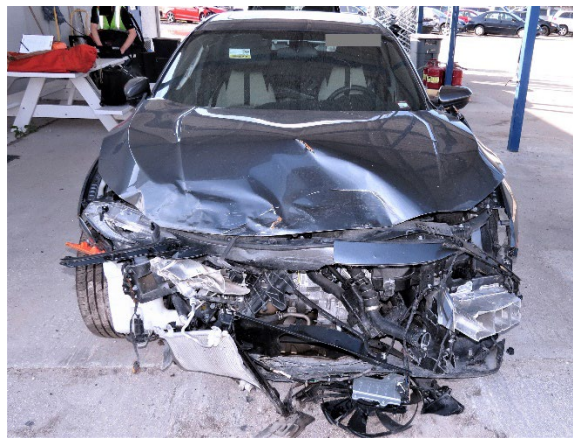
The Honda's front plane damage pattern resembled an angular distributed impact to the right and center aspects of the vehicle. The bumper fascia, grille, bumper beam, and other frontal components were completely separated from the vehicle by the angular crash forces. Figure 7 shows the damage pattern from a horizontal frontal perspective, while Figure 8 shows the direct contact and front damage profile from overhead. Direct contact on the hood began on the far right corner and extended to 29 cm (11.4 in) left of center. The hood itself was shifted 10 cm (3.9 in) to the left. Overall direct damage width measured 111 cm (43.7 in), beginning at the right front bumper corner. Rubber tire transfer from the left front tire/wheel of the Lexus was visible on the center aspect of the Honda's deformed/separated bumper beam.

*Figure 7. Front plane damage to the Honda at the time of the SCI vehicle inspection*

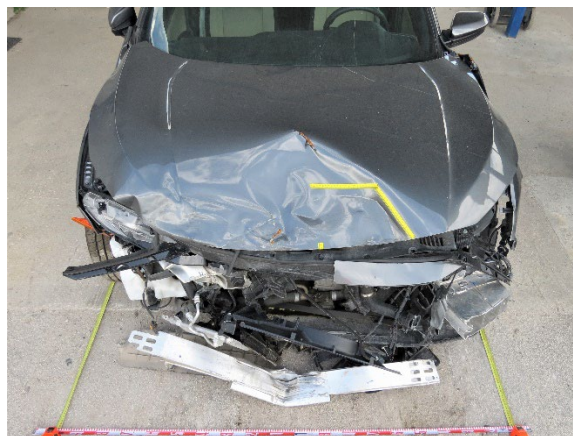
*Figure 8. SCI documentation of the Honda's front plane damage pattern*

A residual crush profile was documented to the remaining front plane components to serve as a most representative profile of the sustained crush. The corresponding direct and induced damage width (Field-L) was 149 cm (58.7 in). Resultant measurements included: C1 = 10 cm (3.9 in), C2 = 14 cm (5.5 in), C3 = 34 cm (13.4 in), C4 = 30 cm (11.8 in), C5 = 23 cm (9.1 in), and C6 = 22 cm (8.7 in). Maximum crush was observed immediately to the right of the Honda's centerline. A collision deformation classification (CDC) of 01FDEW2 was assigned to the Honda's front plane damage profile. The damage algorithm of the WinSMASH model was used to calculate the severity of the crash. The total calculated vehicle velocity change (delta V) of the crash for the Honda was 26 km/h (16 mph). Specific longitudinal and lateral components of the calculated delta V were -20 km/h (-12 mph) and -17 km/h (-11 mph), respectively. Based on SCI expertise and observed vehicle damage, and compared to the EDR-reported delta V values, these results fit the collision model but were underestimated.

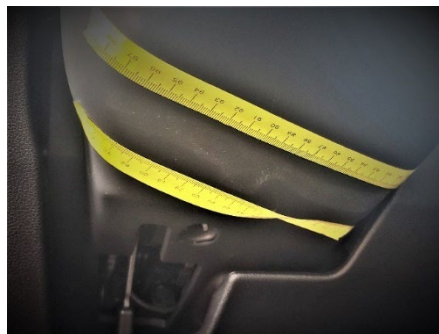
*Figure 9. Left knee scuff and skin transfer to the underside of the Honda’s steering column*

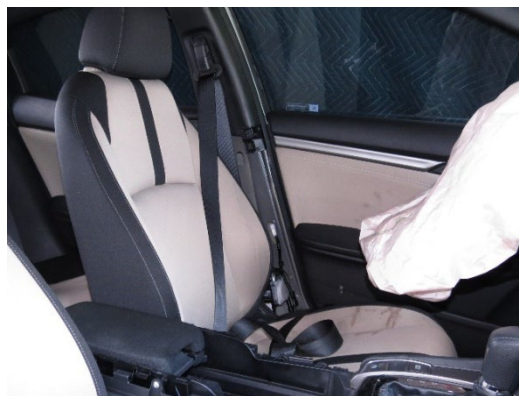
At the time of the inspection, the SCI investigator found the driver seat belt system hanging loosely against the B-pillar, with the D-ring adjusted to its highest position and the webbing extended in a used position. The retractor pretensioner was actuated, and the webbing was locked in position. Examination of the webbing identified several areas of polymer transfer and apparent loading evidence, and the webbing was observed to be gathered and jammed into the latch plate.

Figure 10 shows the driver's seat belt during the SCI vehicle inspection, while Figure 11 shows the driver's latch plate. There were 188 cm (74.0 in) of exposed webbing from the D-ring to the latch plate, and an additional 85 cm (35.5 in) of exposed webbing from the latch plate to the lower anchor. The lower anchor was loose in the vehicle, no longer threaded into or otherwise attached to the lower B-pillar mounting location. Figure 12 shows the loose lower anchor/bolt, while Figure 13 shows the mounting location in the lower left B-pillar.

*Figure 10. Driver's seat belt in the Honda during the SCI vehicle inspection*

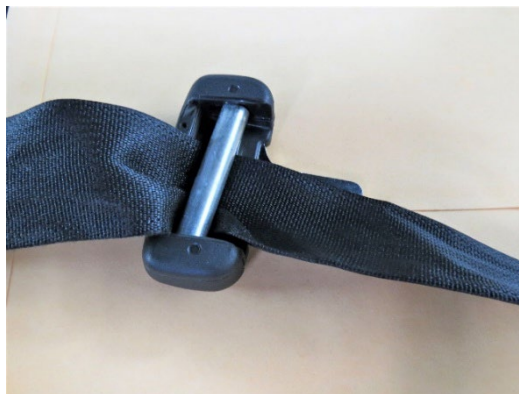
*Figure 11. Seat belt webbing gathered in the latch plate of the Honda's driver seat belt*

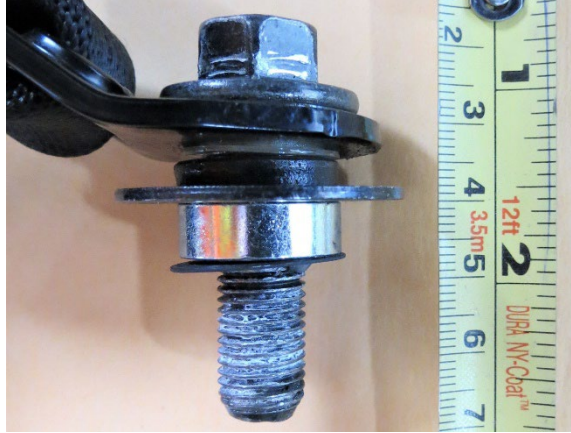
*Figure 12. Lower anchor bolt of the Honda's driver seat belt system at the time of the SCI inspection*

The lower anchor bolt had tool marks visible on the hexagonal head. There was residue from the OEM thread lock in the threads, which showed the bolt had been removed since the vehicle was manufactured. Of the exposed circumferential threads on the bolt, only the bottom two appeared damaged. These two bottom threads were bent slightly. The mounting location showed circumferential scratching on the metallic surface of the lower B-pillar that evidenced removal of the bolt. The outermost thread of the hole was peened, and there was a swiping mark on the polymer trim at the forward upper corner. Despite the damage to the bottom two threads of the bolt and the outermost thread of the hole, the SCI investigator was able to thread the bolt back into its mounting location with numerous revolutions.

Based on the minor damage to the bolt and its mounting location, it was evident that the bolt was only inserted/tightened a maximum of two complete revolutions when the crash occurred. Under the significant loading force from the driver that was translated through the webbing to the bolt during the crash, the un-torqued bolt pulled loose from its mounting. This was evidenced by the swipe/peen mark on the forward upper corner of the hole in the polymer fascia. It was obvious to the SCI investigator that the bolt had been removed after the Honda's original manufacture and not properly installed and re-torqued.

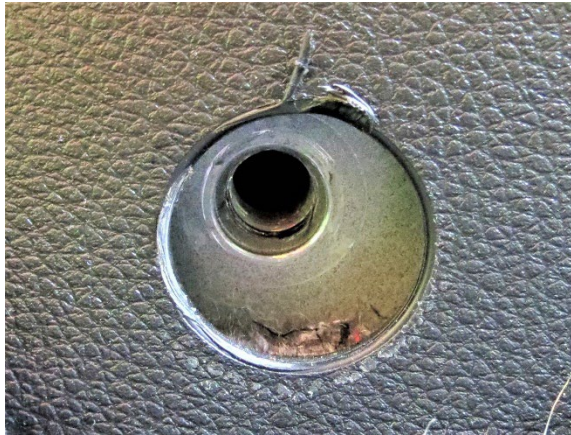
*Figure 13. Lower B-pillar mounting location of the driver seat belt's lower anchor in the Honda*

In order to route this subwoofer wire from the amplifier to the trunk space, the installer had removed the lower anchor bolt of the driver's seat belt system. It would not have been possible to route the wire in this manner without removing the bolt, as removal of the lower anchor bolt was required in order to remove the lower B-pillar fascia and surrounding trim. Based on all available evidence, the installer of the aftermarket stereo system had removed the lower anchor bolt of the driver's seat belt system from the Honda to facilitate installation of the aftermarket stereo equipment, and then neglected to properly re-torque the lower anchor bolt upon completion of the stereo system installation. Over the months between the installation of the aftermarket stereo system and the crash under investigation, the improperly re-installed bolt likely loosened further, to the point that it was inserted less than two circumferential threads into the anchor location. Under the loading force experienced during the crash under investigation, the improperly installed and loose bolt pulled from its mounting location. The release of the Honda's lower anchor did not appear to be a result of manufacturer negligence or vehicle performance malfunction, but rather was an isolated occurrence with specific and unique circumstances as described.

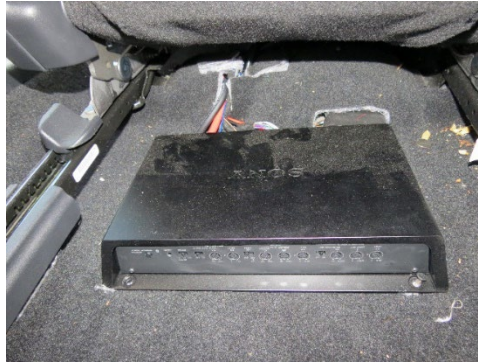
Further investigation revealed the aftermarket stereo equipment installed in the Honda. This included a Sony model XM-GS6DSP class-D 6/5 channel amplifier mounted to the floor beneath the driver's seat (Figure 14). Aftermarket electrical wiring to supply power to the amplifier was routed from the amplifier to the left sill, beneath the trim/fascia along the sill to the left A-pillar, up the A-pillar and through the firewall into the engine compartment, and connected directly to the Honda's 12-V battery. In addition, an aftermarket 12-gauge copper paired primary wire with quick connectors was found in the trunk space (Figure 15).

*Figure 14. Aftermarket Sony amplifier installed beneath the Honda's driver seat*

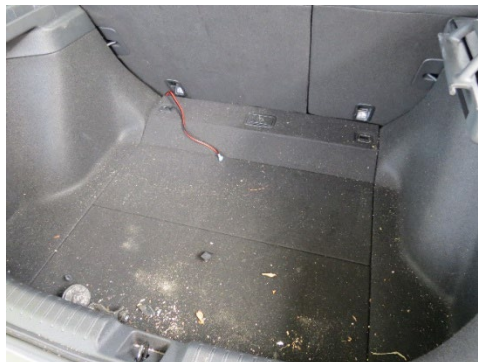
*Figure 15. Exposed wiring in the Honda's trunk space, determined to be for an aftermarket subwoofer*

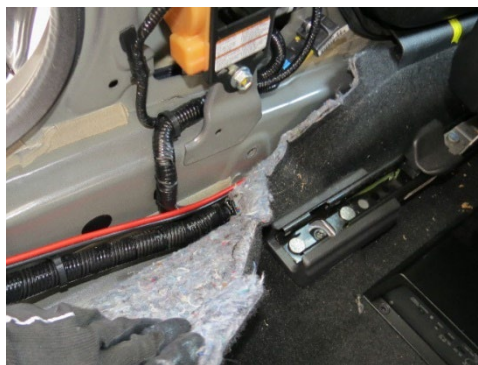
*Figure 16. View of the subwoofer wire routed behind the trim, fascia, and carpet along the Honda's left sill*

This aftermarket wire was routed down below the carpeting to the left C-pillar, along the left sill beneath and behind the trim/fascia past the left-pillar (Figure 16). It continued back to the amplifier, where it was connected to the positive and neutral terminals of the woofer/subwoofer outlet on the back of the amplifier. In order to visualize/observe the subwoofer wiring and trace its path, the SCI investigator had to remove the B-pillar fascia and surrounding trim panels.

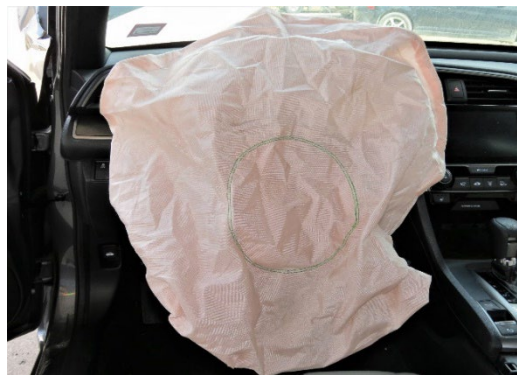
The driver's frontal air bag deployed from the steering wheel hub-mounted module and through the tri-configuration cover flaps without damage. In its deflated state, the driver's frontal air bag measured approximately 70 cm (28 in) in overall diameter. It had a 19 cm (7.5 in) wide circular center stitch pattern, to which internal tethers were affixed. The air bag was vented on its rear aspect by a pair of 5 cm (2.0 in) diameter vent ports, located at the 11 o'clock and 1 o'clock

positions. There was no discernable occupant contact evidence or other crash-related damage to the Honda's deployed driver's frontal air bag.

*Figure 17. View of the deployed driver's frontal air bag in the Honda at the time of the SCI inspection*

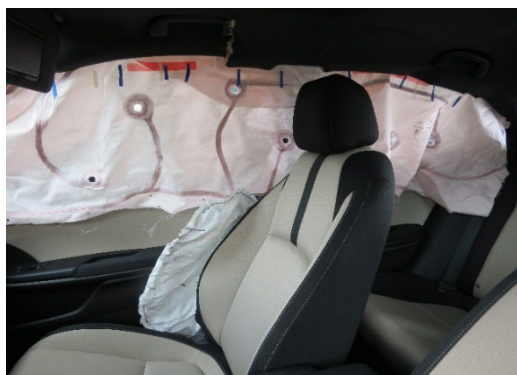
The Honda's right front seat-mounted side impact air bag deployed forward through the outboard edge stitching of the seatback. In its deflated state, the air bag measured approximately 58 cm (23 in) tall and was a maximum of approximately 28 cm (11 in) wide. There were two 3 cm (1.2 in) diameter vents located on the upper forward aspect. There was no damage or contact to the Honda's deployed right front seat-mounted air bag.

The right IC air bag deployed downward from the roof side rail mounting location through the edge of the headliner. It extended the full 203 cm (79.9 in) length from the right A-pillar to the right C-pillar, and provided outboard protection for the full glazing height from the roof side rail to below the beltline. A fabric tether attached the lower aspect to the A-pillar. There was no contact to the deployed right IC air bag; however, the fabric had been cut post-crash by an unknown person (presumably to gain unobstructed access to the Honda's interior).

*Figure 18. View of the deployed right front seat-mounted side impact and right IC air bags in the Honda*

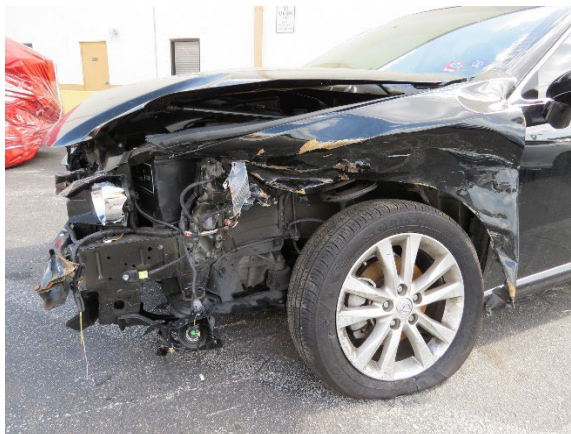
*Figure 20. Left front corner impact damage to the Lexus from the impact with the Honda*

The Lexus sustained front plane, left aspect damage from the impact with the Honda and front plane, center aspect damage from the secondary impact with the palm tree. Damage from first event with the Honda began on the left front bumper corner and extended 35 cm (13.8 in) to the right. A residual crush profile documented to the bumper beam of the front plane revealed crush only to the left end of the bumper beam (C1), with a magnitude of only 3 cm (1.2 in). The damage associated with the Honda struck extended down the left plane to the left A-pillar (Figure 20), and the left wheelbase was reduced by 19 cm (7.5 in). The corresponding CDC assigned to the Lexus was 11FLEE5.

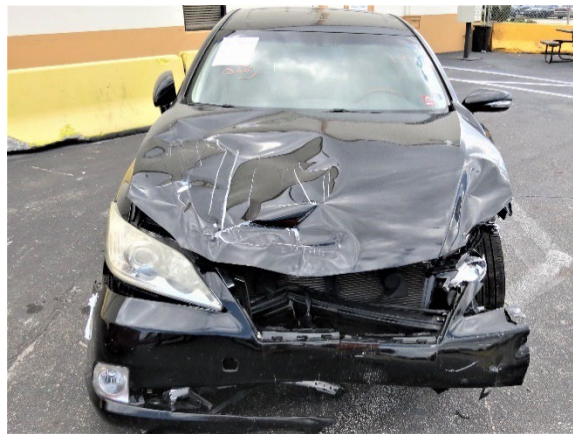
The secondary impact with the palm tree was centered in the Lexus' front plane (Figure 21). Direct contact measured 48 cm (18.9 in) wide. A residual crush profile was documented across the entire width of the front bumper beam, which measured 112 cm (44.1 in) wide. Resultant measurements included: C1 = 0 cm (0 in), C2 = 12 cm (4.7 in), C3 = 21 cm (8.3 in), C4 = 29 cm (11.4 in), C5 = 17 cm (6.7 in), and C6 = 0 cm (0 in). Maximum crush was observed at the Lexus's centerline. The CDC assigned to the Lexus for the large diameter tree impact was 12FCEW2. The damage algorithm of the WinSMASH model was used to calculate the severity of the crash. The total calculated vehicle velocity change (delta V) of the tree impact for the Lexus was 33 km/h (21 mph). Specific longitudinal and lateral components of the calculated delta V were -33 km/h (-21 mph) and 0 km/h (0 mph), respectively. Based on SCI expertise and observed vehicle damage, these results fit the collision model but appeared overestimated.

*Figure 21. Front plane damage to the Lexus, with the initial damage from the Honda on the left edge and the tree impact damage in the center aspect*
