DOT HS 813 350

**Special Crash Investigations:
On-Site Seat Belt Pretensioner Fire
Investigation;
Vehicle: 2016 Infiniti QX60;
Location: South Carolina;
Crash Date: October 2019**

Special Crash Investigations
On-Site Seat Belt Pretensioner Fire Investigation
Office of Defects Investigation
Case Number: CR19034
Vehicle: 2016 Infiniti QX60
Location: South Carolina
Crash Date: October 2019

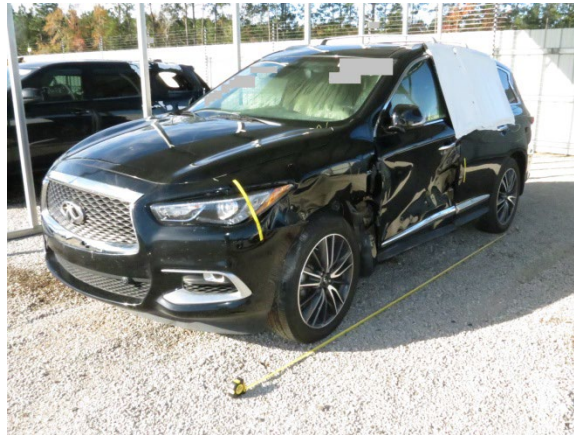
Figure 1. Left plane damage to the 2016 Infiniti QX60

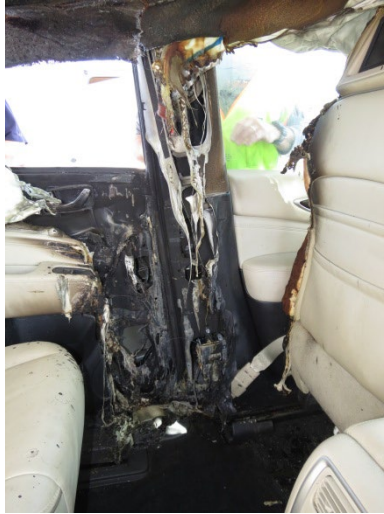
Figure 2. Interior view of the left B-pillar area and the fire damage

Through the course of the investigation, inspection, and the process of elimination, it was determined that the fire originated at the base of the left B-pillar. It is hypothesized that it was most likely caused by superheated exhaust gases of the left lower anchor pretensioner igniting combustible products associated with vehicle's components that were located in close proximity to its rear aspect, adjacent to the left B-pillar.

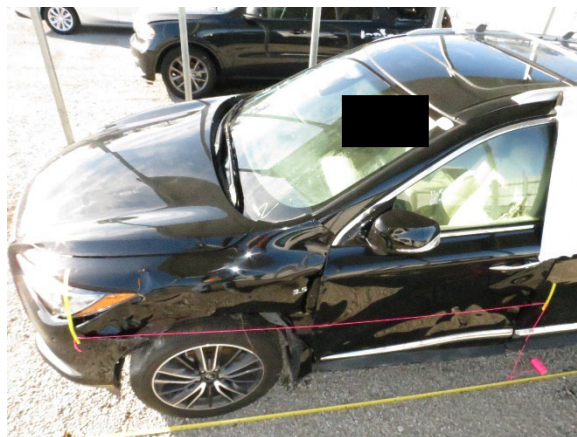
The deer ran into the left side of the Infiniti (Figure 5); the initial contact appeared to be a leg scuff at the corner of the front bumper fascia. As the deer struck the left front fender, it rotated counterclockwise by the forward velocity of the Infiniti. The deer dented the left front fender and driver's door. The direct contact damage began 341 cm (134.3 in) forward of the left rear axle position and ended 124 cm (48.8 in) forward of the referenced axle. A crush profile was documented at the level of the mid door along the damaged plane and was as follows: C1 = 0 cm, C2 = 9 cm (3.5 in), C3 = 6 cm (2.4 in), C4 = 6 cm (2.4 in), C5 = 6 cm (2.4 in), C6 = 0 cm. The Collision Deformation Classification (CDC) assigned to the damage pattern was 11LYES1. The damage to the left rear door jammed the door closed. There was no change in wheelbase dimensions or restrictions to the left side tires. The sideswipe/yielding animal impact was outside the scope of the WinSMASH program. For reference, the calculated barrier equivalent speed of the damage was 13 km/h (8 mph).

Figure 5. Left plane damage to the Infiniti

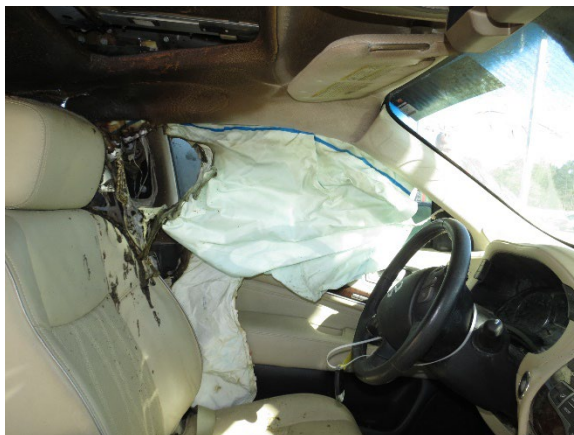
The Infiniti had the CAC driver's and passenger's frontal air bags, front-seat-mounted side impact air bags and roof side rail-mounted IC air bags. Only the driver seat-mounted side impact air bag and left IC air bag deployed in the crash. These air bags were damaged in the fire (Figures 6 and 7).

Figure 6. Lateral view of the Infiniti's deployed left seat-mounted side impact and IC air bags

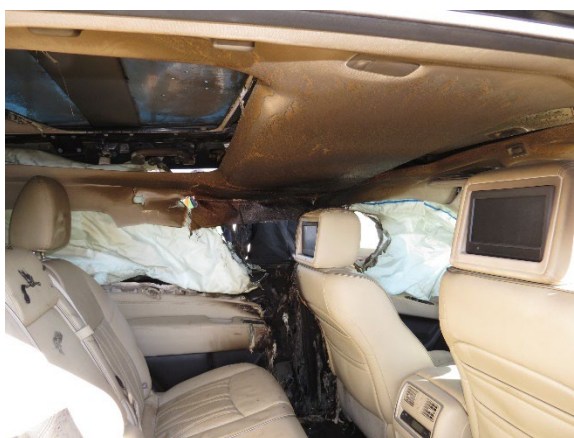
Figure 7. Left lateral view of the Infiniti's deployed left IC air bag at the second row

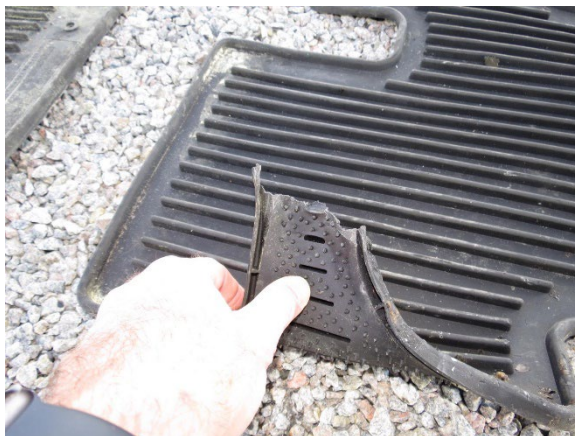
Figure 10. View of the Infiniti's OEM second row rubber floor mat damaged by the fire

Fire damage was present at the left end of the second row rubber mat. A 6 cm (2.4 in) long section of the mat at its extreme left end was consumed by the fire (Figure 10). This section would have been positioned adjacent to the B-pillar. The carpeted mat directly on top of the consumed section had no observable damage (Figure 11).

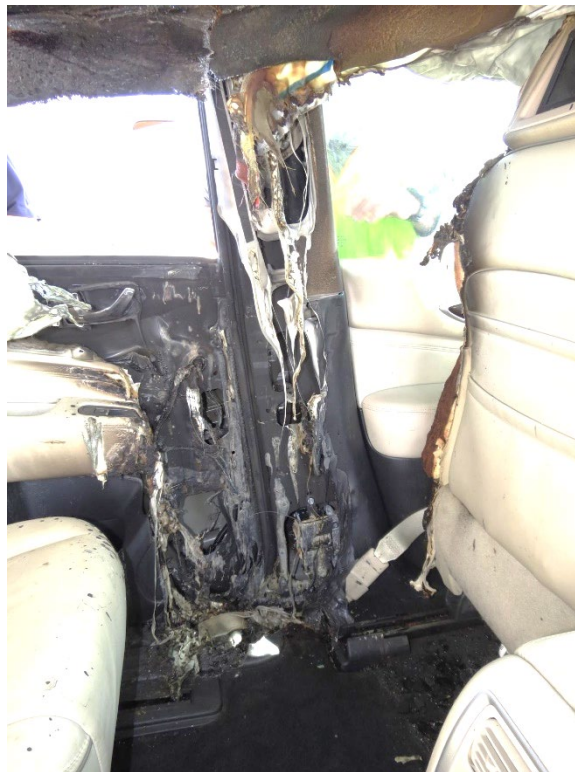
Figure 12. Overall view of the Infiniti's fire damage

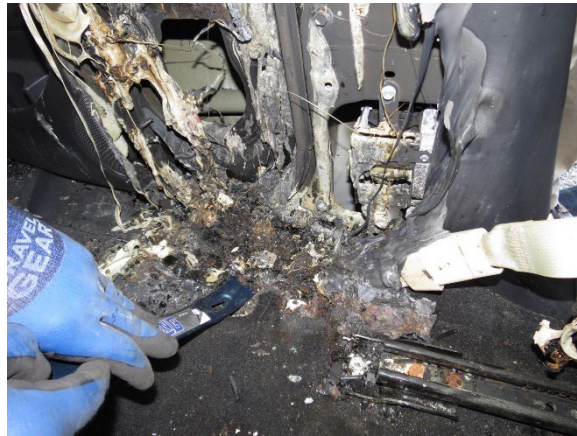
To improve access to the fire-damaged area (Figure 12), the electronic driver seat was moved 18 cm (7.1 in) forward, from its mid-to-rear at-crash track position, and tilted forward. During the inspection, fire debris was removed layer-by-layer to gain access to wiring harnesses, the retractor pretensioner, and the lower anchor pretensioner. The fire debris consisted of melted plastic and glass, as the consumed materials at the mid-pillar and left second door panel fell onto the floor and became fused (Figure 13). After the passengers got out, the driver seat belt webbing became involved in the fire. A portion of the webbing was recovered from the debris. The carpet and insulation surrounding this debris field was cut and removed. There was a heat-stressed area immediately behind the B-pillar at the floor level, but there was no damage to the wiring harness to suggest that the fire had initiated in the harness (Figure 14).

Figure 13. Close-up view of the fire debris and damage at the base of the Infiniti's B-pillar

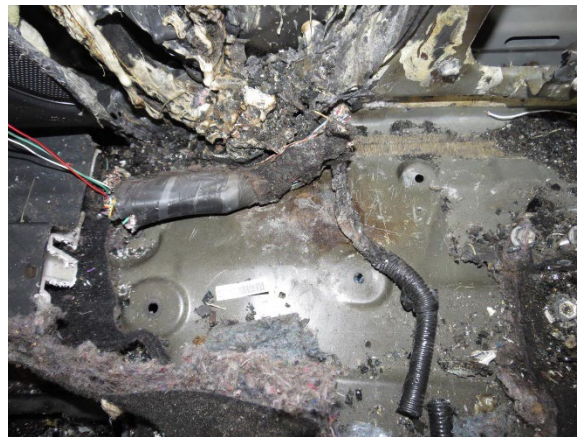
Figure 14. View after the removal of the fire debris at the base of the Infiniti's B-pillar

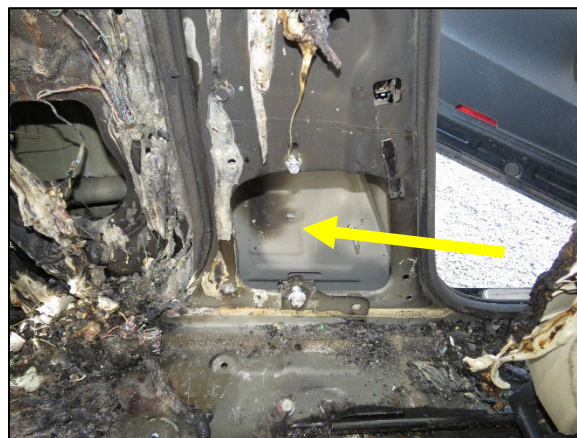
A region of discoloration was noted in the B-pillar cavity after the removal of the retractor (Figure 16). The discoloration was located behind the mounted location of the retractor and to the aft aspect of the cavity.

Figure 16. Image showing the Infiniti's left B-pillar cavity, discoloration in the cavity and aft of the retractor location

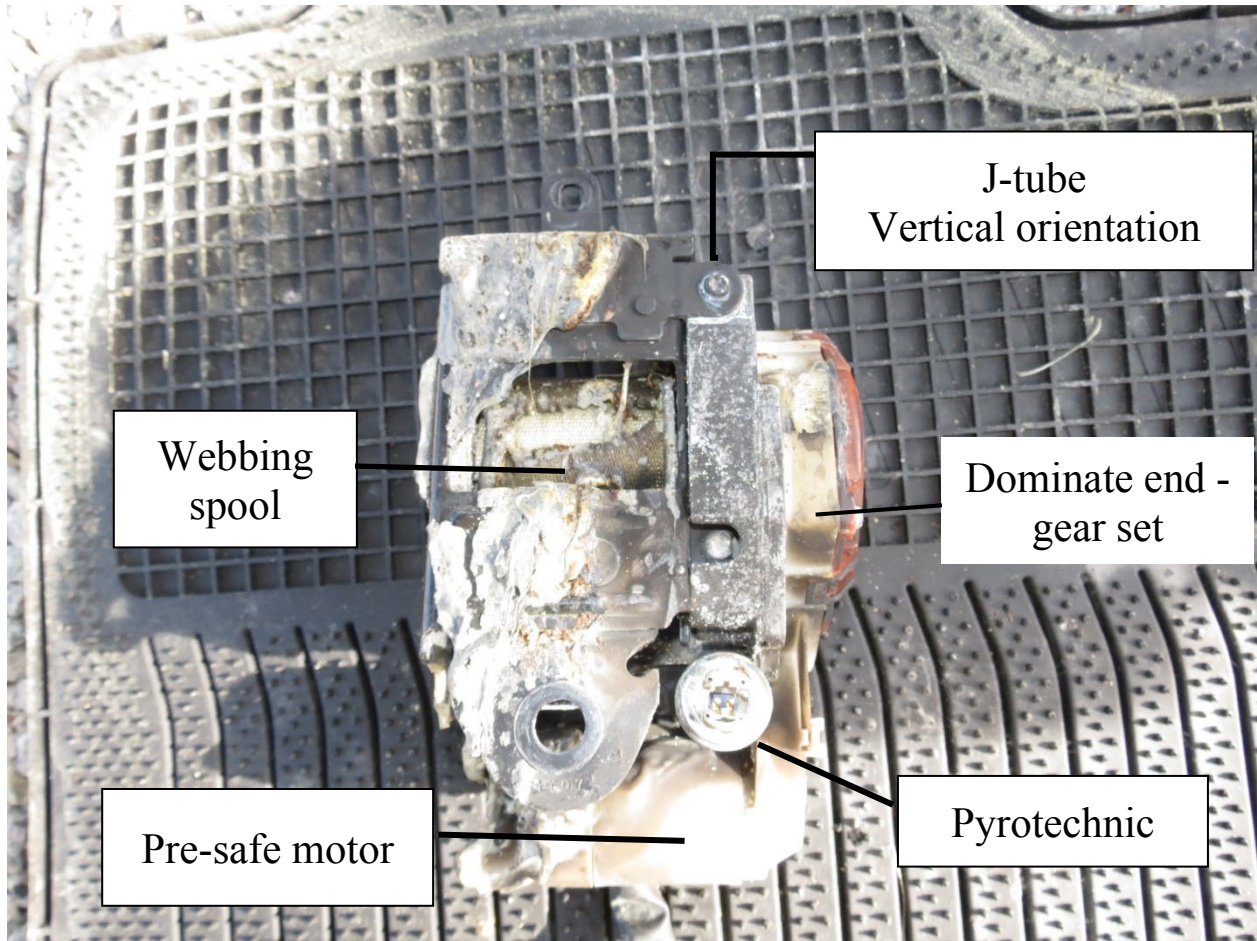
Figure 17. Close-up image showing the left retractor pretensioner after removed from the Infiniti. (interior surface shown)

Upon examination, heat stress and discoloration were noted on aft, interior, and bottom surfaces of the left retractor.

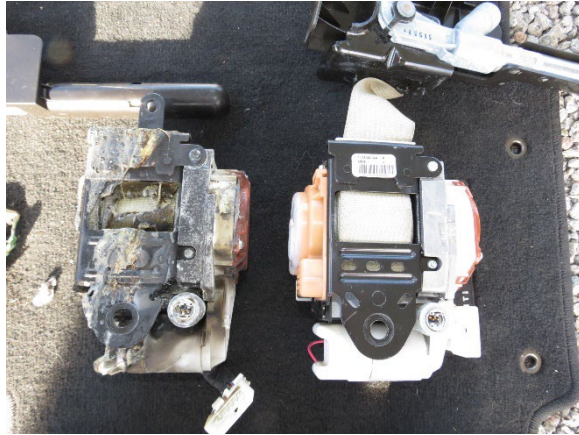
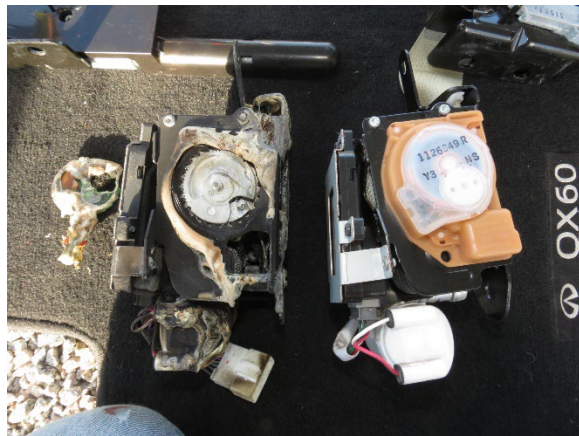
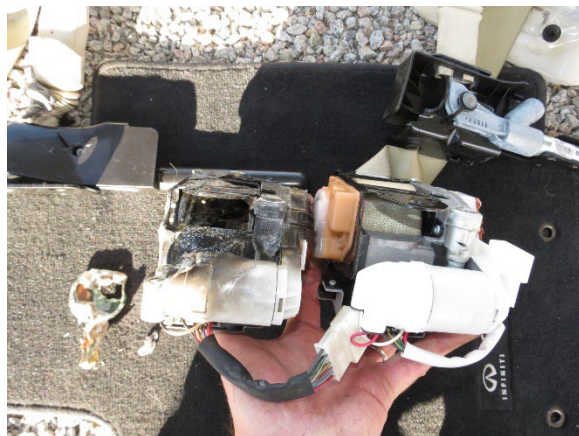
The undamaged right retractor was also removed and examined for comparison (Figures 18 - 20). A plastic cover on the exterior the left retractor melted during the fire, separated, and was recovered from the bottom/aft aspect of the left B-pillar cavity. The plastic component separated from the non-dominant (aft aspect) of the retractor (Figure 19).

Figure 18. Image showing the left and right retractor pretensioners (interior surface shown) removed from the Infiniti

Figure 19. Image showing the left and right retractor pretensioners (aft surface shown) removed from the Infiniti

Figure 20. Image showing the left and right retractor pretensioners (bottom surface shown) removed from the Infiniti

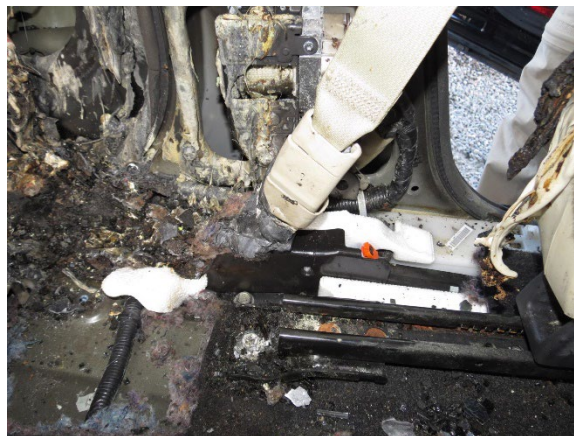
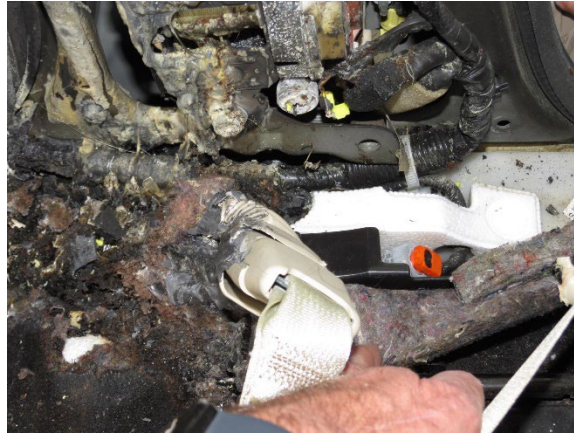
The left lower anchor pretensioner is shown in Figures 24 and 25 prior to its removal. A significant fire damage pattern was located aft of the lower anchor pretensioner. The combustible materials surrounding the rear aspect of the left pretensioner were consumed during the fire. The combustible materials surrounding the rear aspect of the left lower anchor, below the level of the carpet were damaged or consumed by the fire. This included insulation, polystyrene foam, and a small area of the carpet. The SCI investigator observed that this was the lowest area of fire damage, located in a protected area beneath the top surface of the carpet.

Figure 24. Interior image showing the left lower anchor and fire damage in the Infiniti

Figure 25. Interior image showing the left lower anchor and fire damage in the Infiniti

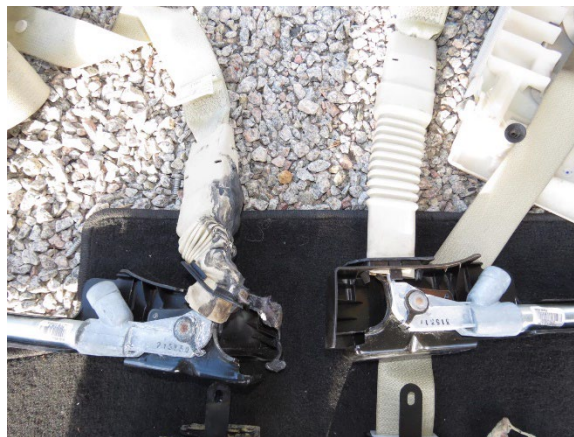
Figure 26. View of the Infiniti's driver and right passenger anchor pretensioners

The examination of the lower anchor pretensioner exhibited fire damage at its rear aspect at the junction with the mounting bracket and accordion sleeve surrounding the pull cable. The pyrotechnic remained crimped and visually sealed. The accordion sleeve appeared fully compressed. All melted/burned debris was external to the pretensioner assembly.
