DOT HS 813 364

**Special Crash Investigations:
On-Site Air Bag Non-Deployment
Crash Investigation;
Vehicle: 2016 Ford Explorer Police
Interceptor;
Location: Louisiana;
Crash Date: April 2017**

Special Crash Investigations
On-Site Air Bag Non-Deployment Crash Investigation
Office of Defects Investigation
Case Number: CR17007
Vehicle: 2016 Ford Explorer Police Interceptor
Location: Louisiana
Crash Date: April 2017

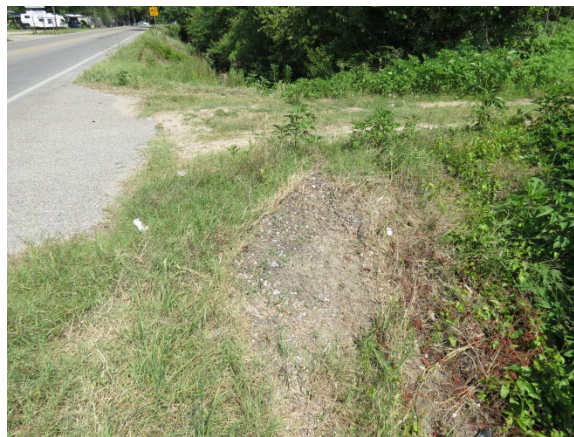
The first crash event occurred as the Ford gently ramped up the west edge of a driveway that intersected the roadway. This caused the undercarriage of the Ford to scrape the soil/gravel surface (Event 1), evidenced by displacement of the material as observed at the time of the SCI crash site inspection. Crash forces were of insufficient magnitude to affect or alter the Ford's errant trajectory.

Figure 3. East-facing view of the gouge mark in the soil/gravel surface of the roadside from the Ford's undercarriage impact (Event 1)

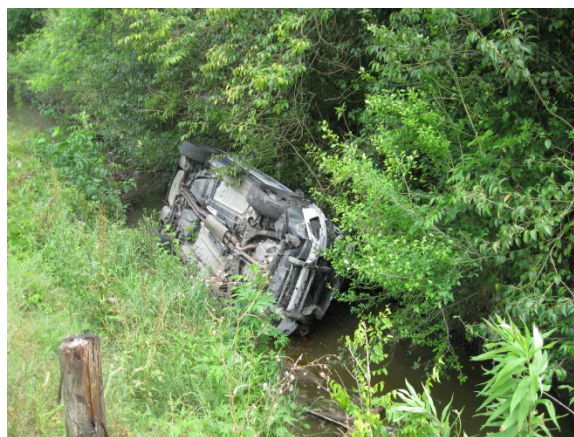
In this manner, the Ford stood nearly upright on its front plane in the drainage ditch before it flopped downward into the water onto its left plane (Event 3). This rollover event was not interrupted, but brought the Ford to final rest in the water of the drainage ditch. At rest, the Ford was positioned facing west and on its left plane, located approximately 16.0 m (52.5 ft) east of the initial undercarriage impact. Figure 3 shows the driveway and area of impact for the first event, while Figure 4 shows the drainage canal and the Ford's final rest position in an on-scene image obtained from the law enforcement agency.

Figure 4. View of the Ford on its left plane at final rest in the drainage canal (on-scene image obtained from the law enforcement agency)

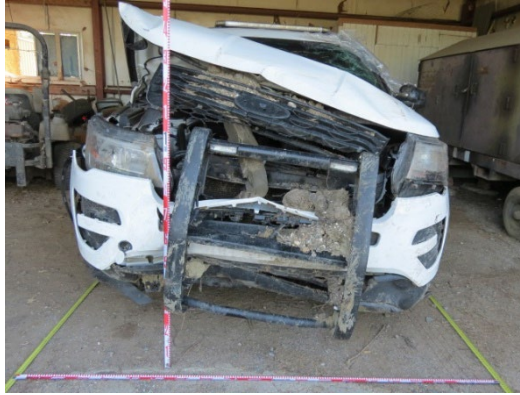
Damage from the Event 2 impact with the bottom of the drainage canal was located on the Ford’s front plane, biased to the right side. Mud was packed into the various surfaces of the front plane, with significant visible damage and deformation to surrounding components. An aftermarket bumper guard was slightly deformed, with mud packed into its left aspects. The bumper beam and fascia were also deformed, the grille was fractured and displaced, and the hood was deformed in a vertical “tented” fashion (Figure 6). It was apparent to the SCI investigator that the aftermarket bumper guard provided additional rigidity to the Ford’s front plane, and therefore decreased the significance of the deformation sustained to it.

Figure 6. View of the Ford's front plane damage

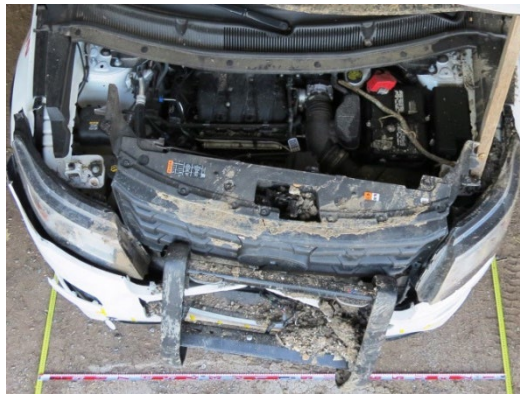
Direct contact appeared to span the entire 180 cm (70.9 in) end width of the vehicle. Using a direct and induced damage length (Field-L) of 120 cm (47.2 in) across the bumper beam’s entire width, a residual crush profile was documented with the following resultant measurements: C1 = 6 cm (2.4 in), C2 = 11 cm (4.3 in), C3 = 14 cm (5.5 in), C4 = 16 cm (6.3 in), C5 = 14 cm (5.5 in) and C6 = 6 cm (2.4 in). Maximum crush was located 12 cm (4.7 in) right of the vehicle’s centerline. Figure 7 shows the Ford’s front plane deformation from overhead . The CDC

assigned to the Ford for the Event 2 impact was 00FDEW1. The barrier algorithm of the WinSMASH model was used to calculate a borderline reconstruction of the Event 2 impact for analysis purposes. The total calculated delta V was 23 km/h (14 mph), with a longitudinal component of -23 km/h (-14 mph) and a lateral component of zero.

Figure 7. Overhead view of the Ford's front plane damage profile

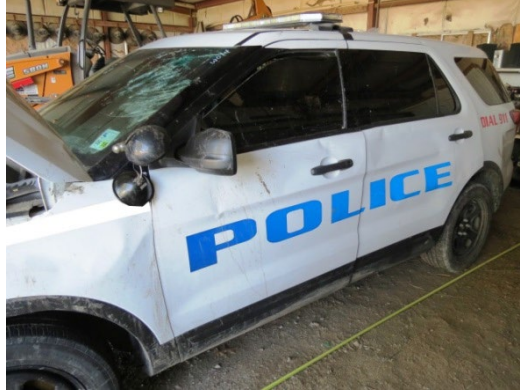
Figure 8 shows the Ford's left plane damage. There was slight deformation to the left door panels, with the maximum lateral deformation that measured approximately 5 cm (2.0 in) in magnitude located on the upper aspect of the left front fender. The CDC assigned to the Ford for the Event 3 damage was 00LDAO2. No delta V calculations could be performed due to the non-horizontal nature of the impact forces, the lack of deformation to the vehicle, and the dynamics of the roll that were beyond the capabilities of the WinSMASH model.

Figure 8. Minimal damage to the Ford's left plane

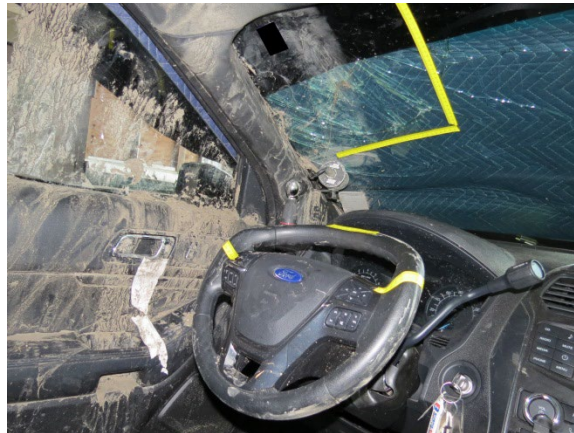
There were two particular areas of occupant contact identified in the Ford. The first was significant forward collapse/deformation of the upper half of the steering wheel rim. It was apparent the driver loaded the steering wheel rim with her chest and abdomen during the crash sequence. Despite significant deformation to the rim, the column and shear capsules remained intact. The second area of occupant contact was located on the left upper aspect of the windshield. This consisted of an approximate 30x30 cm (11.8x11.8 in) area that was fractured in a circular pattern, with numerous strands of the driver’s hair captured on the sharp edges of the fractured glazing. It was apparent that this contact was from the driver’s head and face. Figure 9 shows the identified contacts in the Ford. It is probable that the driver also struck the left upper

A-pillar, left roof side rail, and windshield header during the rollover sequence and as the vehicle came to final rest. She also likely struck the partially opened [<5 cm (<2.0 in)] left front glazing. However, these surfaces were covered in mud residue at the time of the SCI inspection as a result of water infiltrating into the overturned vehicle following the crash. This prevented identification and documentation of such contact. With exception to the windshield that was fractured by occupant contact, all the Ford's remaining glazing remained intact and was undamaged during the crash sequence.

Figure 9. Driver contact to the steering wheel rim and windshield with the Ford

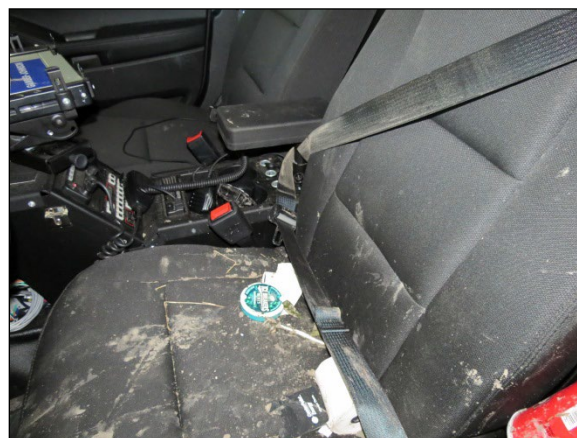
Figure 10. View of the driver's seat belt in the Ford at the time of the SCI inspection

At the time of SCI inspection the driver seat belt was extended from the retractor with the webbing wrapped around the armrest of the center console (Figure 10). There was no discernable loading evidence to the latch plate or webbing material.

It was initially theorized that the belt was routinely positioned in this fashion with the latch plate engaged in the buckle as a form of habitual non-use with intent to overcome the repetitive seat belt chime warning. However, the imaged EDR data indicated that the driver's seat belt system was unbuckled at the time of the crash. Therefore, although the specific positioning of the seat belt system remains unknown, it is certain that the system was not in use by the driver at the time of the crash. The front right occupant's seat belt system remained functional and was loosely stowed against the B-pillar. It was not in use at the time of the crash. The same was true of all three of the second row seat belt systems.

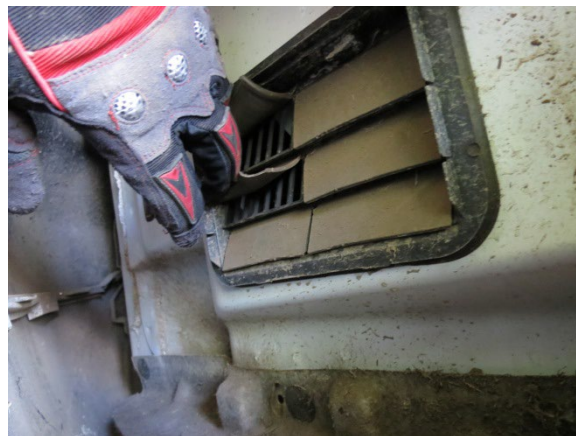
Figure 11. View of the Ford's right rear air extractor

Figure 11 shows the Ford's air extractor at the right rear corner of the vehicle at the time of the SCI vehicle inspection. The extractor was a polymer vent that had six flexible flaps on the outer surface. It should be noted that at the time of the SCI on-site investigation, the SCI investigator was aware only of the right rear air extractor. Following the vehicle inspection, it was learned that there was an additional air extractor on the left side of the vehicle in the same general location. The left air extractor was not visually inspected as part of the on-site vehicle inspection.

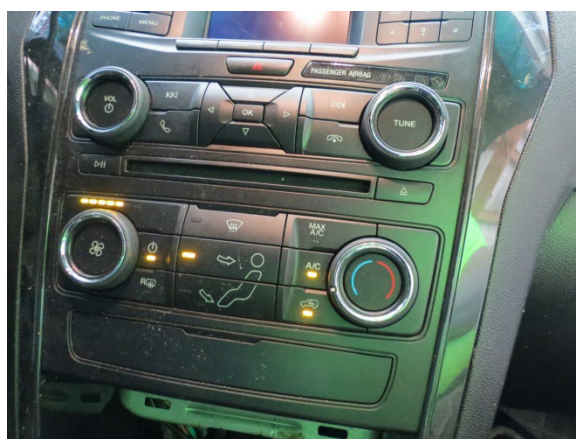
The SCI investigator succeeded in turning on the Ford's ignition, and observed the climate control system as it became energized and began operation. Unaltered from the time of the crash, the HVAC was turned on and the temperature control was adjusted to its coldest setting, with the blower adjusted to a 5/7 (70%) power setting and the recirculate turned on. The HVAC discharge setting was adjusted to direct air toward the occupant torso/face. Figure 12 shows the HVAC and climate control knobs/and adjustments.

Figure 12. Energized and operating HVAC and climate system controls in the Ford during the SCI inspection

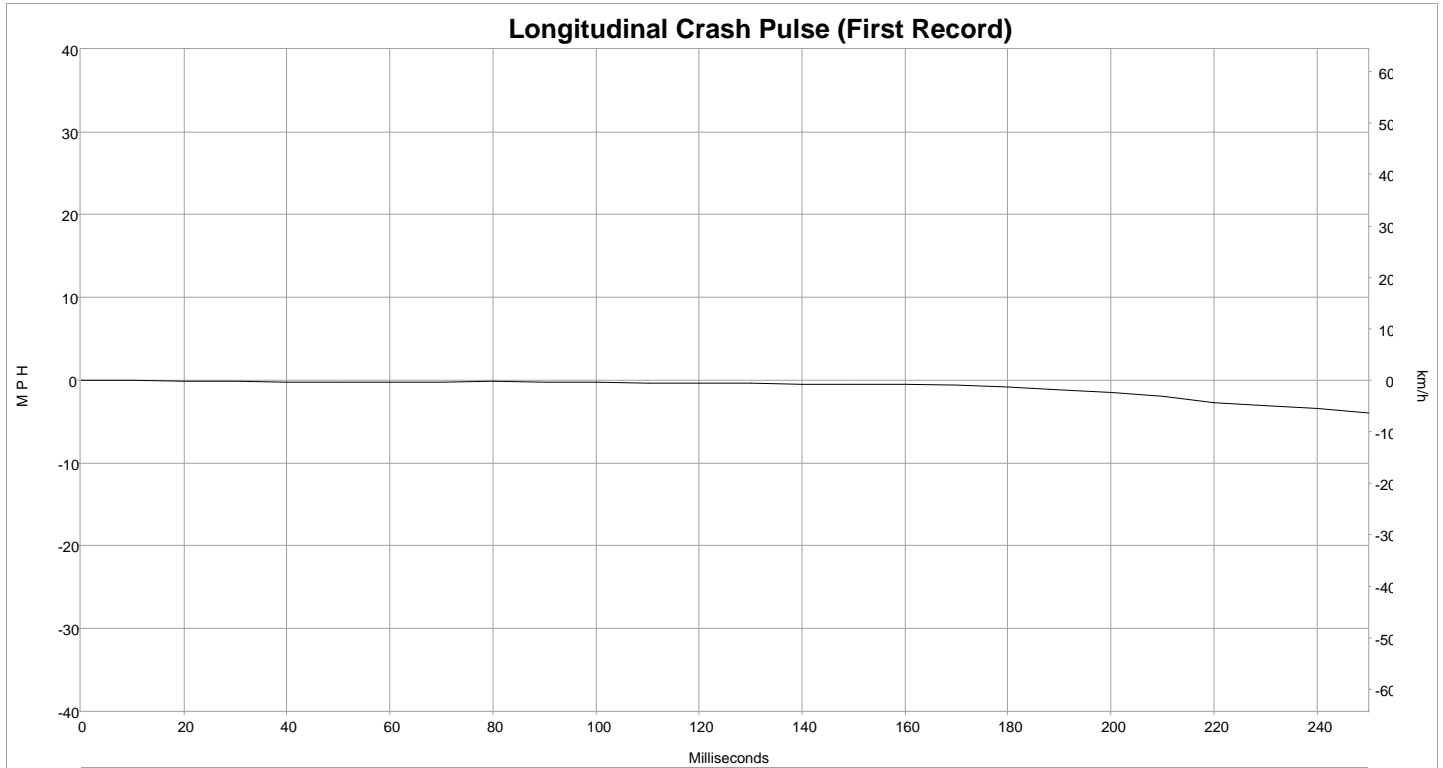
Longitudinal Crash Pulse (First Record)

After a review of the imaged data, the SCI investigator noted that the data were truncated at 250 milliseconds, and therefore the entire crash pulse was not captured by the recorded data. The recorded data corresponded only to Event 1 of the crash (undercarriage impact/engagement). As this was the only event recorded by the Ford’s RCM, it was apparent that the RCM was unable to distinguish a separation in the crash event sequence, and therefore did not recognize, record, or respond to the Event 2 frontal impact or the Event 3 rollover. This explained the lack of supplemental restraint deployment, which was related to the low overall severity of the recorded longitudinal crash pulse.
