DOT HS 813 377

**Special Crash Investigations:
On-Site Pretensioner Malfunction
Crash Investigation;
Vehicle: 2021 Hyundai Elantra;
Location: North Carolina;
Crash Date: September 2021**

Special Crash Investigations
On-Site Pretensioner Malfunction Crash Investigation
Office of Defects Investigation
Case Number: CR21023
Vehicle: 2021 Hyundai Elantra
Location: North Carolina
Crash Date: September 2021

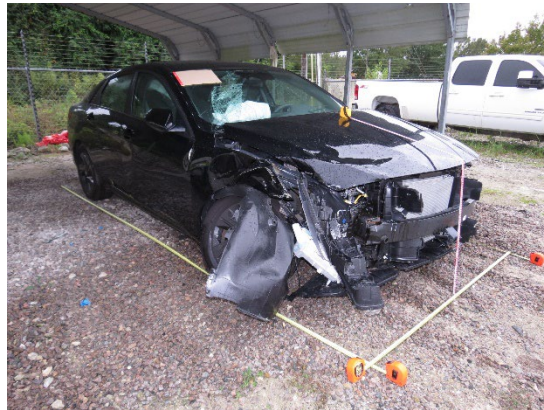
Figure 1. Right front oblique view of the Hyundai

The front and right planes of the Hyundai were damaged (Figure 5) in the impact (Event 1). The bumper fascia and grille separated in the impact. The direct damage began 52 cm (20.5 in) right of center and extended 8 cm (3.1 in) to the right corner. The damage pattern then wrapped

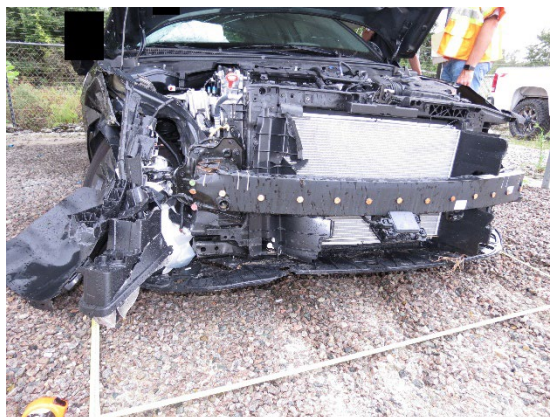
around the corner onto the forward aspect of the right plane and extended 76 cm (29.9 in) rearward. The right front wheel assembly was displaced 5 cm (2.0 in) rearward and was tilted inward. The front crush was measured along the front bumper reinforcement on a 119 cm (46.9 in) field L. The residual crush was as follows: C1 = 0 cm, C2 = 0 cm, C3 = 0 cm, C4 = 0 cm, C5 = 3 cm (1.2 in), C6 = 10 cm (3.9 in). The direction of the impact force was in the 2 o'clock sector (50 degrees). The collision deformation classification (CDC) was 02FREN1. The crash severity (total delta V) calculated by the WinSMASH program was 18 km/h (11mph). The longitudinal and lateral delta Vs were -12 km/h (-7 mph) and -14 km/h (-7 mph). Analysis of the collision fit the model; however, the results were considered low. For comparison, the longitudinal delta V recorded by the EDR was -27 km/h (-17 mph) at 147.5 milliseconds and the lateral delta V was -27 km/h (-17 mph) at 65.0 milliseconds.

Figure 6. Right oblique view of the Hyundai's frontal damage

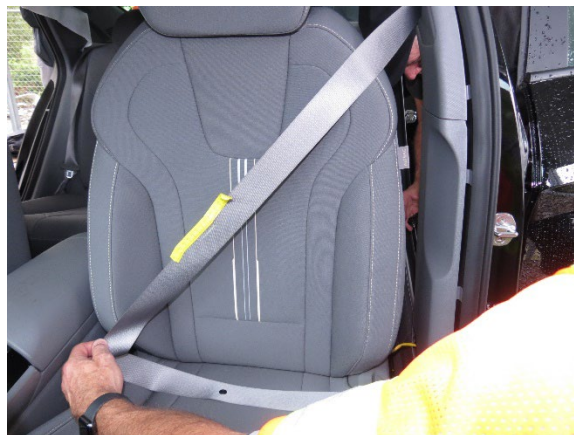
Observation of the driver seat belt found the webbing locked and extended, lying on the driver seat due to pretensioner actuation. The locked/extended webbing measured 165 cm (65.0 in) from the floor anchor to the D-ring, which was adjusted to its full-up position. Examination of the webbing revealed contact and loading from the driver's chest during the crash evidenced by a linear, colored fiber transfer to the webbing (Figure 7). The 12 cm (4.7 in) long transfer was located over the central aspect of the driver's chest 54 cm (21.3 in) below the D-ring. There was a 3 cm (1.2 in) abrasion at the D-ring. The latch plate hardware was also abraded by belt loading.

Figure 7. Image of the Hyundai driver's seat belt and transfer to the webbing

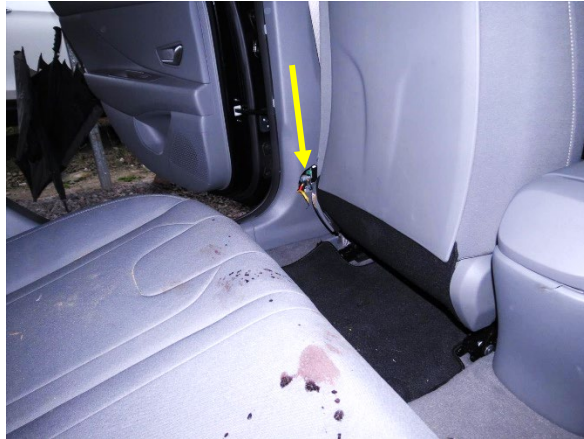
Figure 8. Holed left B-pillar

During the actuation of the driver seat belt pretensioner, the gas generator separated from the assembly and was projected into the interior of the vehicle. This fragment holed the left B-pillar trim panel and struck the left leg of the passenger. The fragment embedded into her leg, fracturing her left fibula in mid-shaft.

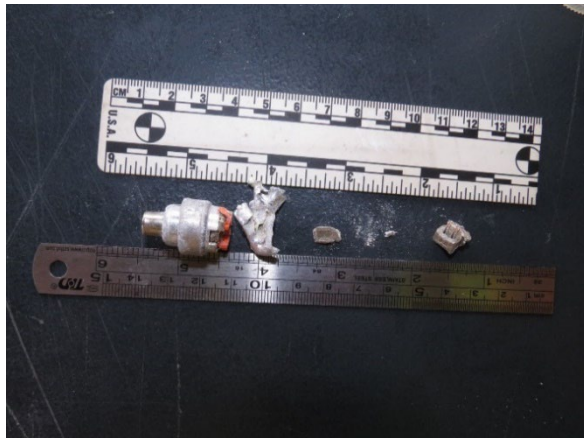
The separated/fragmented pretensioner components (Figure 9) struck and penetrated the left leg of the second-row left passenger, fracturing her fibula in mid-shaft. The shrapnel was surgically removed at a nearby trauma center. These components were then retained by the family and its legal counsel.

Figure 9. LF pretensioner gas generator and shrapnel removed from left-rear passenger's leg

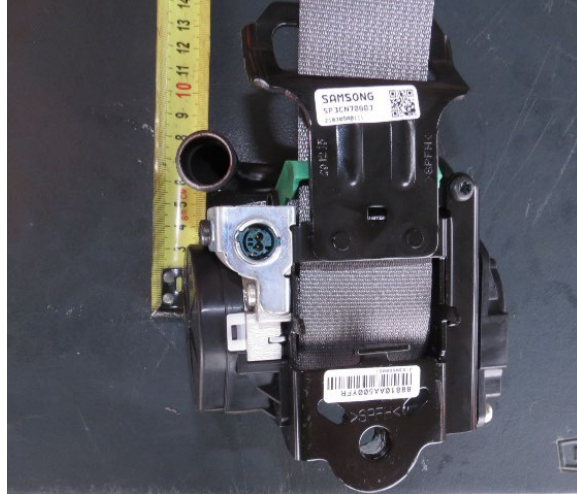
During the vehicle inspection, the driver's seat belt and retractor were removed from the vehicle in a stepwise manner and all attending parties imaged and documented the components. The initial step was removing the B-pillar trim panel. Its lower aspect was holed 8 cm (3.1 in) in diameter. Exhaust gas residue was observed on the back side of the panel. A webbing guide molded into the panel 16 cm (6.3 in) below the D-ring was abraded by contact from the webbing.

Figure 10. Removed driver's retractor pretensioner

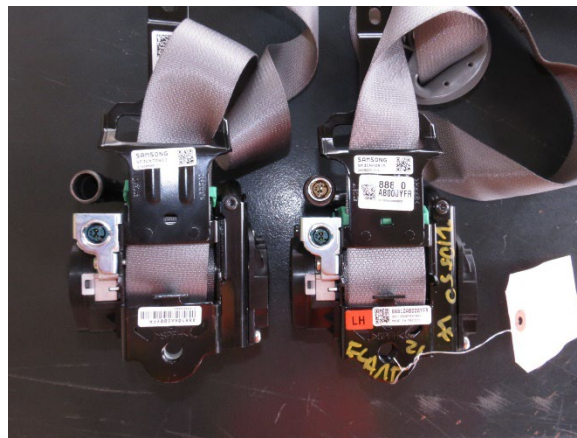
Figure 11. Comparison view driver's retractor and an exemplar (right)

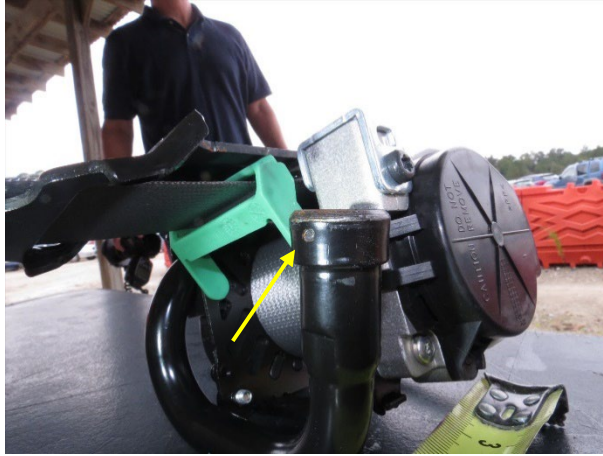
The end of the tube expanded to an approximate diameter of 15 mm (0.6 in) to fit to the body of the gas generator. It appears that a holed end cap was then pressed over the end of the tube and peened at two points 180 degrees (Figures 12 and 13) from each other to secure the end cap and gas generator to the tubing wall. The SCI investigator noted that while examining the gas generator (Figures 14 and 15) and the tubing interior (Figures 16 and 17) only one set of peens were evident although two peening indents were visible on the exterior of the tubing.

Figure 12. Tube top exterior peen marking

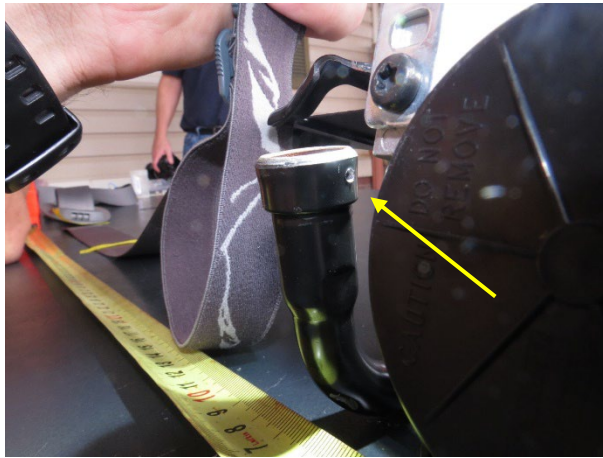
Figure 13. Tube bottom exterior peen marking

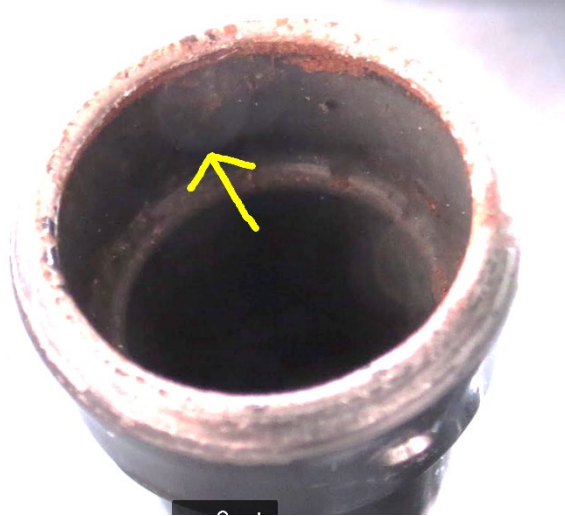
Figure 16. Interior top (no peening markings)

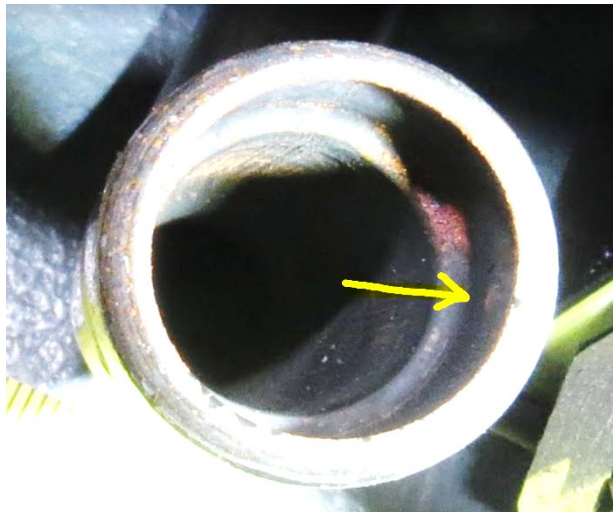
Figure 17. Interior bottom (peening mark visible)

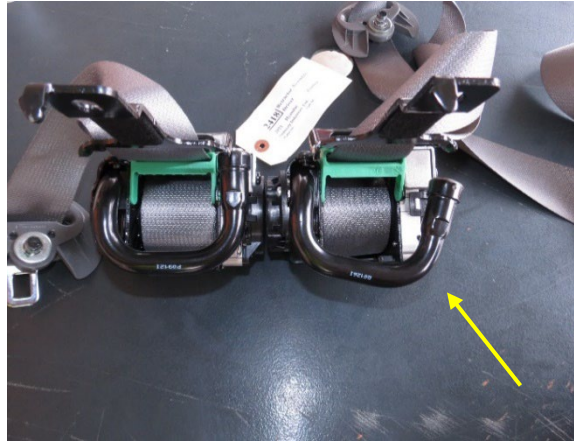
The force of the explosion caused the gas generator to separate from the end cap and hole the B-pillar trim panel. The tube portion of the pretensioner recoiled approximately 10 degrees clockwise (Figure 18) into the B-pillar structure. The back side of the tube contacted the ends of two exposed bolts in the pillar, causing two indents to be formed in the tube structure (Figure 19).

Figure 18. Exemplar pretensioner (left) and damaged pretensioner (right), note the recoiled tube

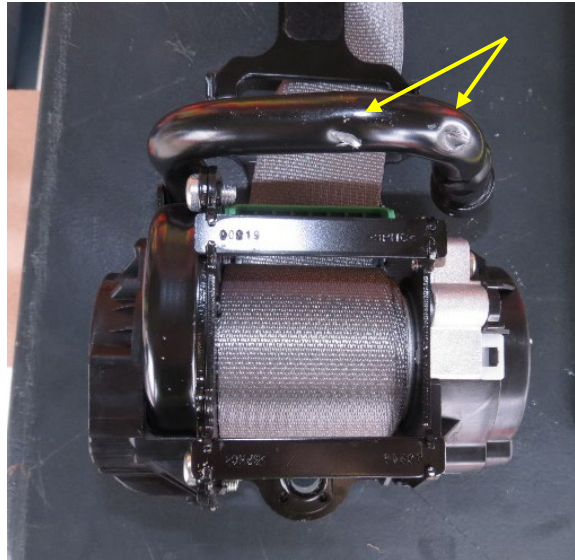
Figure 19. Damaged tube of the removed retractor pretensioner

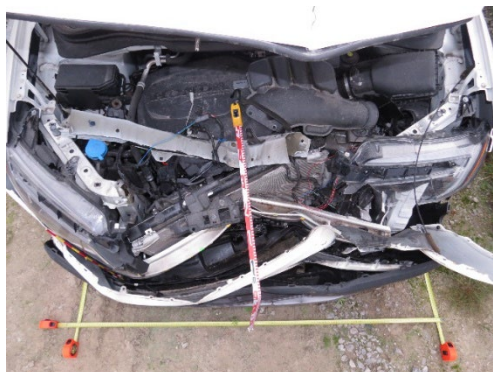
Figure 21. Overhead view of the Honda's overlapping frontal damage

The front plane of the Honda was damaged in the crash sequence. The damage pattern extended across entire 171 cm (67.3 in) end width with overlapping damage from events 1 and 2 (Figure 21). The direct damage from the event 1 crash began 15 cm (5.9 in) right of center and extended 63 cm (24.8 in) to the left corner. The CDC associated to this Event 1 damage pattern was 11FDEW1 (PDOF = 330 degrees).

In the frontal deformation, a distinct 26 cm (10.2 in) pattern from the impact with the brick pillar was evident. The center of this pattern was located 21 cm (8.3 in) left of the vehicle's centerline. The CDC of this Event 2 damage pattern was 12FYEN1 (PDOF = 0 degrees).
