DOT HS 813 383

**Special Crash Investigations:  
Remote Child Restraint System  
Crash Investigation;  
Vehicle: 2016 Nissan Rogue;  
Location: Maryland;  
Crash Date: November 2019**

**Special Crash Investigations**  
**Remote Child Restraint System Crash Investigation**  
**Office of Defects Investigation**  
**Case Number: CR20015**  
**Vehicle: 2016 Nissan Rogue**  
**Location: Maryland**  
**Crash Date: November 2019**

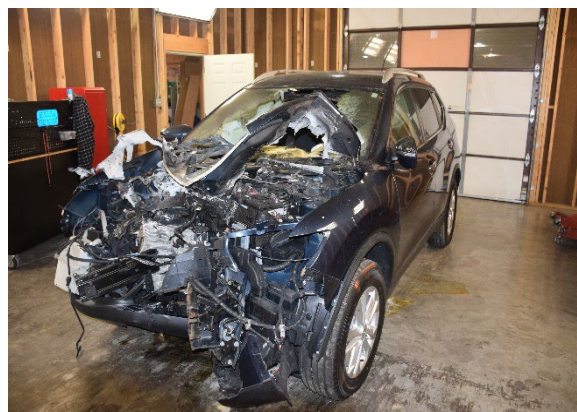
This remote crash investigation documented the road-departure, fixed-object crash of a 2016 Nissan Rogue (Figure 1) and the fatal injuries sustained by a 4-year-old male restrained in a forward-facing child restraint system (CRS) secured in the second-row left position. The shell of the child's Britax Frontier Clicktight XE CRS reportedly fractured during the impact, allowing forward excursion of the child against the internal harness system. An advocate with knowledge of the crash circumstances notified the National Highway Traffic Safety Administration in March 2020. Further research was requested and the notification was forwarded to the Crash Investigation Division and assigned to the Special Crash Investigations (SCI) team at Crash Research & Analysis the same month. The SCI team contacted the investigating law enforcement agency, interviewed the investigator, and obtained copies of the police investigation, vehicle and crash site images, images of the CRS and the event data recorder (EDR) output. Additionally, SCI obtained copies of the hospital medical records for the driver and the 4-year-old child, as well as his autopsy report. The police interview, the obtained documents, and images provided the basis for this report. COVID-19 restrictions prevented physical inspection of the CRS by SCI.

*Figure 1. Left front oblique view of the Nissan.  
Image obtained from the police investigation.*

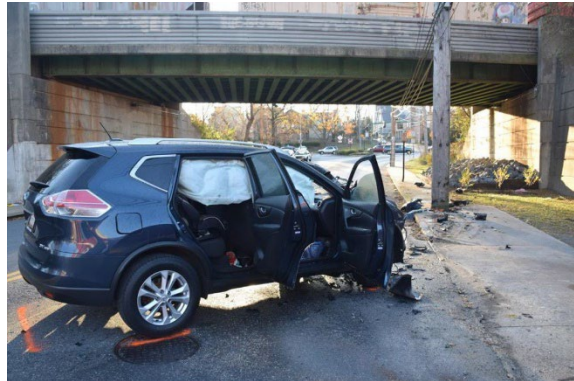
*Figure 2. East-facing police image of the Nissan at final rest*

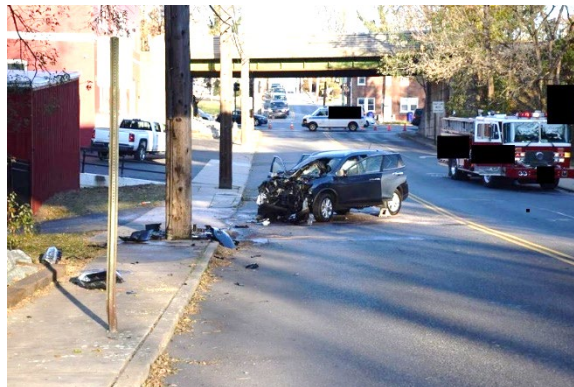
*Figure 3. West-facing police image of the Nissan at final rest*

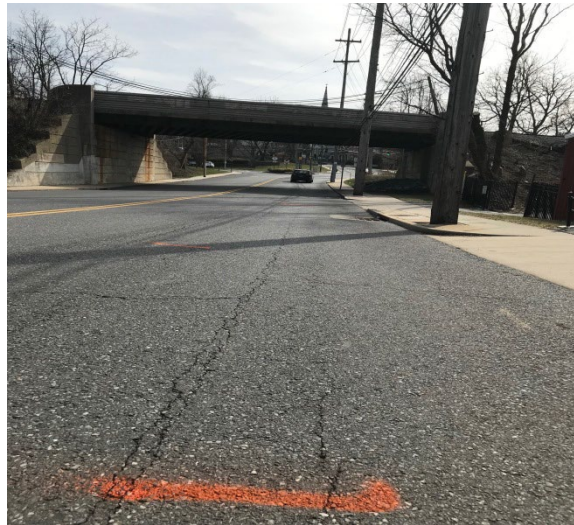
The crash occurred on a three-lane city street (Figure 4) during the morning. It was dark with artificial lighting. The National Weather Service reported the following at the time of the crash: sunrise at 0653 hours, temperature of 6 °C (22 °F), 63 percent humidity, WSW winds at 14 km/h (9 mph) and fair conditions. The police reported the surface condition as dry. The crash occurred on the three-lane road with one lane for eastbound traffic and two lanes for opposing westbound traffic. The westbound lanes consisted of a designated right-turn lane and the left lane marked as a combination through- and left-turn lane. In the immediate vicinity of the crash site, the travel lanes were straight with a negative grade to the east that transitioned to a sag at the impact location. The road surface was asphalt and both edges of the roadway were bordered by concrete curbs. The east and westbound travel lanes were separated by a double yellow centerline. Concrete sidewalks extended from the curb lines. Located in the south sidewalk adjacent to the eastbound travel lanes were several large diameter wood utility poles. The struck pole, estimated at 46 cm (18 in) in diameter, was centered approximately 0.6 m (2 ft) south of the curb line. A driveway curb cutout and was located immediately prior to the location of the pole. A railroad overpass was located immediately east of the struck utility pole. A 4-leg intersection was located west of the crash site and traffic flow was regulated by a traffic signal system. The posted speed limit was 40 km/h (25 mph). A crash diagram is included at the end of this technical report.

*Figure 4. Police image of the Nissan's eastbound approach to the crash site*

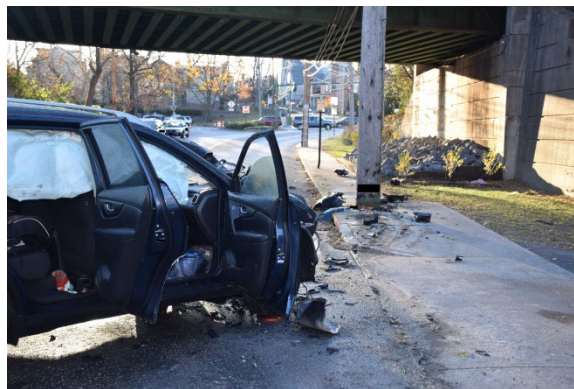
The Nissan departed the right (south) edge of the travel lane at a driveway cutout. The front plane, center aspect of the Nissan struck the large-diameter utility pole (Event 1) that was centered approximately 0.6 m (2 ft) south of the road edge (Figure 5). The EDR-recorded speed at impact was 49 km/h (30 mph). The resultant direction of force was 12 o'clock. The Nissan crushed to maximum engagement then rebounded back onto the travel lane, where it came to final rest. The EDR recorded a maximum longitudinal delta V of -56 km/h (-35 mph) at 132.5 msec of AE. The maximum lateral delta V was recorded at -2 km/h (-1 mph) at 77.5 msec of AE. The crash actuated the front-row pretensioners at 29 msec of AE and deployed stage 1 of the driver's frontal air bag at 29 msec of AE and stage 2 at 32 msec of AE. The seat-mounted side impact air bags and the inflatable curtain (IC) air bags deployed at 41 msec of AE.

*Figure 5. Impact with the utility pole and rebound to final rest. Image obtained from the investigating police agency.*

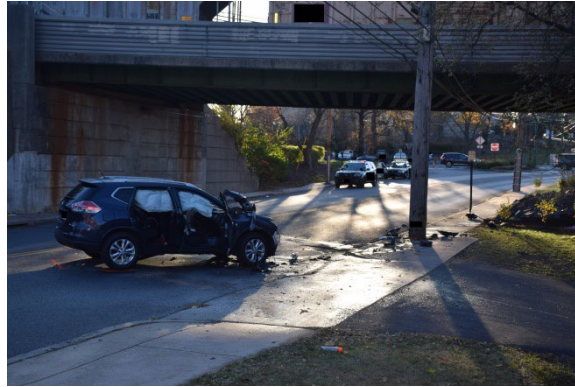
As the vehicle rebounded, it rotated approximately 30 degrees clockwise, coming to rest in the eastbound lane facing south (Figure 6). A fire began in the engine compartment (Event 2) and spread to the interior.

*Figure 6. Rebound and final rest position of the Nissan. Image obtained from the investigating police agency.*

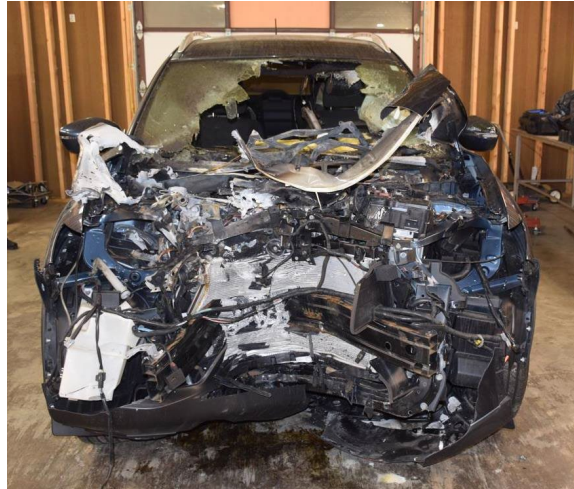
The Nissan's front plane center and right aspects struck the utility pole (Event 1). The direct contact damage was estimated to be approximately 45 cm (18 in) wide and was centered approximately 10 cm (4 in) right of the vehicle's centerline. Based on police images, the depth of crush was estimated at approximately 60 cm (24 in) occurring on the bumper beam approximately 10 cm (4 in) right of the centerline (Figure 7). Damaged components included the bumper fascia, bumper beam, upper and lower radiator supports, hood, right front fender, both headlight assemblies, and grille with rearward displacement of the transverse-mounted engine and transmission. The EDR recorded a longitudinal delta V of -56 km/h (-35 mph) that occurred at 132.5 msec of AE and a lateral delta V of -2 km/h (-1 mph) that was recorded at 77.5 msec of AE. The direction of force was 12 o'clock. The collision deformation classification (CDC) was 12FZEW3.

The post-crash fire (Event 2) originated in the Nissan's engine compartment, appeared to have melted the aluminum hood, and spread rearward through the windshield and into the occupant compartment (Figure 8). The mother and police officer removed the children prior to passenger compartment involvement.

*Figure 7. Frontal damage to the Nissan. Image provided by the investigating police agency.*

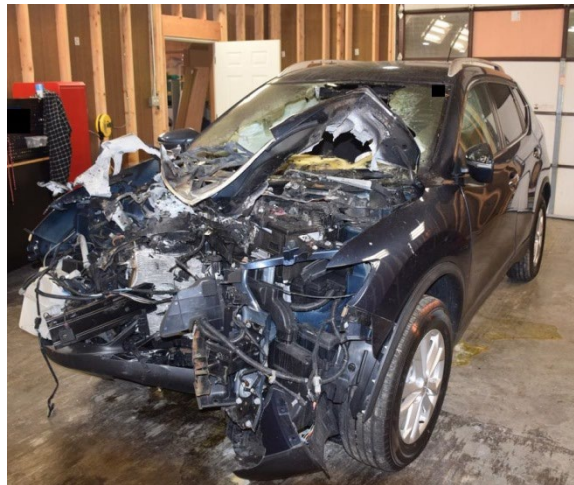
*Figure 8. Front left oblique view of the frontal damage. Image provided by the investigating police agency.*

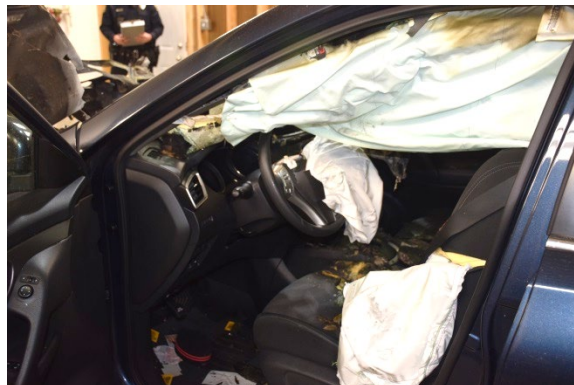
The Nissan (Figure 9) sustained damage attributed to air bag deployment and the post-crash fire. The occupant compartment did not appear to have been reduced in size by intrusion. The A-pillars were not displaced, and the center console appeared to be intact and not displaced by floor or cowl deformation. The driver’s frontal air bag deployed from the steering wheel-mounted module as designed. Both IC air bags deployed through the separation of the headliner from the roof side rails and both outboard seat-mounted air bags deployed through the vertical seams of the seatbacks. Suspected driver contact to the lower instrument panel/knee bolster did not appear to have caused any deformation to the component.

The post-crash fire spread through the windshield into the occupant compartment after the occupants were out of the Nissan. Fire damage occurred to the windshield, upper instrument

panel, headliner, driver's head restraint, center console, and the driver's seat cushion. Firefighters extinguished the fire with water.

*Figure 9. Fire damage to the front interior of the Nissan. Image provided by the investigating police agency.*

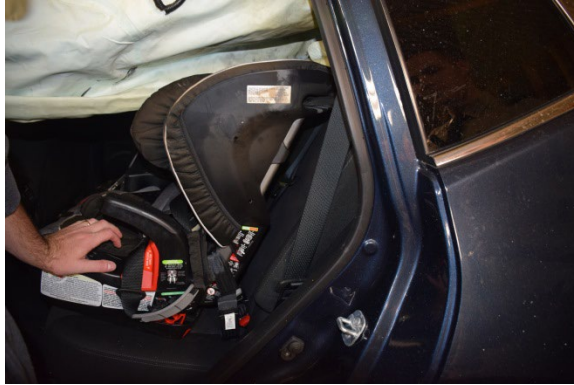
The CRS manufacturer's installation manual recommended the use of the top tether for all installations but required top tether use for children over 29.5 kg (65 lb) when using the 5-point harness system. The 4-year-old was seated forward-facing in the Britax Frontier Clicktight XE and restrained by the internal 5-point harness system. The CRS was secured to the vehicle by the lower anchor straps that were routed through the proper belt path (Figure 10). During the frontal crash, the child loaded the harness system. His loading of the harness appeared to have fractured the shell of the CRS. The police images supported a separation of the two halves of the backrest. The CRS was designed with a vertical adjustment mechanism for shoulder belt height. This mechanism remained with the forward half of the CRS shell while the locking cogs for the height adjustment remained with the aft half. The shoulder belts dropped to the lowest position and produced a horizontal fracture of the polymer shell (Figure 11). This fracture and separation apparently induced additional length to the shoulder harness resulting in forward excursion of the child occupant. Due to the remote nature of this investigation, the placement of the harness system is unknown as well as the use and position of the chest retainer clip. Also, there was no documentation of the top tether, therefore its use is unknown. Based on the fracture of the CRS shell, it seems possible that the tether was used because the aft half of the CRS shell appeared to have remained against the seatback.

*Figure 10. Installed Britax CRS in the second-row left position of the Nissan. Image obtained from the investigating police agency.*

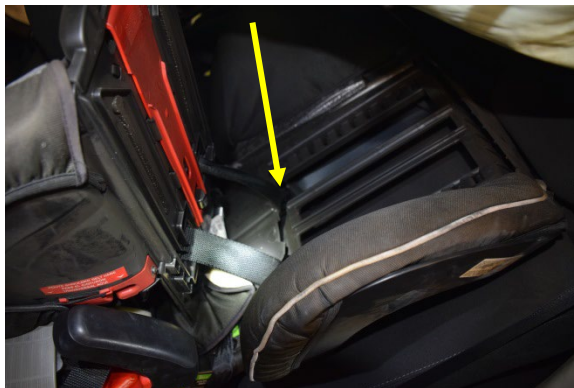
*Figure 11. Separation of the Britax CRS shell and the horizontal fracture at the bottom of the harness adjustment mechanism. Image provided by the investigating police agency.*

The child would have initiated a forward trajectory in response to the crash forces and loaded the integral harness straps of the CRS. His loading of the harness system fractured the polymer structure of the CRS, thus separating the adjustment cogs from the vertical adjustment system of the CRS. This caused the harness straps to move to the lowest position which increased the length of the straps, allowing the occupant to translate forward beyond the confines of the CRS (Figure 14). The lower shell of the CRS also fractured horizontally at the lowest adjustment point

from occupant loading, thus resulting in additional length to the harness straps. As previously noted, the use and position of the chest clip is unknown. On inspection of the Britax, police reported the CRS was installed loose with approximately 10 cm (4 in) of forward movement of the CRS and 5 to 8 cm (2 to 3 in) of lateral side-to-side movement.

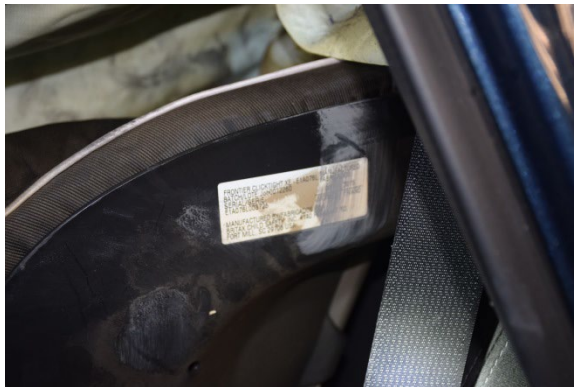
The left aspect of the outer shell of the Britax CRS was abraded in a vertical pattern over a label. This abrasion was attributed to the deployment of the left IC air bag (Figure 12) as it deployed between the CRS and the closed window.

*Figure 12. IC abrasions to the shell of the Britax CRS. Image provided by the investigating police agency.*

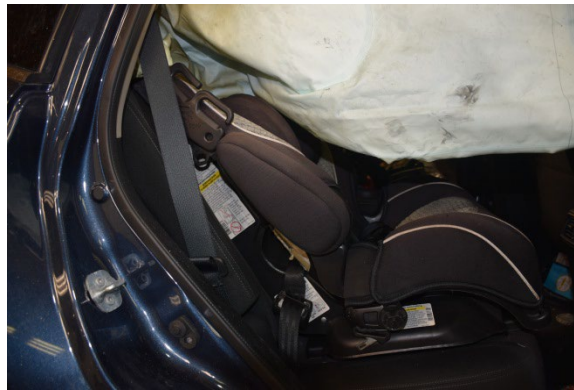
The second-row right 2-year-old child was restrained forward-facing in a Dorel Alpha-Omega CRS (Figure 13). Police noted this CRS was manufactured in May 2011 and was labeled as having an 8-year life span. Based on the crash date, this CRS had expired 6 months earlier. The CRS appeared to have been used in a reclined position and secured to the vehicle by the lower anchor attachments. They were routed through the correct belt path. Use of the upper tether is unknown. The child was restrained by the 5-point internal harness system. The adjustment of the harness and use of the chest retainer clip is unknown. Based on the police images, there was no apparent damage to this CRS.

*Figure 13. Doral Alpha-Omega CRS in the second-row right position. Image provided by the investigating police agency.*

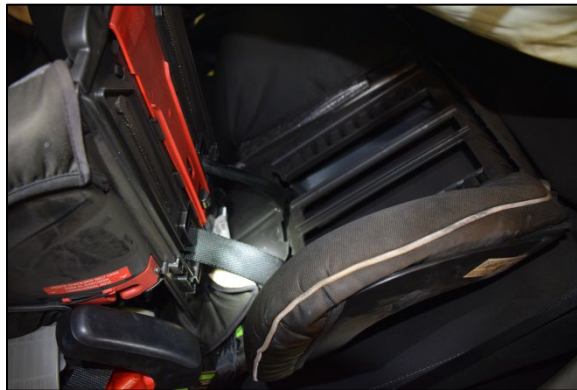
At impact with the utility pole, the vehicle experienced a 12 o’clock direction of impact force and underwent a longitudinal velocity change of -56 km/h (-35 mph). The IC air bags deployed as a result of the frontal crash event at 41 msec of AE. The IC air bag deployed between the left aspect of the CRS shell and the door glazing. A vertically oriented abrasion was noted to the shell of the CRS over a label that resulted from IC deployment.

*Figure 14. Fractured seat back of the Britax CRS and the altered position of the integral harness. Image provided by the investigating police department.*
