DOT HS 813 384

**Special Crash Investigations:
On-Site Air Bag Non-Deployment
Crash Investigation;
Vehicle: 2019 Hyundai Tucson;
Location: Massachusetts;
Crash Date: August 2020**

Special Crash Investigations
On-Site Air Bag Non-Deployment Crash Investigation
Office of Defects Investigation
Case Number: CR20026
Vehicle: 2019 Hyundai Tucson
Location: Massachusetts
Crash Date: August 2020

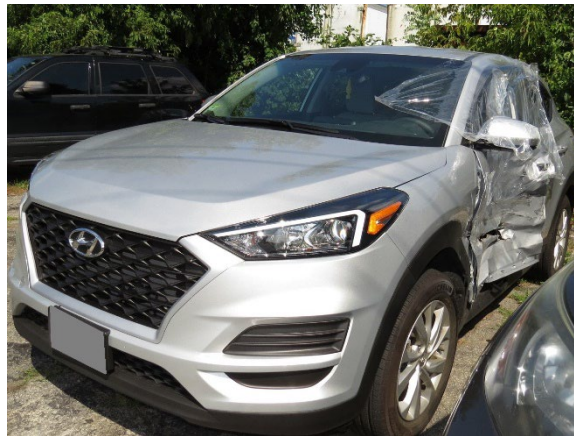
Figure 1. Left front oblique view of the 2019 Hyundai Tucson

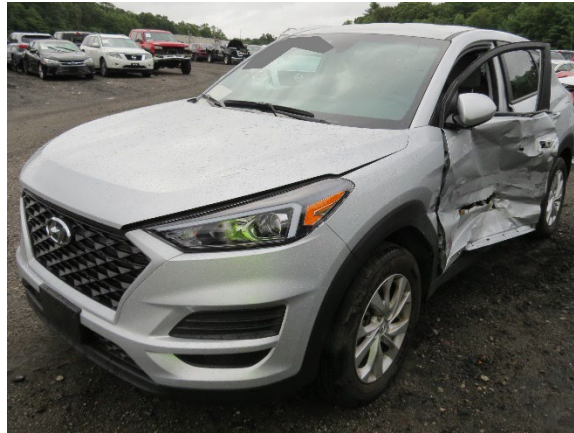
Figure 4. Left front oblique view of the 2019 Hyundai Tucson at the time of the SCI vehicle inspection

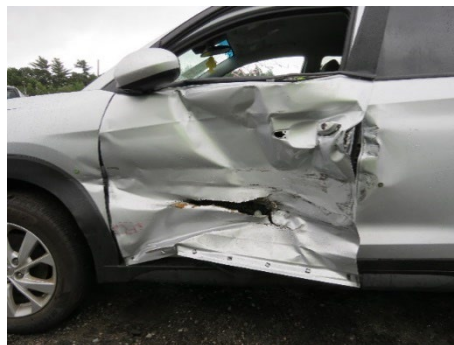
A residual crush profile was obtained across the mid-door level using a profile that matched the direct contact, which produced the following resultant measurements: C1 = 0 cm, C2 = 4 cm (1.6 in), C3 = 8 cm (3.1 in), C4 = 8 cm (3.1 in), C5 = 6 cm (2.4 in), and C6 = 3 cm (1.2 in).

Maximum crush measured 8 cm (3.2 in) and was located near the center of the left front door, 103 cm (40.6 in) rearward of the left front axle position. A corresponding collision deformation classification (CDC) of 10LPEW1 was assigned to the Hyundai's left plane damage profile. The damage algorithm of the WinSMASH model was used to calculate the severity of the crash. The total calculated vehicle velocity change (delta V) was 12 km/h (7.5 mph), with specific longitudinal and lateral components of -8 km/h (-5.0 mph) and 9 km/h (5.6 mph). These results seemed reasonable, fit the model, and were similar to the EDR-recorded values.

Figure 5. Left plane damage profile to the Hyundai

Through the course of this SCI investigation, it was apparent that the crash was of insufficient severity to warrant/result in supplemental restraint actuation/deployment. The left plane impact by the Ford resulted in minor damage to the door of the Hyundai, and only produced a maximum lateral delta V of 9 km/h (5.6 mph) as recorded by the EDR. The impact was focused in the softer center area of the door, and did not involve the surrounding structure or frame of the vehicle.

Of note, the right front tow hook of the Ford tore the metal skin of the Hyundai's left front door. In the door, as part of the vehicle's sensing and diagnostic equipment, was a peripheral pressure sensor. Based on SCI expertise and confirmed by the Hyundai representative, peripheral pressure sensors are specifically designed to measure and detect rapid changes in atmospheric pressure resulting from deformation, such as the deformation to a door that occurs in a crash. Pressure sensors, in conjunction with had peripheral accelerometers, provide data to the supplemental restraint system's control module. The control module must make a near-instantaneous determination – approximately 5 milliseconds or less - as to whether or not supplemental restraint system actuation/deployment commands are warranted. This decision is based on the analysis of data provided by the peripheral sensors relative to the manufacturer's proprietary algorithms.

The SCI investigator observed, and the Hyundai representative confirmed, that the damage and tear of the Hyundai's door skin could affect the *future* performance of the peripheral pressure sensor. However, in this crash, the tear to the door would have occurred *after* the pressure sensor had already detected the deformation to the door, measured the atmospheric pressure differential, and provided that data to the Hyundai's ACU. Therefore, it is unlikely that the tear to the door affected ACU or its deployment algorithm, which ultimately determined supplemental restraint system actuation/deployment should not have occurred in this crash.

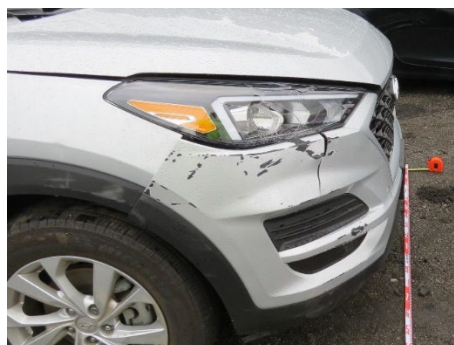
Figure 6. Minor right front corner damage to the Hyundai

There was cosmetic damage to the right corner of the front bumper fascia that had resulted from the impact with the wooden utility pole. The damage included a fracture to the right headlight assembly, with abrasions to the bumper fascia and right front fender. There was no discernable deformation to the bumper beam or any of the Hyundai's structure (Figure 6). The CDC assigned to the minor front damage profile was 12FREE3. No WinSMASH calculations could be computed due to the lack of residual deformation.

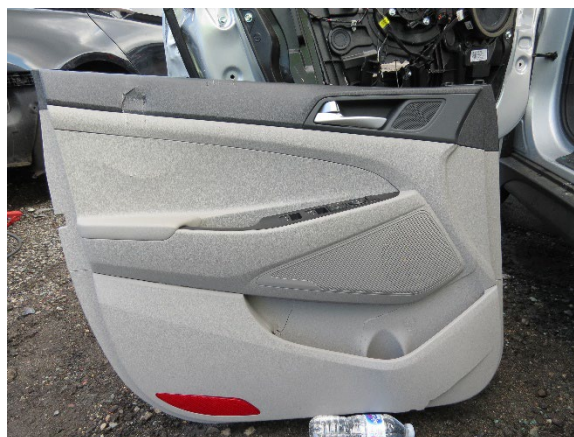
Minor intrusion into the occupant compartment associated with the crash consisted of the 8 cm (3.1 in) lateral intrusion of the forward and rear lower quadrants of the left front door. The interior fascia panel of the door was found loose in the trunk area of the Hyundai during the SCI inspection; it likely came off of the left front door as a result of the fire department's use of the hydraulic rescue tools. Figure 7 shows the left front door panel at the time of the SCI vehicle inspection.

Figure 7. View of the Hyundai's driver door panel, devoid of discernable contact evidence

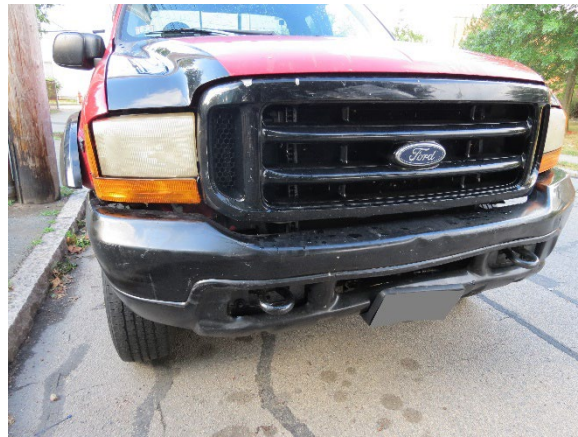
The Ford sustained minor damage on its front right corner aspect from the impact with the Hyundai. Direct contact began at the right front bumper corner and extended 90 cm (35.4 in) to the centerline. There were minor scratches and slight denting to the painted surface of the bumper beam, but there was no physical deformation/crush to the beam's contour. Absent

residual crush, the CDC assigned to the Ford for the minor contact damage from the impact with the Hyundai was 02FZLW1.

Figure 9. View of the Ford's front plane with minor direct contact discernable on the bumper beam
