DOT HS 813 402

**Special Crash Investigations:  
On-Site Semi-Trailer Underride  
Crash Investigation;  
Vehicle: 2019 International Tractor/  
2018 Wabash Semi-Trailer;  
Location: New York;  
Crash Date: February 2020**

**Special Crash Investigations**  
**On-Site Semi-Trailer Underride Crash Investigation**  
**Case Number: CR20009**  
**Vehicle: 2019 International Tractor/2018 Wabash Semi-Trailer**  
**Location: New York**  
**Crash Date: February 2020**

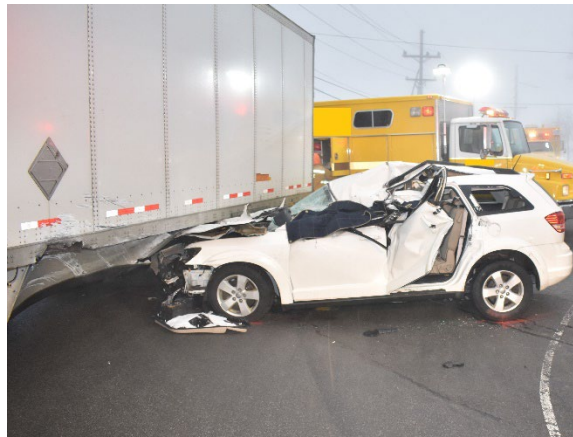
*Figure 1. View of the Dodge and Wabash trailer at final rest (on-scene law enforcement image)*

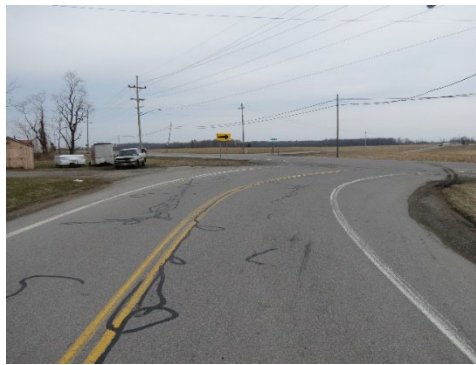
For the eastbound trajectory of the International, the roadway transitioned from an extended straightaway to a sharp right curve at the mouth of the intersection (Figure 2). The eastbound lane measured 3.1 m (10.2 ft) wide, delineated by a single solid white fog line and a double-yellow centerline. Speed was regulated by a posted limit of 89 km/h (55 mph). Traffic on approach to the intersection was controlled by a stop sign and stop bar painted on the asphalt surface.

*Figure 2. Northeast-facing view of the eastbound approach for the International to the intersection*

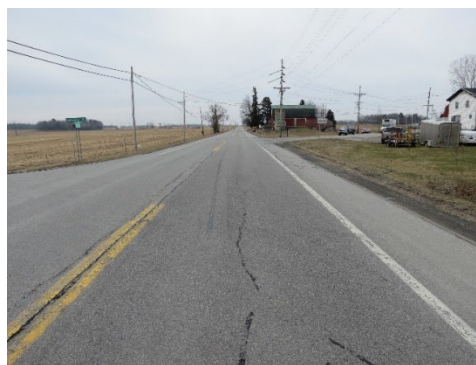
*Figure 3. South-facing view of the southbound approach for the Dodge to the intersection*

For the southbound trajectory of the Dodge, the roadway was straight and level for an extended distance. The southbound lane measured 3.5 m (11.5 ft) wide and was delineated by a single solid white fog line and a double-solid yellow centerline (Figure 3). Speed on the north/south roadway was regulated by a posted limit of 89 km/h (55 mph). Several intersections were located along the roadway in the vicinity, none of which were controlled for the north/south roadway. A crash diagram is included at the end of this report.

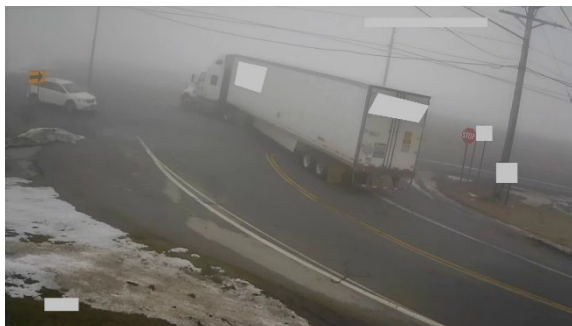
*Figure 6. East-facing surveillance camera view of the turning truck/semi-trailer and approaching Dodge*

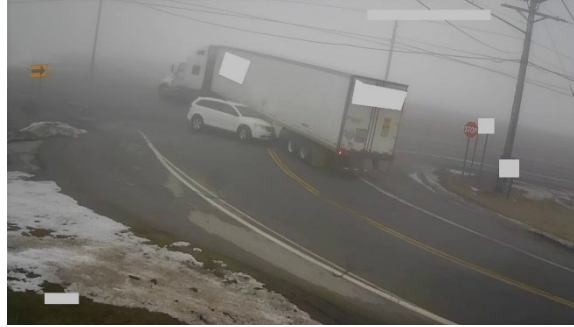
The crash occurred as the front of the Dodge struck and underrode the Wabash semi-trailer. It was visible in the video that the Dodge's headlights were not illuminated at the time of the crash (Figure 6). Initial contact involved the Dodge's front plane, left aspect with the aerodynamic skirt, which deflected the skirt under the semi-trailer (Figure 7).

*Figure 7. East-facing surveillance camera view of the International/Wabash and Dodge at initial impact*

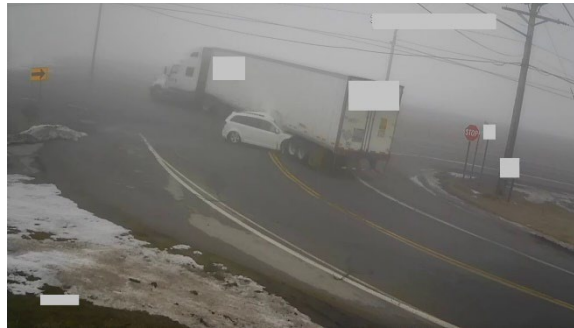
*Figure 8. East-facing surveillance camera view of the Dodge at maximum engagement with the semi-trailer*

As the hood and “greenhouse” of the Dodge underrode the Wabash, its front plane engaged the left tires/wheels (Figure 8). Maximum engagement of the Dodge underneath the Wabash semi-trailer involved a significant portion of the Dodge’s greenhouse/occupant compartment. The left upper A- and B-pillars of the Dodge, as well as the windshield header, roof, and left roof side rail were crushed downward and longitudinally by the underride. This lifted the left side of the semi-trailer and shifted it slightly right, discernable in the surveillance video.

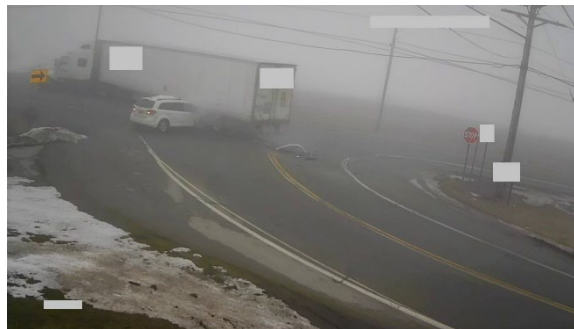
*Figure 9. East-facing surveillance camera view of the International/Wabash and Dodge at final rest*

roadway. The Dodge had rebounded and been displaced slightly northward and rotated counterclockwise from impact to the trailer. Figure 9 shows the International, Wabash, and Dodge at final rest.

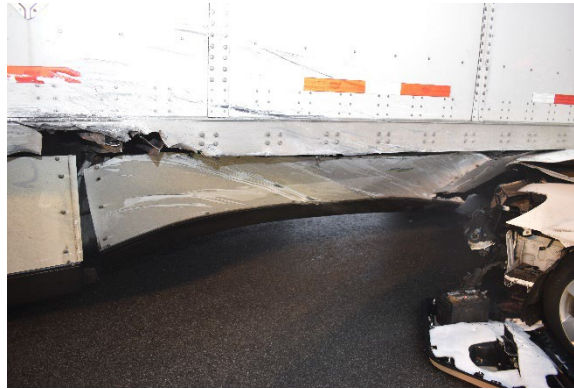
There was no damage to or involvement of the International tractor in the impact by the Dodge. Damage to the Wabash semi-trailer was observed in law enforcement images to the left plane and undercarriage, consisting of direct contact abrasions to the sidewall of the cargo body, minor deformation to the outer sill, direct contact to the aerodynamic side skirt, and deformation of the forward left axle assembly. On-scene images showed the side skirt was folded partially up and under the semi-trailer as a result of the impact and engagement of the Dodge beneath it. Contact damage to the skirt consisted of paint transfers, scuff marks, and abrasions; the panel itself did not appear fractured. Damage to the semi-trailer began immediately forward of the center of the

trailer's left side, at the location of the amber marker light, and extended approximately 3.1 m (10.2 ft) rearward to the tandem axles. There was minor contact (abrasions and scuffs) to the undercarriage of the trailer, and the mounting bracket for the forward axle on the left frame rail was fractured. The truck deformation classification (TDC) assigned to the Wabash was 10LTFWB. Figures 12 and 13 show the damage pattern to the Wabash.

*Figure 12. Damage pattern to the Wabash from the left plane underride impact by the Dodge (on-scene law enforcement image)*

Through the course of this investigation, it was noted that the side skirting was not designed or intended to provide rigid structural protection or prevent underride crash events similar to this crash. Although the Wabash's side skirting provided significant aerodynamic benefit to the tractor/trailer combination unit, the skirting provided no benefit from a crash protection perspective. However, if the side skirting had been manufactured with some type of rigid structural beams and designed to provide crash protection, it likely would have provided some level of mitigation in this crash scenario and likely significantly reduced the degree of underride by the Dodge.

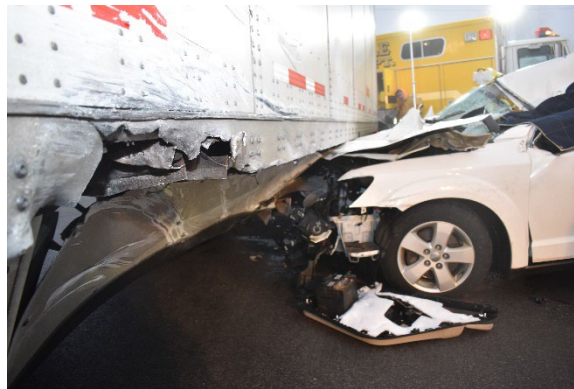
*Figure 13. Close-up of the direct contact to the Wabash's left sill from the left pillar(s) of the Dodge (on-scene law enforcement image)*

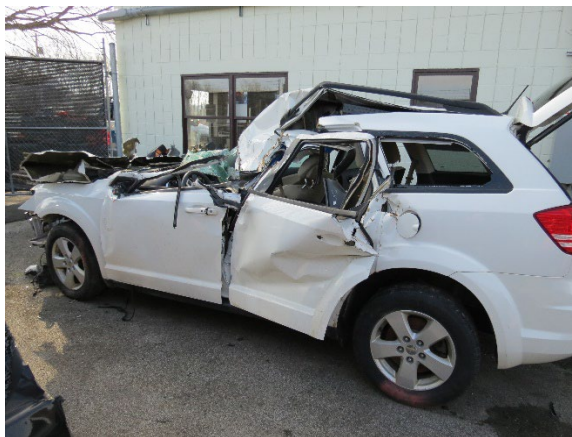
The front plane, left aspect of the Dodge initially contacted the aerodynamic side skirting of the semi-trailer, then the top surface of the hood and left front fender engaged and underrode the semi-trailer. The sequence of contact resulted in severe crush and intrusion to the greenhouse/occupant compartment of the Dodge, including both A-pillars, the windshield header, the left B-pillar, and the roof structure. Direct contact spanned the entire width of the front plane, largely resultant from engagement with the dual tires of the trailer's forward left axle position. There was moderate deformation to the front bumper beam, with direct contact to frontal and engine compartment components. The direct contact damage extended onto the left side plane, consisting of scratches, abrasions, and deformation that primarily were all above the level of the Dodge's tires/wheels and the mid-door aspect. The hood was completely separated from the vehicle and lying loosely in position at the time of the SCI vehicle inspection. The left upper A-pillar and left upper B-pillar were deformed flat in the longitudinal direction. Along the perspective of a diagonal line extending from the left upper C-pillar to the right upper A-pillar, the entire greenhouse was deformed and objects above the beltline were flattened rearward (Figure 15).

*Figure 15. Left plane view of the Dodge and the severe deformation to the greenhouse/occupant compartment*

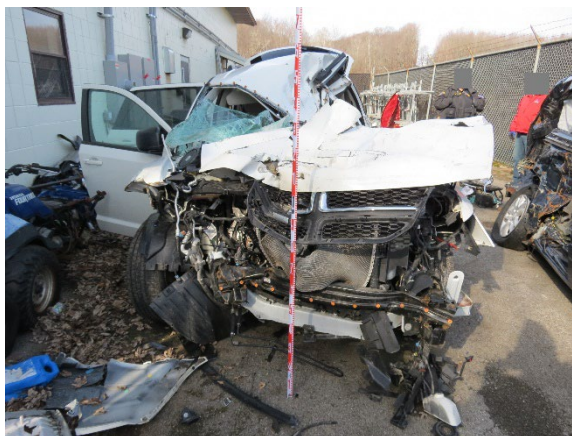
*Figure 16. Front plane view of the Dodge and its damage profile*

Both left doors were jammed closed by exterior deformation and were cut from the vehicle by the firefighters to remove the driver. The rear lift gate and the right side doors remained closed during the crash and were operational at the time of the SCI vehicle inspection. Direct contact from the sill and undercarriage of the trailer was present on the top surface of the interior instrument panel and steering wheel rim. Figure 16 shows the front plane damage profile to the Dodge.

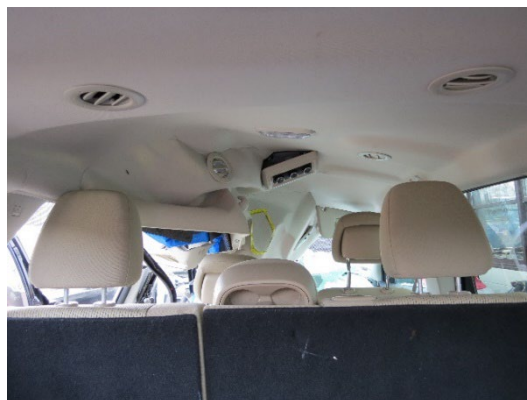
The Dodge’s interior sustained severe damage associated with the exterior deformation and intrusion of the roof structure. The left A-pillar, headliner, roof, and left roof side rail all directly contacted and engaged the left plane and undercarriage of the semi-trailer. Emergency personnel subsequently cut the left A- and B-pillars and the left doors from the vehicle. Residual intrusion at the time of the inspection included 53 cm (20.9 in) rearward displacement of the left windshield header and 64 cm (25.2 in) of downward displacement into the driver’s position. The header intruded rearward 18 cm (7.1 in) and 5 cm (2.0 in) respectively into the center and right positions of the front row.

*Figure 17. Forward-facing view from the rear of the Dodge of the severe intrusion at the driver’s position*

Vertical intrusion into these occupant positions were 41 cm (16.1 in) and 15 cm (5.9 in), respectively. The left roof side rail intruded right laterally 24 cm (9.4 in) into the driver's position and 22 cm (8.7 in) into the second-row left position. Figure 17 shows a forward-facing view of the interior and the severe deformation/intrusion.

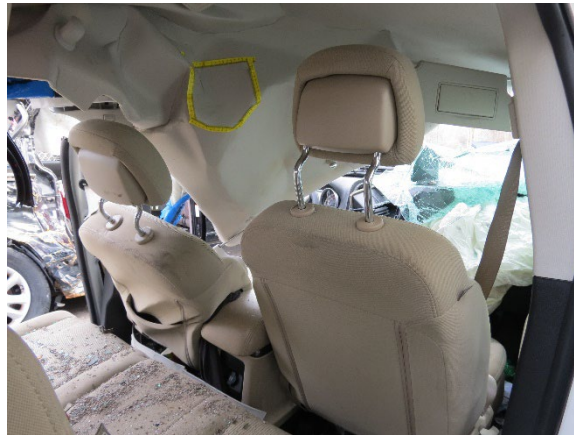
Two distinct areas of occupant contact were identified in the Dodge. The first was an 8x5 cm (3.2x2.0 in) scuff mark on the left lower instrument panel, determined to have resulted from contact and loading by the driver's left knee. The second was a circular impression and visual face mark from the second-row right passenger's head, located on the vertically deformed headliner/roof. A 15x17 (5.9x6.7 in) circular depression was present in the deformed headliner (Figure 18).

*Figure 18. Area of contact from the second-row right occupant's head to the deformed/intruded roof*

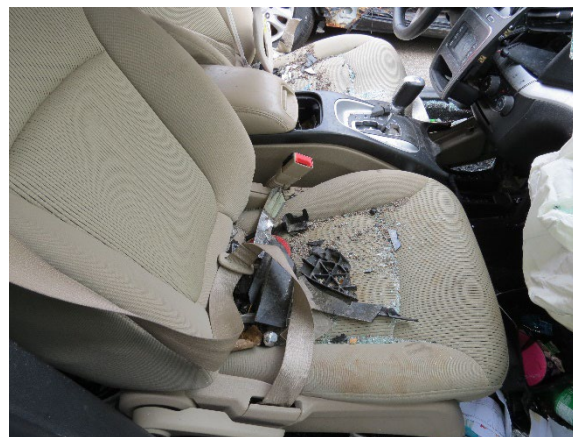
*Figure 20. Front right passenger's seat belt system at the time of the SCI vehicle inspection*

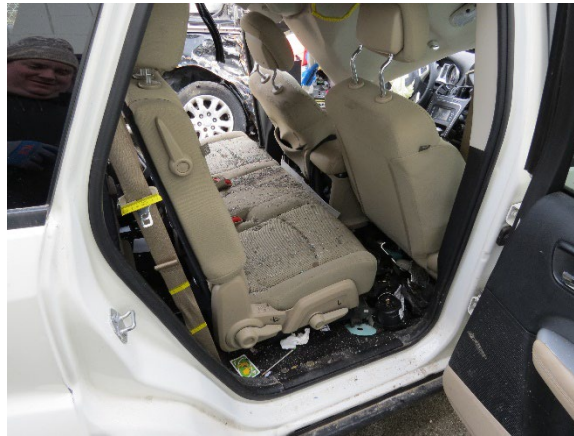
The second-row right passenger was restrained by the manual seat belt system. Based on the evidence on the belt system, the apparent slack in the system, and the contact evidence documented to the deformed roof of the vehicle, it is possible that she was wearing the system with the shoulder belt positioned off her right shoulder, or she otherwise was slightly out-of-position to her left, at the time of the crash. She loaded the belt system, evidenced by subtle frictional abrasions on the polymer surface of the latch plate. Additionally, the lower portion of the lap belt loaded against the outer trim of the seat frame. This caused the webbing to crease 20-33 cm (7.9-13.0 in) above the floor anchor point (Figure 21).

*Figure 21. View of the Dodge's second-row right seat belt system at the time of the SCI vehicle inspection*

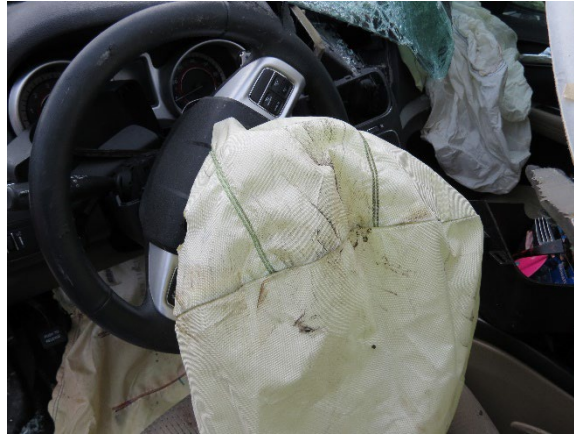
*Figure 22. View of the deployed driver's frontal air bag in the Dodge*

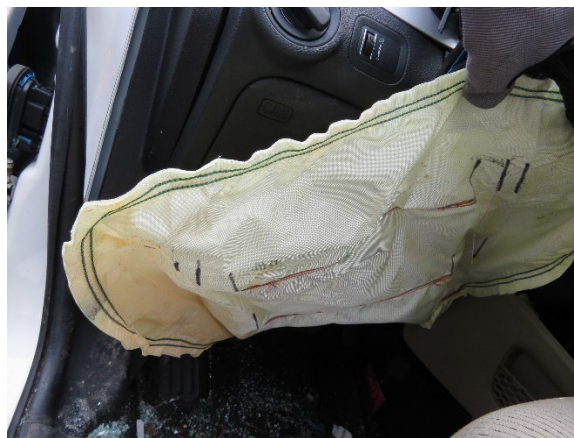
in). It extended 43 cm (16.9 in) rearward in its deflated state. There were two 25 cm (9.8 in) long tether seams sewn into the top surface of the air bag. Nomenclature identifying the air bag was stamped onto the fabric: 312311630d and 46690. There was no damage or contact evidence to the deployed driver knee air bag (Figure 23). However, it was oil soaked.

*Figure 23. View of the Dodge's deployed driver knee air bag*

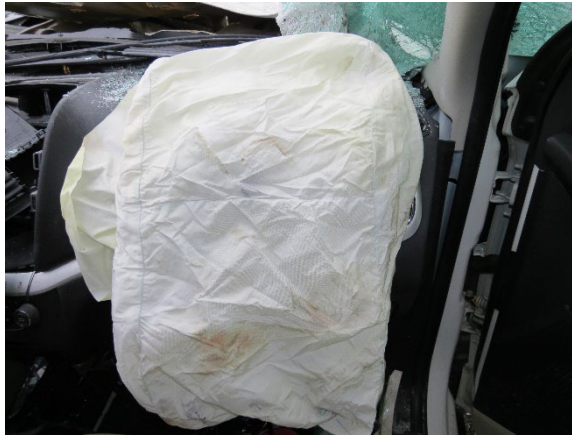
The passenger's frontal air bag deployed from a top-mounted module in the right upper instrument panel (Figure 24). The module consisted of a single forward-hinged cover flap that had overall measurements of 48 cm (18.9 in) wide and 13 cm (5.1 in) in depth. It deployed from the module and was contacted by the displaced and intruding windshield during the crash. A corresponding 9 cm (3.5 in) cut was present on the top center aspect of the air bag. Dimensionally, the face of the passenger's frontal air bag was 29 cm (11.4 in) wide and 58 cm (22.8 in) high. It was vented by a series of ports, with two 1 cm (0.4 in) diameter ports incorporated into a gather portion of air bag fabric on the lateral aspects, located 11 cm (4.3 in) aft of the cover flap. Two more 5 cm (2.0 in) diameter vent ports were located on the sides of the air bag, located 30 cm (11.8 in) from the cover flap. Internal tethers limited the rearward

excursion of the front right air bag to 36 cm (14.1 in), measured in its deflated state. There was no occupant contact evidence present to the deployed passenger's frontal air bag.

*Figure 24. Passenger's frontal air bag deployed in the Dodge at the time of the SCI vehicle inspection*
