DOT HS 813 408

**Special Crash Investigations:  
On-Site Air Bag Non-Deployment  
Crash Investigation;  
Vehicle: 2008 Pontiac G6;  
Location: Ohio;  
Date: July 2020**

**Special Crash Investigations**  
**On-Site Air Bag Non-Deployment Crash Investigation**  
**Office of Defects Investigation**  
**Case Number: CR20034**  
**Vehicle: 2008 Pontiac G6**  
**Location: Ohio**  
**Crash Date: July 2020**

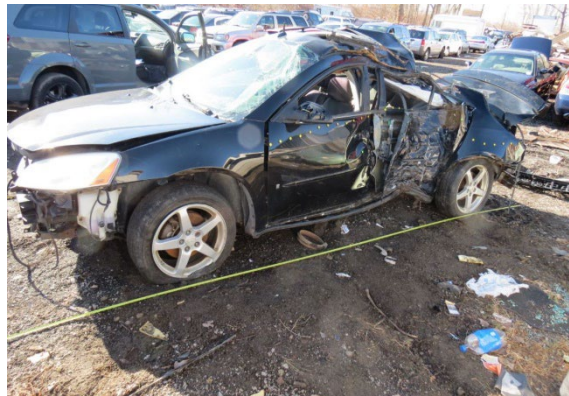
This report documents the on-site investigation of the non-deployment of the side air bag systems in a 2008 Pontiac G6 (Figure 1) involved in a fixed-object crash. The Pontiac had front seat belt pretensioners, driver and passenger frontal air bags, front-seat-mounted outboard side impact, and side-impact sensing inflatable curtain (IC) air bags. The Pontiac was driven by an unbelted 28-year-old male, with an unbelted 18-year-old female right front passenger and a 3-month-old infant in a second row left rear-facing child restraint system (CRS) that was not secured by the harness straps. As the Pontiac was traveling west on a two-lane roadway, the driver lost control and the Pontiac began to rotate clockwise. The Pontiac departed the right side of the road in a clockwise yaw, traveled down an embankment, and through an open field into a treed area. The Pontiac's left plane/rear door area struck a large diameter tree. None of the Pontiac's air bags deployed.

*Figure 1. Left side view of the Pontiac*

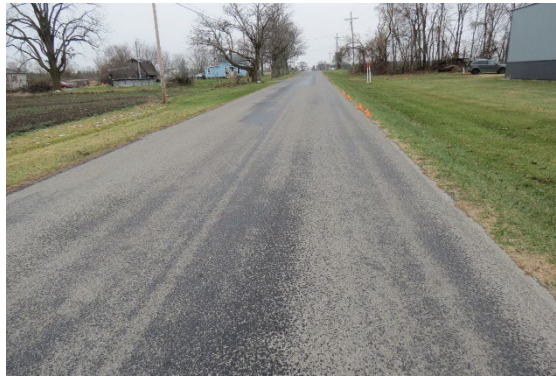
The crash occurred on a two-lane east/west roadway in a rural setting (Figure 2). The bituminous roadway was straight, measured 6.1 m (20.0 ft) in total width, and had no painted markings. The posted speed limit was 89 km/h (55 mph). An open cultivated field was located on the south roadside. The north roadside consisted of grass with a cluster of deciduous trees located farther to the west. Three trees in the cluster were struck by the Pontiac. A crash diagram is included at the end of this report.

*Figure 2. West-looking trajectory view of the Pontiac*

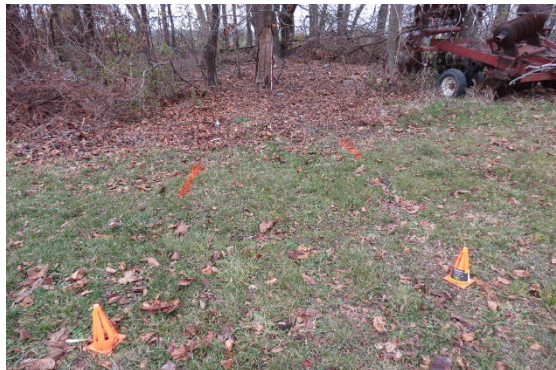
*Figure 3. Northwest trajectory view of the Pontiac approaching the point of impact with the trees*

depart the road. The loss of control developed into a clockwise yaw, as the Pontiac traveled through the grass field approximately 46 m (150 ft) in a northwesterly direction toward the trees (Figure 3).

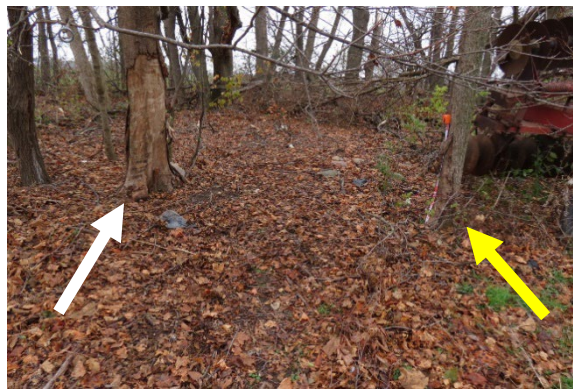
The Pontiac entered the cluster of trees and struck a tree 36 cm (14.2 in) in diameter (Event 1) with its left plane, denoted by the white arrow in Figure 4. This impact had a 10 o'clock direction of force with the maximum deformation centered on the left rear door of the vehicle. The force of the impact aft of the Pontiac's center of mass imparted a counterclockwise rotation to the Pontiac. During the rotation, the right rear corner of the Pontiac struck a tree 21 cm (8.3 in) in diameter (Event 2), denoted by the yellow arrow in Figure 4. The Pontiac's trunk space crushed and deformed laterally to the left.

*Figure 4. Northwest-facing view of the tree impacted during Events 1 (white arrow) and 2 (yellow arrow)*

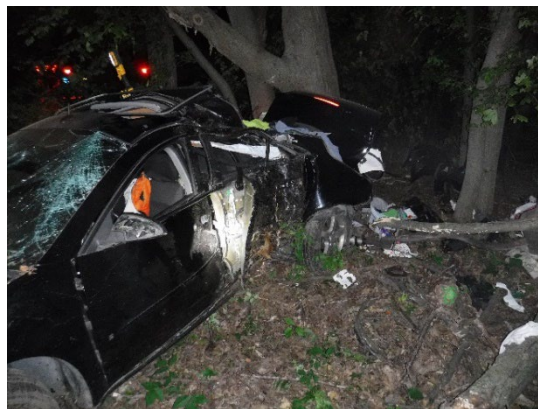
The deformed Pontiac separated from the second tree impact and continued to rotate counterclockwise into the tree cluster. A tree 9 cm (3.5 in) in diameter was struck by the front right corner of the vehicle (Event 3) and fractured. During its rotation to final rest, the undercarriage of the Pontiac rode over the trunk of a previously downed tree (Event 4). This undercarriage impact separated the exhaust system from the vehicle. This latter damage was observed in the on-scene police images (Figures 5 and 6).

*Figure 5. On-scene police image of the Pontiac at final rest and the yielding tree impacts*

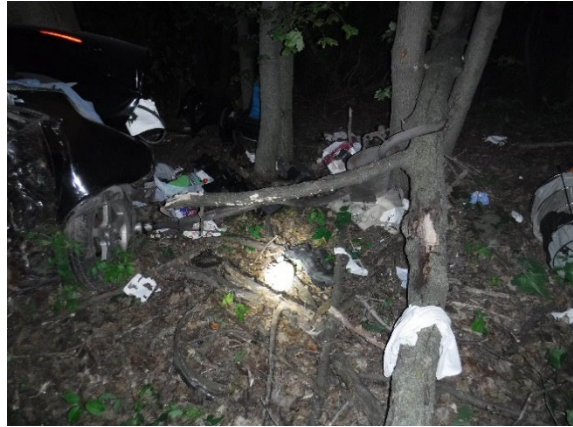
*Figure 6. On-scene police image of the Pontiac at final rest and the displaced exhaust system*

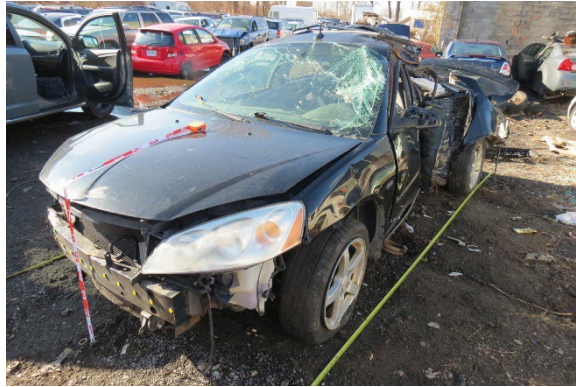
The 2008 Pontiac G6 was a 4-door sedan (Figure 7) identified by VIN 1G2ZG57NX84xxxxxx. It had the SE-level trim package. The date of manufacture was unknown. The jammed status of the left front door prevented access to the certification label. The battery was discharged; the odometer reading was unknown. The last known odometer reading was 312,344 km (194,087 miles) in May 2020 according to a vehicle history report. The Pontiac was configured on a 285 cm (112.2 in) wheelbase with an overall length of 480 cm (189.0 in). The powertrain consisted of a 3.5-liter, 6-cylinder gasoline engine linked to an automatic transmission. Standard equipment included power-assisted front disc/rear drum brakes with ABS, traction control, and power steering. The curb weight was 1,507 kg (3,322 lb). At the time of the crash, the Pontiac had four Mastercraft MC-440 tires of the vehicle manufacturer recommended size 225/50R17. All tires had greater than 3 mm (4/32 in) of tread and were not damaged in the crash.

*Figure 7. Left front oblique view of the Pontiac*

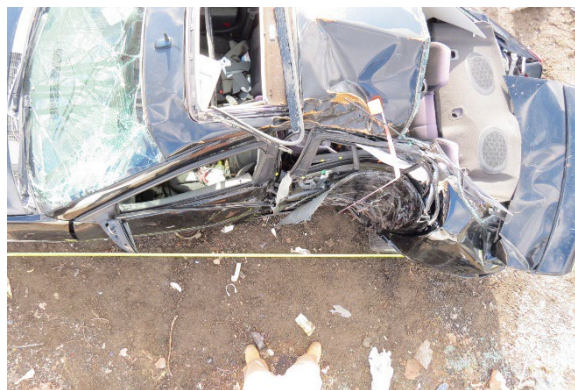
The Pontiac sustained direct contact damage to the left, right, front, and undercarriage planes during the multiple event crash sequence. The highest severity impact was the Event 1 left plane impact to the 36 cm (14.2 in) tree (Figure 8). The direct contact damage began on the mid-aspect of the left front door and extended rearward 108 cm (42.5 in). The combined width of the direct and induced damage measured 310 cm (122.0 in). This field L began 49 cm (19.3 in) aft of the left front axle and extended rearward. The maximum crush was 29 cm (11.4 in) located at the mid-aspect of the left rear door, 233 cm (91.7 in) aft of the left front axle. The residual crush profile was as follows: C1 = 13 cm (5.1 in), C2 = 26 cm (10.2 in), C3 = 29 cm (11.4 in), C4 = 12 cm (4.7 in), C5 = 3 cm (1.2 in), C6 = 0. Both left doors were jammed shut in the impact. The left front, left rear and backlight glazing disintegrated during this event. The collision deformation classification (CDC) assigned to the damage pattern was 10LZAW3, with a PDOF of 310 degrees.

*Figure 8. Overhead view of the Pontiac's left plane deformation*

The damage algorithm of the WinSMASH program was used to calculate the severity of the impact. The calculated total delta V was 33 km/h (21 mph). The longitudinal and lateral components were -21 km/h (-13 mph) and 25 (16 mph), respectively. Analysis of the crash fit the parameters of the WinSMASH program; however, based on SCI field experience the results were considered low, underestimating the severity of the impact.

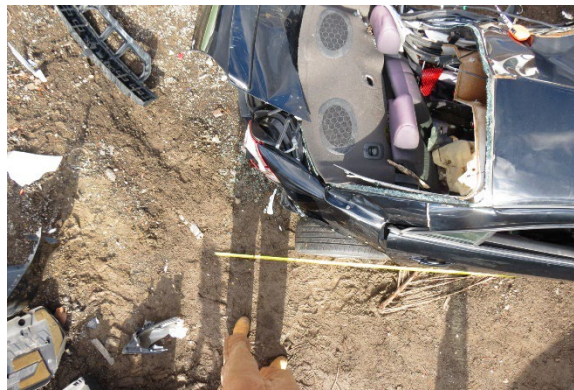
The Pontiac rotated counterclockwise and the aft-aspect of the right plane struck the 21 cm (8.3 in) diameter tree (Event 2, Figures 9 and 10). The direction of force was in the 3 o'clock sector. The direct contact damage began 38 cm (15.0 in) aft of the rear axle and extended 21 cm (8.3 in) to the right rear bumper corner. The combined width of the direct and induced damage (field L) measured 64 cm (25.2 in). The force of the impact collapsed the trunk space and deformed the end structure to the left. The residual crush profile was as follows: C1 = 44 cm (17.3 in), C2 = 36 cm (14.2 in), C3 = 24 cm (9.4 in), C4 = 16 cm (6.3 in), C5 = 12 cm (4.7 in), C6 = 8 cm (3.1 in). The maximum crush was located at the right rear corner and measured 44 cm (17.3 in). The CDC assigned to the damage pattern was 03RBEN4. The calculated WinSMASH total delta V for this impact was 14 km/h (9 mph) with longitudinal and lateral components of 0 km/h and -14 km/h (-9 mph), respectively. These results were considered low, underestimating the severity of the impact.

*Figure 9. Overhead view of the Pontiac's right plane deformation*

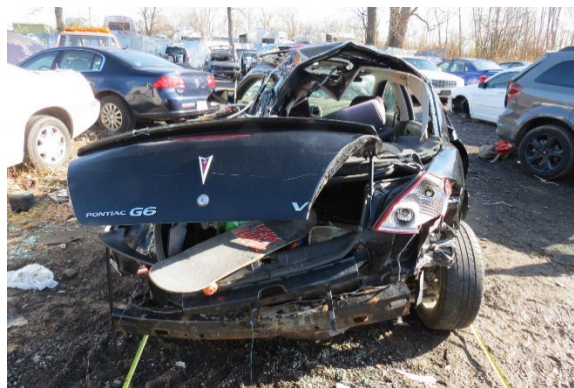
*Figure 10. Back plane view of the Pontiac's deformation*

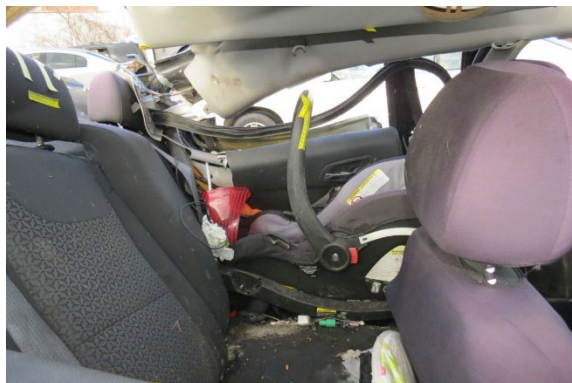
Interior damage to the Pontiac consisted of the intrusion of multiple components to the left occupant compartment and were attributed to the Event 1 tree impact. Refer to the table below. The most severe intrusions were located at the second-row left position. The intruding left rear door contacted and deformed the rear-facing CRS (Figure 11). The CRS compressed into the seat cushion and the door deformed around the left aspect of the CRS. There was no actuation or deployment of any supplemental safety systems.

*Figure 11. Lateral view across the second row of the Pontiac and the CRS in the left position*

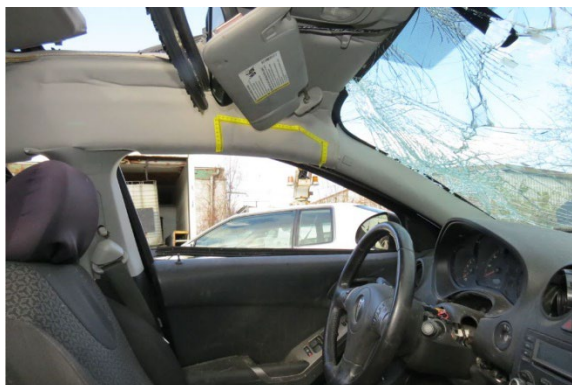
Several areas of occupant contact were noted in the front interior and were attributed to the unbelted driver and unbelted front passenger. The driver loaded the steering assembly and displaced the column from the shear capsules. The steering column had dropped down and was resting on the left lower knee bolster (Figure 12). A scuff was noted on the headliner covering the left roof side rail attributed to the driver's face. The right aspect of the windshield was fractured in a star pattern directly forward of the unbelted front passenger. The fracture was attributed to head contact.

*Figure 12. View of the driver's contact to the steering wheel and left roof side rail*

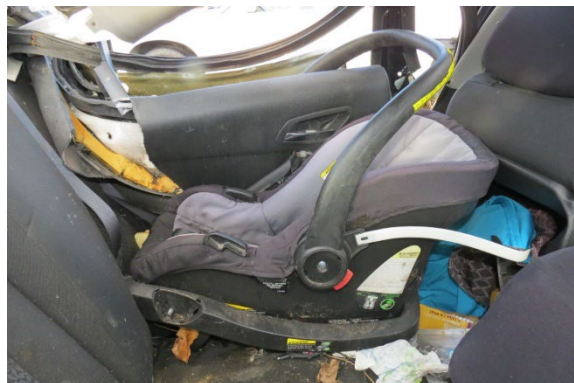
The three seat belts in the second row consisted of continuous loop webbing with sliding latch plates and switchable ALR/ELR retractors. The second-row left seat belt was used to secure the rear-facing CRS, which was still with the vehicle at the time of the SCI inspection (Figure 13). The webbing was routed through the rear-facing belt path of the base. Due to the crash damage and intrusion, the seat belt webbing was not accessible until the seat belt buckle was unlatched and the CRS removed (Figure 14). At inspection, the second-row left retractor was not accessible due to deformation and the webbing could not extend or retract. It was not possible to determine the mode of the switchable retractor. Alternatively, it was possible that the second-row left retractor was locked in emergency mode due to deformation of the left C-pillar.

*Figure 13. View of the CRS and intruded left rear door*

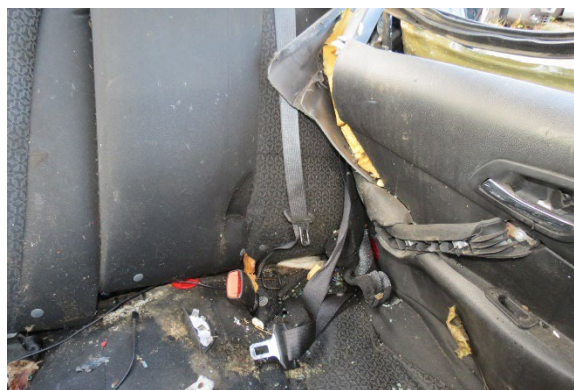
*Figure 14. View of the (extended) second-row left seat belt used to secure the CRS. Note that the left position was nearly eliminated by the intruded door.*

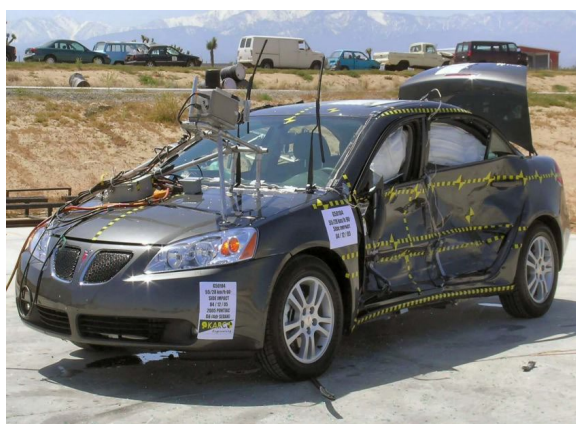
For comparison, NHTSA Test G50194 was a side impact NCAP test of a 2005 Pontiac G6 (Figure 15). The test vehicle was struck by a crabbed (27 degree) moving deformable barrier at 61.9 km/h (38.5 mph). The maximum lateral crush was 24 cm (9.4 in). The measured maximum longitudinal and lateral delta Vs of the test vehicle were -2.8 km/h (-1.2 mph) and 21.5 km/h (13.3 mph), respectively. In the test, the left front-seat-mounted side impact air bag and the left IC air bag deployed. Subjectively, the test vehicle involved in a lesser severity impact deployed the side impact air bags, yet the Pontiac under investigation involved in what appeared to be a greater severity crash (as compared by WinSMASH) did not deploy air bags.

*Figure 15. Post-test image depicting the left side deformation of the 2005 Pontiac G6*

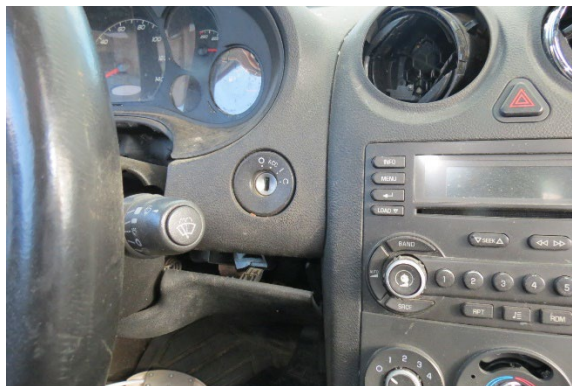
Of particular note is the lack of EDR data related to the crash sequence. The EDR did not record any of the events in this crash. A possible power loss to the SDM was investigated. The SDM fuse in the interior fuse block was checked during the SCI inspection and the 10 amp fuse was observed to be intact. The ignition switch of the Pontiac G6 was designed into the face of the instrument panel, right of the steering column (Figure 16) and the switch was in the off-position. The key was missing and not available for the inspection, therefore the fob and any additional weight hanging on the key was not known. The key slot was aligned in the longitudinal direction relative to the vehicle and in this orientation rotation of the key due to the longitudinal deceleration experienced by the vehicle would not be expected. Pre-crash rotation of the key by one of the Pontiac's occupants could not be ruled out as a possibility. The driver stated to the police investigator that the front passenger grabbed the steering wheel during an argument, which caused the vehicle to depart the road.

*Figure 16. Image depicting the ignition switch of the Pontiac*

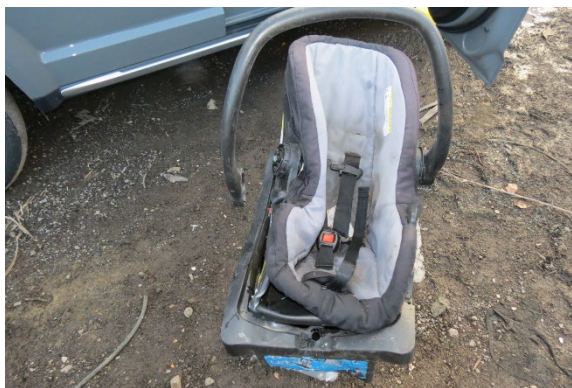
The CRS installed in the second-row left position of the Pontiac was an Evenflo Urbini Sonti rear-facing infant seat (model number: 25HB4Y-TLKU, Figure 17) that was manufactured in November 2016. Its construction consisted of a molded polymer shell, a rigid Styrofoam liner and a fabric cover. The CRS was designed for use with or without its detachable base. The base unit was designed with LATCH; however, it was not used. An adjustable carrying handle was mounted to the midpoint of the lateral aspects of the CRS. The CRS handle could be in any position when the vehicle was in motion. Manufacturer specifications listed occupant size was 1.8-15.8 kg (4-35 lb) in weight and less than 81 cm (32 in) in height. The demographics of the 3-month old male occupant were within the recommended weight and height limits of the CRS.

*Figure 17. Image of Evenflo CRS*

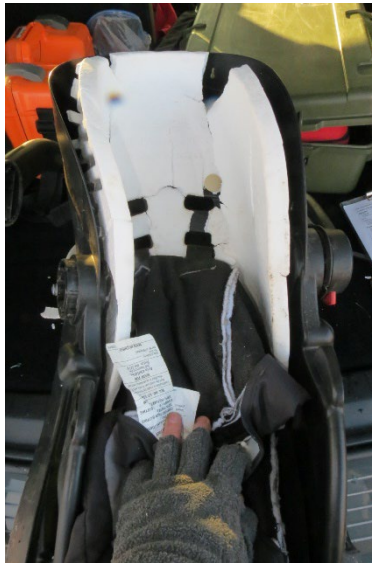
The CRS was designed with an internal 5-point harness system that was adjustable in the shell. According to the police report, the harness was not used to secure the child. At SCI inspection, it was observed that there were four vertical adjustment slots for the shoulder straps. The harness straps were adjusted to the third highest slots. At inspection and initial observation, the chest clip of the harness was adjusted to the top of the straps in a position that rendered it most likely unusable. The right side of the shell intruded/deformed laterally 8 cm (3.1 in) due to contact with

the left rear door of the Pontiac. The styrofoam liner in the shell was completely fractured (Figure 18).

*Figure 18. View of the fractured liner in the CRS*
