U.S. Department  
of Transportation  
**National Highway  
Traffic Safety  
Administration**

DOT HS 813 412

**Special Crash Investigations:  
On-Site Ambulance Crash  
Investigation;  
Vehicle: 2008 Ford Econoline E350  
Super Duty Type II Ambulance;  
Location: South Dakota;  
Crash Date: August 2020**

**Special Crash Investigations**  
**On-Site Ambulance Crash Investigation**  
**Case Number: DS20011**  
**Vehicle: 2008 Ford Econoline E350 Super Duty Type III Ambulance**  
**Location: South Dakota**  
**Crash Date: August 2020**

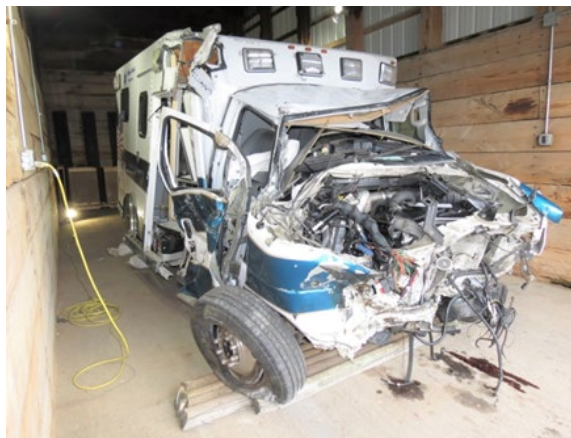
*Figure 1. The 2008 Ford E350 Type III ambulance*

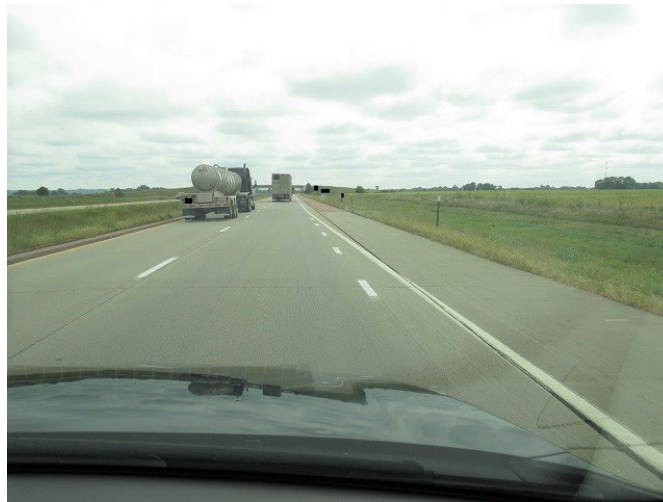
*Figure 2. Area of departure, the 2008 Ford E350 Type III ambulance, looking north*

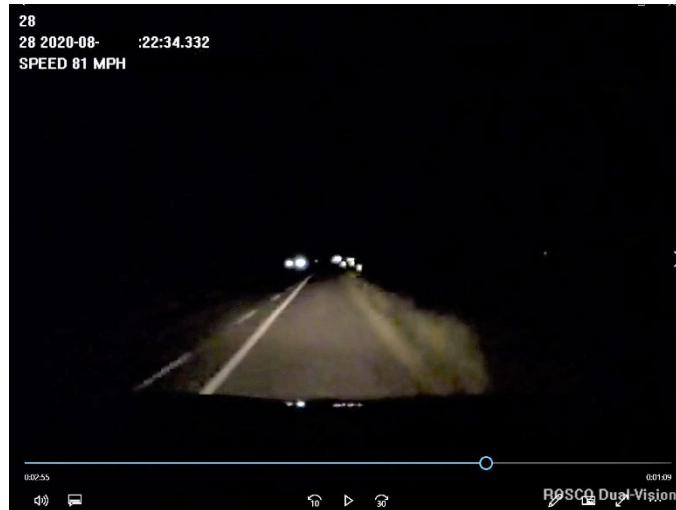
*Figure 3. Area of departure, the 2008 Ford E350 Type III ambulance, looking south (screen shot taken from on-board video camera)*

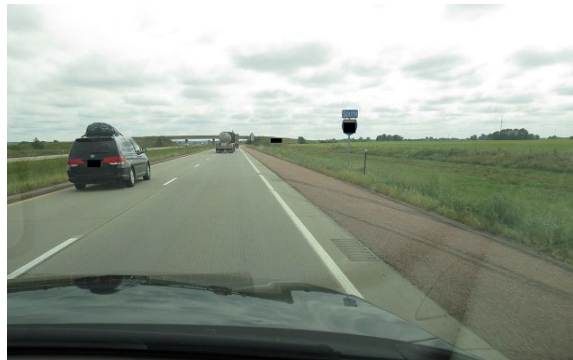
After departing the roadway on the right edge, the ambulance traveled southbound parallel to the roadway for approximately 34 m (110 ft) and struck the first of two reflectorized delineator posts with its front plane (Event 1). The post yielded and this was a low delta V event. The vehicle traveled another 30 m (100 ft) and struck the second delineator post with its front plane (Event 2). The ambulance driver awoke and steered left, returning the vehicle to the roadway approximately 129 m (423 ft) south of where it departed (Figure 4). The ambulance returned to the roadway at a speed of 114 km/h (71 mph). The driver overcorrected his steering to the left, the vehicle crossed the southbound lanes, and entered the center median at a speed of 100 km/h (62 mph). The video shows the driver actively steering and the front passenger appears to be bracing her right arm and hand on her seat back and cushion. The ambulance crossed over the center median and entered the northbound lanes where its front plane struck the left plane of the Volvo (Event 3) (Figure 5). The last frame of video before impact indicated a vehicle speed of 76 km/h (47 mph). Impact forces caused the ambulance to rotate counterclockwise and its right plane struck the left plane of the tanker (Event 4). During Event 4, it appears the right side door of the ambulance came open when the latch disengaged from the striker. The unbelted EMT was fully ejected through the open door and her head struck the tanker, causing a critical severity avulsive head injury, according to the police report. She came to rest in the center median. The ambulance came to rest facing east on the right shoulder of the northbound lanes approximately 20 m (66 ft) north of the area of impact.

*Figure 4. Tire marks at point of return to roadway, looking south, the 2008 Ford E350 Type III ambulance*

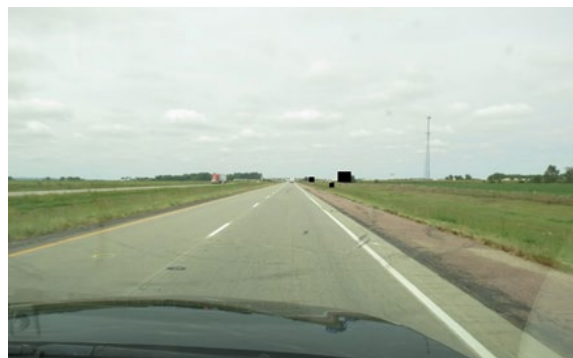
*Figure 5. Tire marks at area of impact, looking north, the 2020 Volvo VNR 640 perspective*

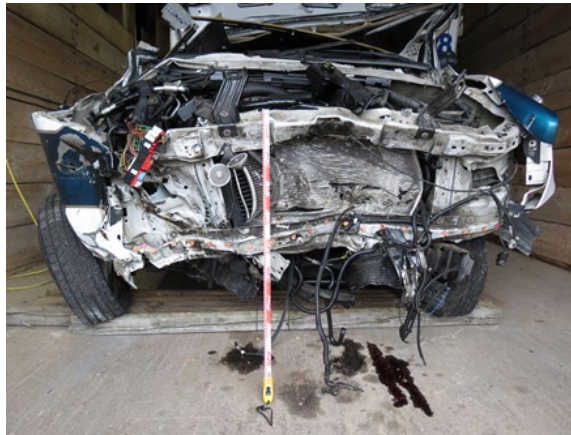
The ambulance struck two roadside reflectorized delineator posts with its front plane (Events 1 and 2). These were lightweight posts that yielded, and damage to the ambulance from the impacts was minor or masked by later events. The ambulance sustained severe crush damage to the front plane during the Event 3 impact with the Volvo. Direct damage at bumper level was distributed from bumper corner to bumper corner and the field L measured 150 cm (59.1 in). Twenty measurements were taken at bumper level using the Nikon total station and the AutoCrush tool calculated six crush measurements as follows: C1=33 cm (13.0 in), C2=40 cm (15.7 in), C3=50 cm (19.7 in), C4=37 cm (14.6 in), C5=30 cm (11.8 in), C6=27 cm (10.6 in). Maximum crush was 52 cm (20.5 in) at 90 cm (35.4 in) right of the front left bumper corner and the truck deformation classification (TDC) for the ambulance in Event 3 was 01FDEW3 (Figure 6).

*Figure 6. Front plane damage, the 2008 Ford E350 Type III ambulance*

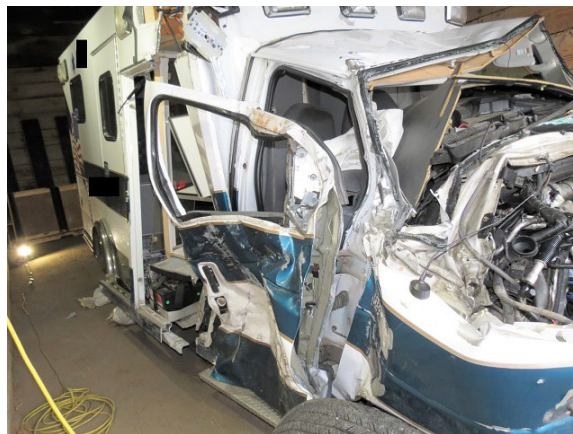
*Figure 7. Right plane damage, the 2008 Ford E350 Type III ambulance*

The ambulance sustained moderate severity crush including direct and induced damage to the right plane caused during the Event 4 side plane to side plane impact with the tanker. Direct damage at mid-door level began at 228 cm (89.8 in) forward of the right rear axle extending forward to 373 cm (146.9 in) forward of the right rear axle. Direct damage extended vertically to the right roof rail. The field L measured 150 cm ((59.1 in). A string line was used to measure six

crush measurements as follows: C1=15 cm (5.9 in), C2=0 cm, C3=5 cm (2.0 in), C4=0 cm, C4=8 cm (3.1 in), C6=0 cm. Maximum crush was located 318 cm (125.2 in) forward of the right rear axle and the TDC for the ambulance in Event 4 was 05RDAW3 (Figure 7).

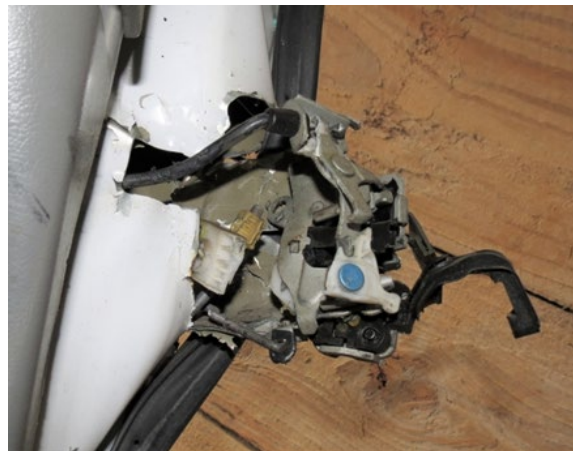
The occupant compartment was damaged by impact forces, integrity loss, air bag deployments, and occupant contacts. The windshield was fractured and out of place and the passenger side window glass was disintegrated. The front right door appeared to have opened during the crash due to damage and separation of the latch (Figure 8) from the striker (Figure 9). The striker plate and upper and lower hinges were unremarkable. Both frontal air bags deployed. The driver's seat belt exhibited scuff and stretch marks caused by occupant loading. The front row was reduced by vertical intrusion of the left roof (16 cm [6.3 in]), middle roof (24 cm [9.4 in]), right roof (10 cm [3.9 in]), left windshield header (21 cm [8.3 in]), center windshield header (28 cm [11.0 in]) and right windshield header (15 cm [5.9 in]); it was reduced by lateral intrusion of the right A-pillar (20 cm [7.8 in]) and left seat back (25 cm [9.8 in]); and it was reduced by longitudinal intrusion of the center instrument panel (15 cm [5.9 in]) and right instrument panel (15 cm [5.9 in]). The right door panel trim was fractured in all four quadrants and the right window frame was bent at the forward, upper, and rearward aspects.

*Figure 8. Right side door latch, the 2008 Ford E350 Type III ambulance*

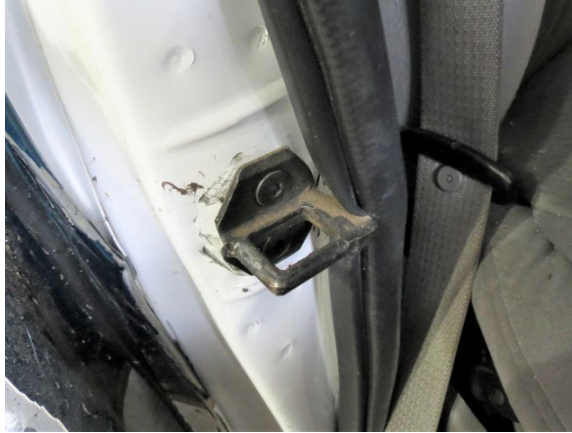
*Figure 9. Right side door striker, the 2008 Ford E350  
Type III ambulance*

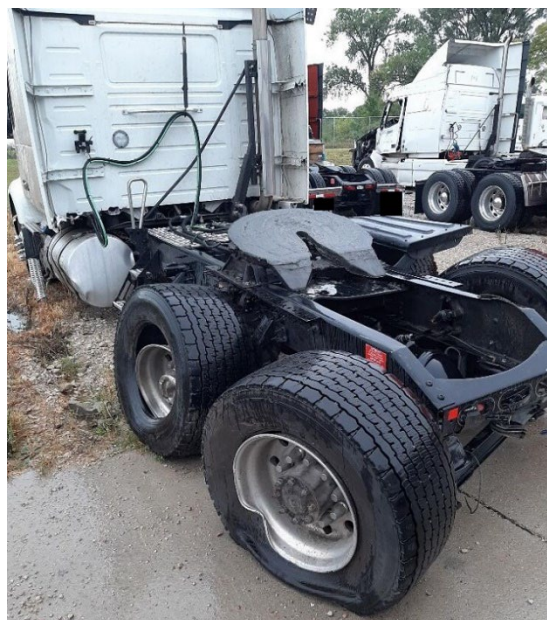
The Volvo tractor was damaged on the left plane in Event 3 and on the right plane during the rollover. The Walker tanker was damaged on the left plane in Event 4 and on the right plane during the rollover. It was unknown if post-crash damage occurred. A partial exterior inspection was completed by SCI using insurance and police photos. The second and third axle left tires of the Volvo were flat and de-beaded (Figure 10). The left side metal fuel tank was dented and the windshield was fractured and in place. The right plane including the side door and rear-view mirror showed scrape marks and minor deformation caused by ground contact. The left plane of the stainless steel tank was dented and a metal seam was split open (Figure 11). The rear aspect of the tank's right plane was dented and scraped. An access ladder mounted to the tank's right plane was bent. The left front rim of the tanker was bent and the tire was flattened. The metal fenders above the left and right side tires were deformed. The TDC for the Volvo in Event 3 was 10LKEWA. The TDC for the tanker in Event 4 was 11LTFWA. The TDC for the Volvo and tanker for the Event 5 rollover was 33RDAOA.

*Figure 10. The 2020 Volvo VNR 640 (insurance photo)*

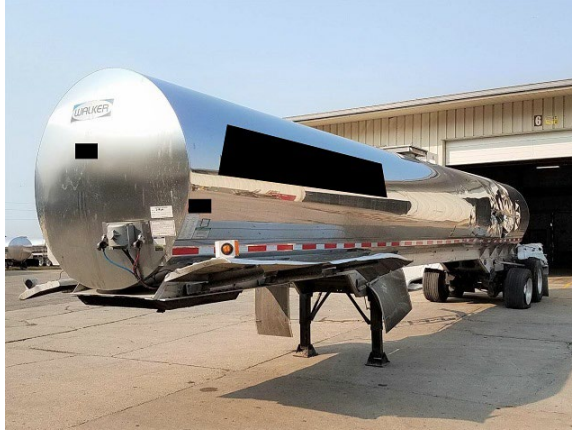
*Figure 11. The 2019 Bulk Tank International/Walker tanker trailer (insurance photo)*
