DOT HS 813 418

**Special Crash Investigations:  
On-Site Move-Over-Law Crash  
Investigation;  
Vehicle: 2016 Dodge Challenger;  
Location: Texas;  
Crash Date: December 2020**

**Special Crash Investigations**  
**On-Site Move-Over-Law Crash Investigation**  
**Case Number: CR20039**  
**Vehicle: 2016 Dodge Challenger**  
**Location: Texas**  
**Crash Date: December 2020**

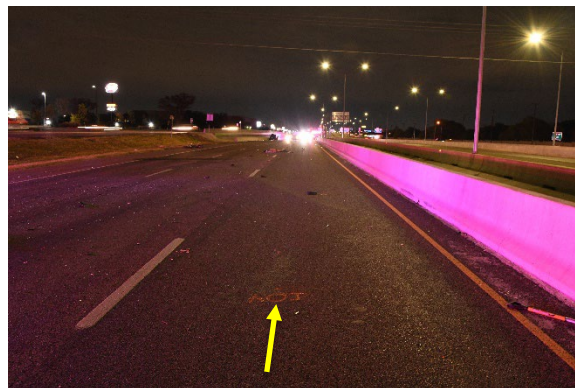
During the SCI interview, one of the on-scene firefighters reported that he was walking east with the struck non-occupant, with their backs to the west. Another firefighter nearby noticed the eastbound Dodge traveling the wrong way toward his colleagues and yelled at them, warning them of the oncoming vehicle. Both firefighters turned to their right; however, neither could take evasive action. The firefighter was struck by the front of the Dodge (Figure 3), wrapped onto the left side of the hood, and was projected forward approximately 31 meters (102 ft). He came to final rest in the center lane. The other firefighter was not struck.

*Figure 3. East view on WB lanes, police on-scene image of area of impact (AOI)*

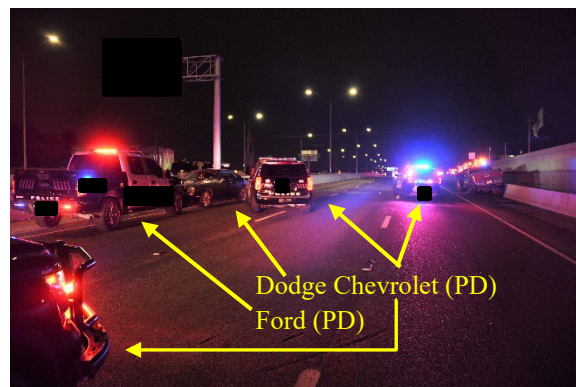
The Dodge continued forward in the left lane for approximately 158 m (520 ft). At the east end of the previous crash scene, police vehicles were spread across all lanes. The Dodge driver attempted to travel in between (Figure 4) one of the police department's Chevrolets and the concrete median barrier. One of the officers behind the line of police vehicles moved his vehicle (Ford) into this gap, blocking the Dodge's path. The Dodge came to a stop facing east and the driver was apprehended by police.

*Figure 4. West view, the Dodge at final rest, blocked by police vehicles*

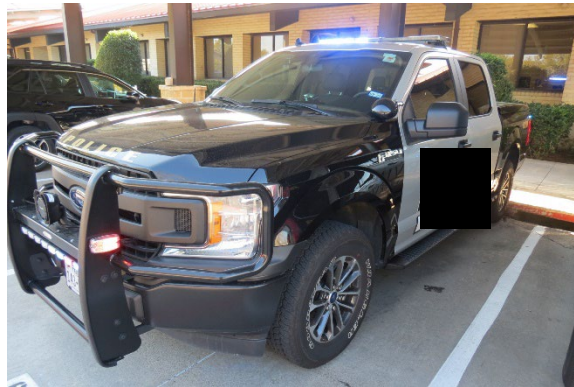
*Figure 6. Police F-150 with top bar and side push bar lights illuminated*

Emergency LED lighting manufactured by Whelen was present on all sides of the vehicle (Figure 6). The light bar across the roof featured blue LEDs on the right side and red LEDs on the left. All LEDs for each half alternately flashed with the other half at a slow pace. The lighting scheme was the same for the front and back of the light bar. The push bar on the front plane had a horizontal array of eight small LEDs mounted at the bumper level. Each of these lights was either red, blue, or white and they would flash in four different symmetrical patterns. A small rectangular LED was mounted on each side of the uprights of the push bar and each LED would flash red and blue. The only other lighting on the side planes was a single small LED on the upper back corner of the truck bed that flashed red and blue.

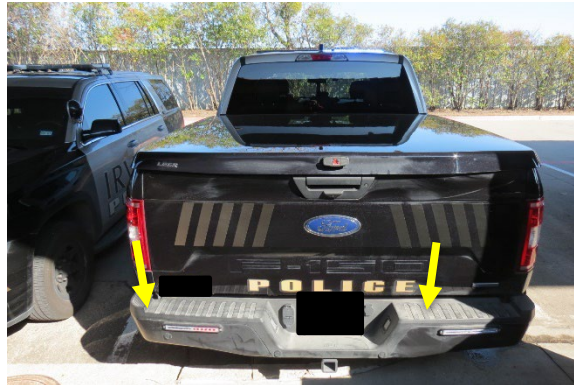
The back plane of the vehicle (Figure 7) featured reflective diagonal decals on each outboard aspect of the tail gate and “POLICE” lettered in the center of the lower tailgate, just above the bumper, also with reflective decals. Warning lighting consisted of the aforementioned light bar on the roof and two narrow LEDs mounted horizontally on the back bumper on each side of the license plate. Each LED would flash half blue and half red and each half would switch colors. The two modules were not in sync with each other.

*Figure 7. Back plane of the F-150*

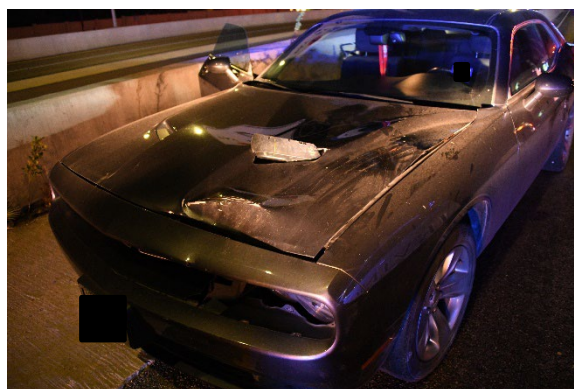
The Dodge sustained damage to the front plane during the impact with the non-occupant. There was direct damage to the bumper fascia, upper and lower grilles, left head lamp assembly, and hood (See Figure 1 above). The direct damage started 24 cm (9.4 in) right of the left front bumper corner and extended 39 cm (15.4 in) to the right. There was no crush damage to the bumper but the non-occupant wrapped onto the hood (Figure 21). The contact to the hood extended approximately 70 cm (28 in) rearward and was 18 cm (7.1 in) wide. The maximum longitudinal crush to the front of the hood was approximately 5 cm (2 in), occurring 53 cm (22.0 in) left of the centerline. The collision deformation classification (CDC) for this impact was 12FYEN1. Scratching and dents were noted on the left side plane, but this damage occurred as police officers forced the vehicle to a stop and apprehended the driver.

*Figure 21. On-scene police image of the left side hood damage from impact with non-occupant*
