U.S. Department  
of Transportation  
**National Highway  
Traffic Safety  
Administration**

DOT HS 813 489

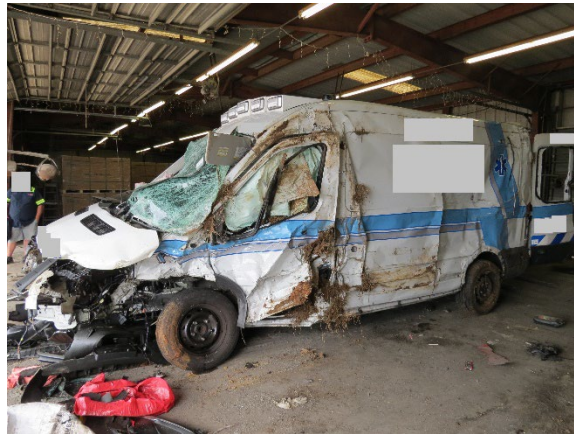
*Figure 1. Left plane view of the 2017 Ford Transit ambulance at the time of the SCI inspection*

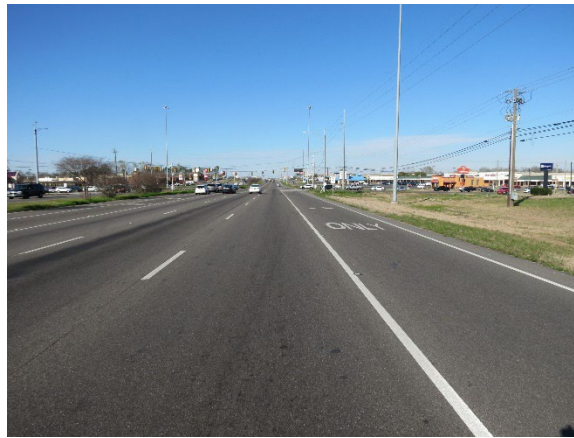
*Figure 2. North-facing view of the roadway for the ambulance's pre-crash travel trajectory*

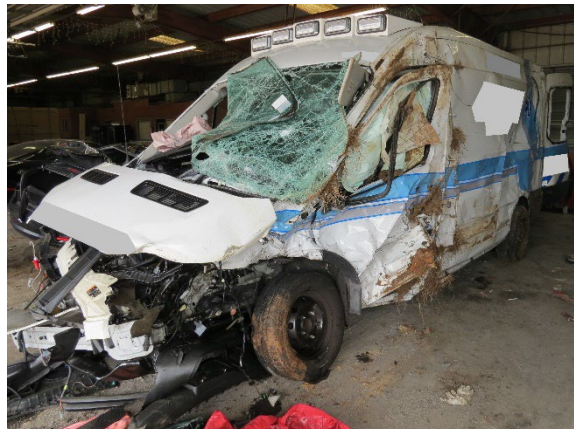
*Figure 7. Left front oblique view of the 2017 Ford Transit Type II ambulance*

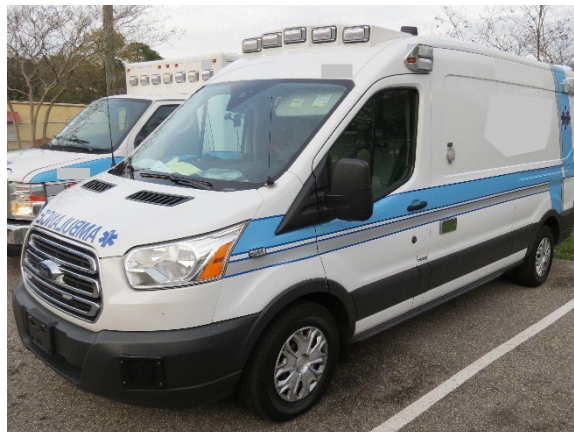
*Figure 8. Left front oblique view of an exemplar Ford Transit ambulance of the same agency*

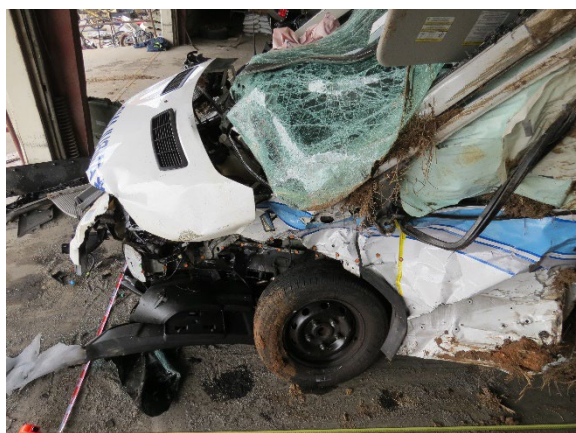
*Figure 10. Overhead perspective view of the Event 1 damage profile to the ambulance*

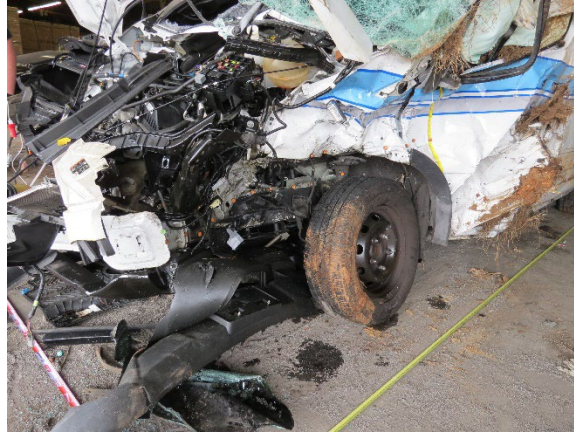
*Figure 11. View of the deformation to the ambulance's left front from the impact by the Hyundai*

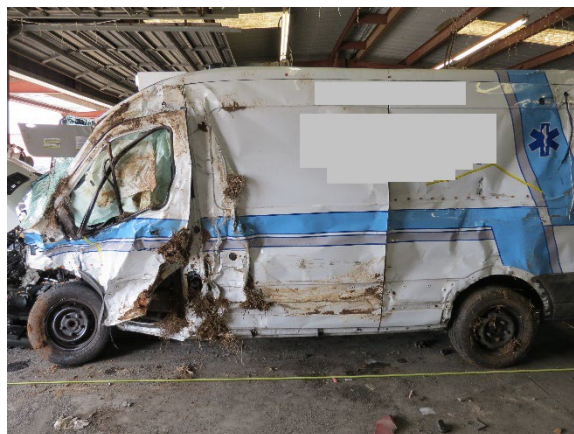
*Figure 12. Left plane view of the ambulance and the side slap profile above the left rear axle position*

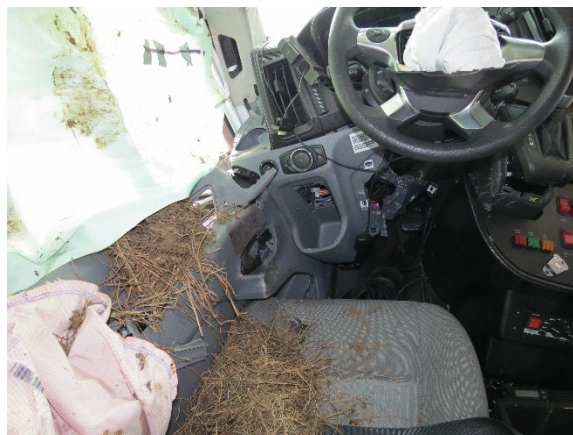
*Figure 13. View of the driver's position and the left side intrusions, including displacement of the steering wheel*

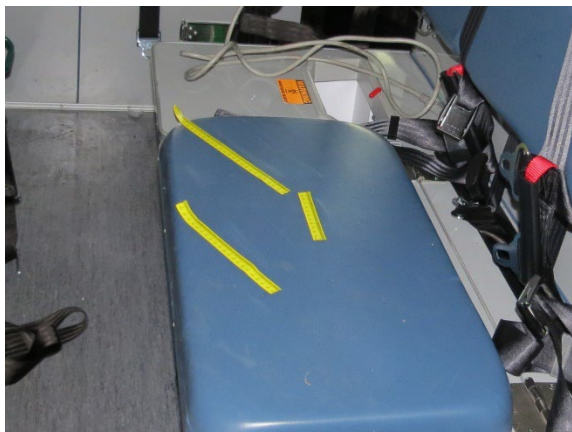
*Figure 14. Contact evidence on the bench seat from the EMT's posterior*

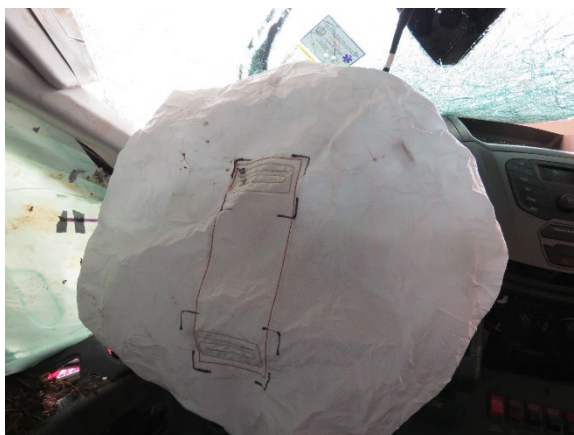
*Figure 18. Deployed driver's frontal air bag in the ambulance at the time of the SCI inspection*

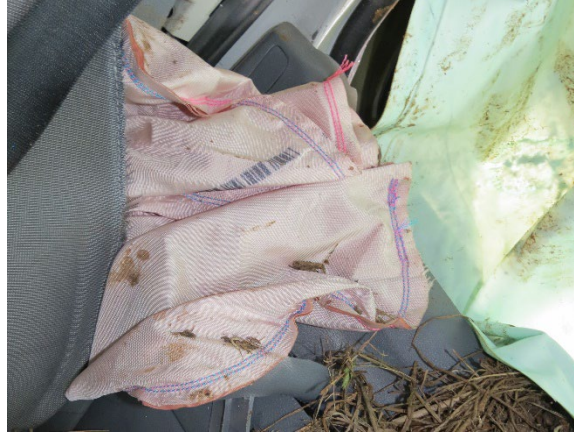
*Figure 19. View of the deployed driver's seat-mounted side impact air bag at the time of the SCI inspection*

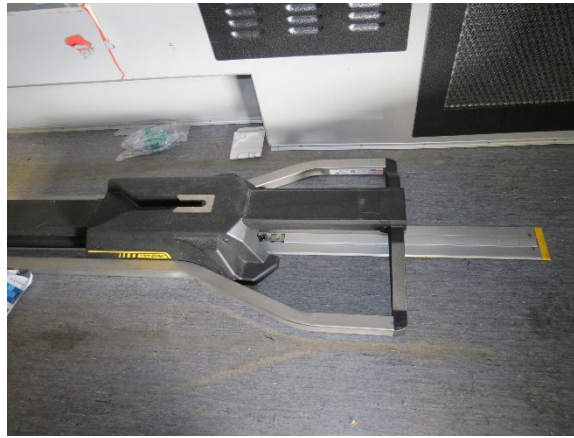
*Figure 23. Head-end view of the cot fastener system in the ambulance's patient compartment*

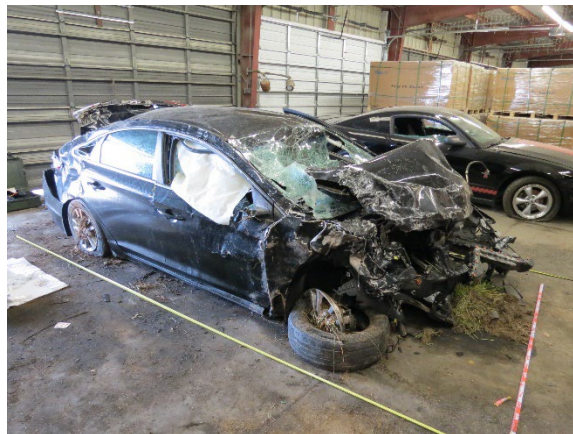
*Figure 24. Right front oblique view of the Hyundai at the time of the SCI inspection*

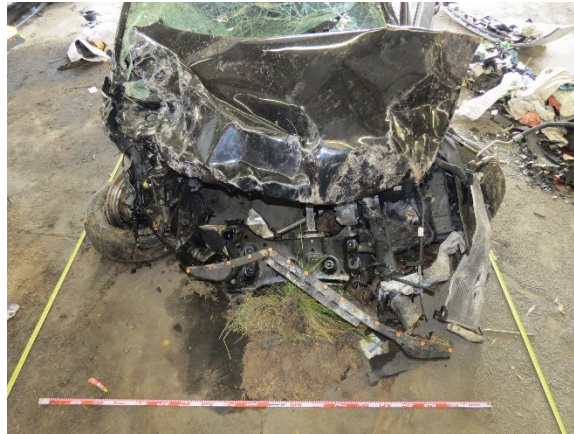
*Figure 25. View of the severe front plane damage profile from the Event 1 impact with the ambulance*

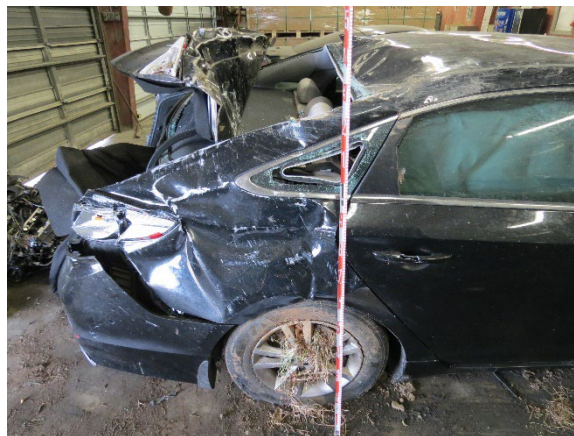
*Figure 26. View of the right plane damage from the side slap (Event 2) and rollover (Event 5)*

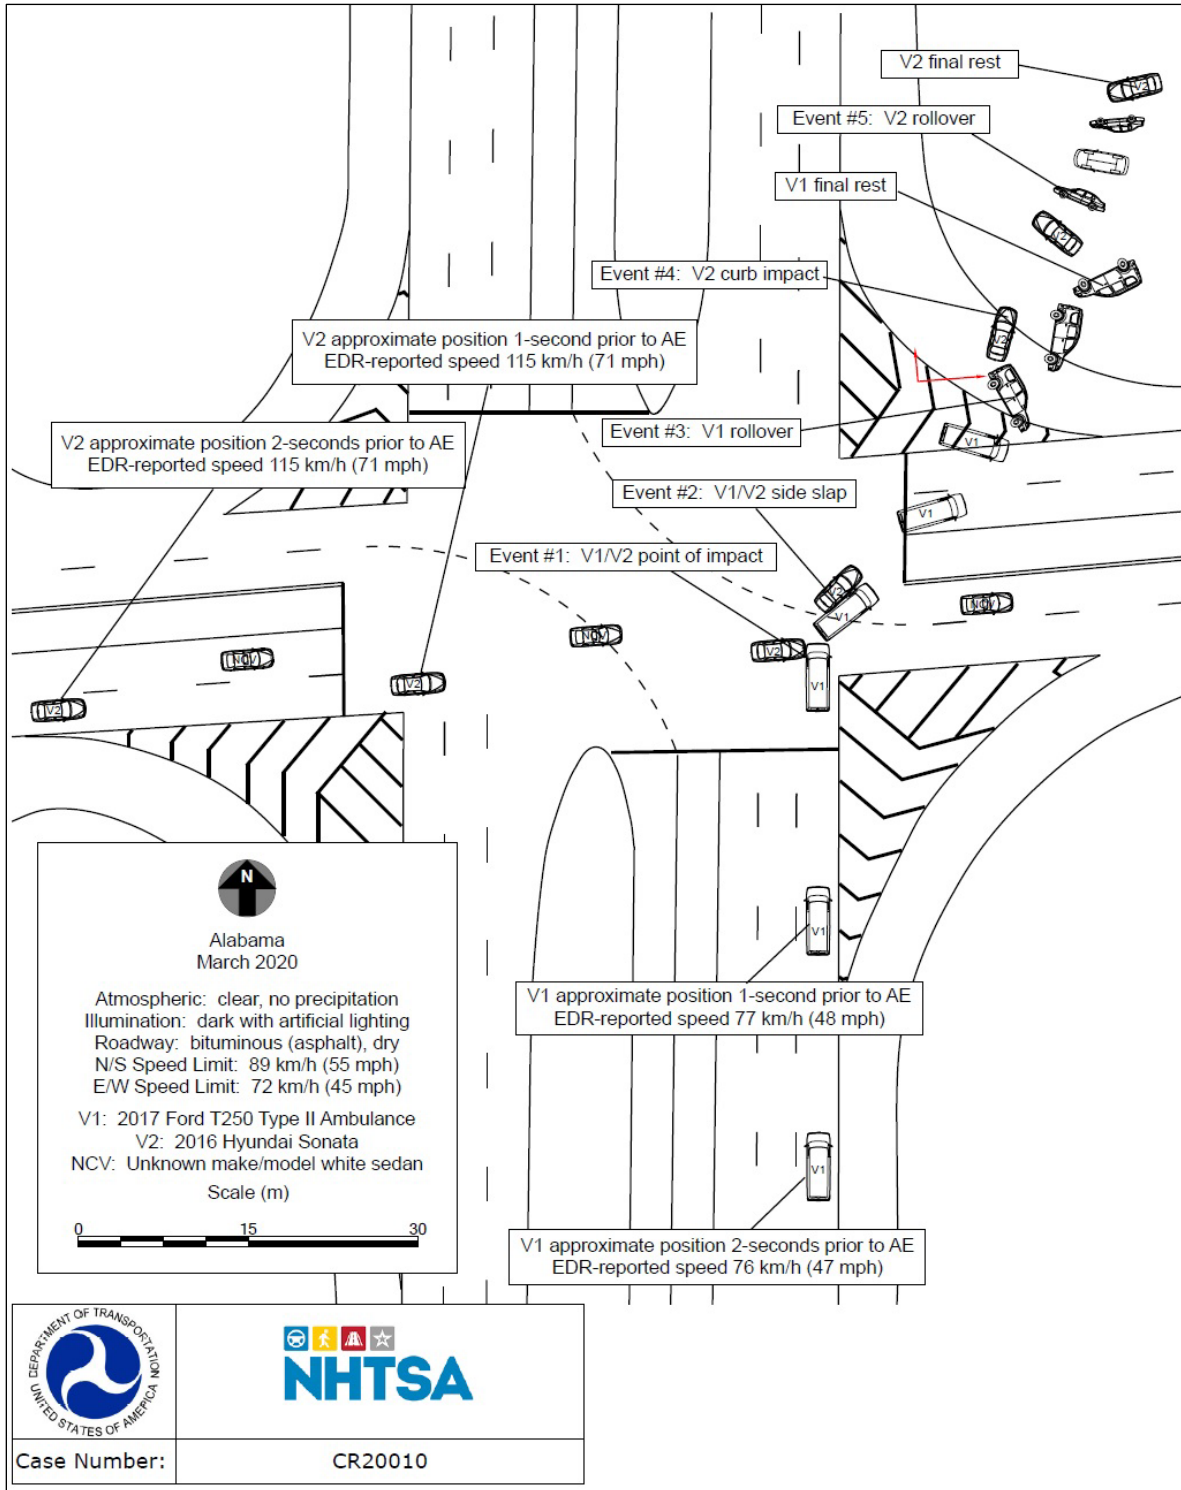
## **Appendix A: 2017 Ford Transit Event Data Recorder Report<sup>3</sup>**
