DOT HS 813 511

**Special Crash Investigations:
On-Site Reported Unintended
Acceleration Crash Investigation;
Vehicle: 2009 Hyundai Santa Fe;
Location: Pennsylvania;
Crash Date: July 2017**

Special Crash Investigations
On-Site Reported Unintended Acceleration Crash Investigation
Office of Defects Investigation
Case No: CR20038
Vehicle: 2009 Hyundai Santa Fe
Location: Pennsylvania
Crash Date: July 2017

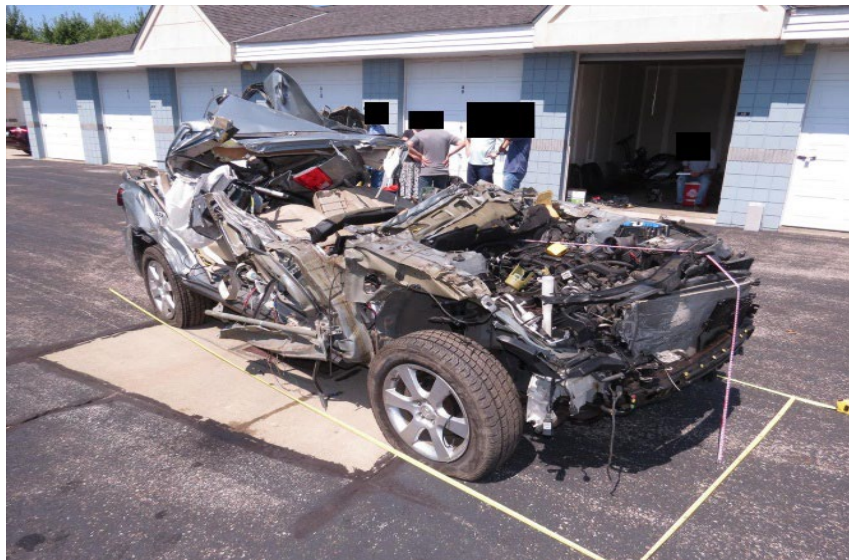
Figure 1. Right-front oblique view of the Hyundai

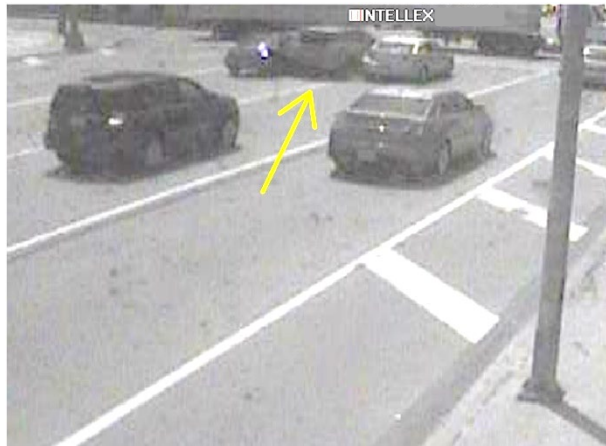
As their traffic signal turned green, the northbound vehicles entered the intersection. The Scion began a left turn onto the westbound lanes. The tractor-trailer continued straight and was approximately three-quarters of the way through the intersection when the Hyundai passed between the two stopped vehicles and underrode the trailer's right side without applying the brakes (Figure 4).

Figure 4. Camera view of Hyundai rear prior to impact (yellow arrow points to the rear of the Hyundai) Security camera image

At inspection, the SCI investigator observed that the driver's right footwear (size 12 flip-flop) was lying in the floor space. The footwear's underside showed evidence of a pedal imprint (Figure 17). The imprint was centered on the ball of the foot, measured 4 cm (1.6 in) across and extended 10 cm (3.9 in) from the tip. Further examination found that the imprint matched the accelerator (Figure 18). The right footwear was applied to the corresponding pedal at the time of the crash. During the frontal crash, the driver would have responded forward, loading the accelerator with his foot. The imprint was evidence of his kinematic loading. Additionally, the security camera footage (Figure 4) showed there was no brake light illumination prior to impact.

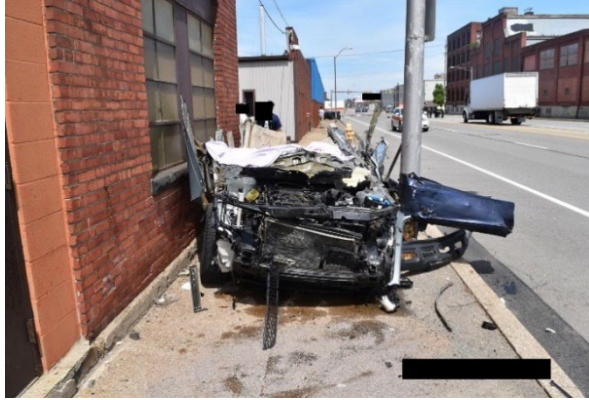
Figure 6. Final rest of the Hyundai looking east (On-scene police image)

counterclockwise striking the building with its right side (Event 5). It came to rest wedged between the light pole and building 128 m (420 ft) from the intersection (Figure 6).

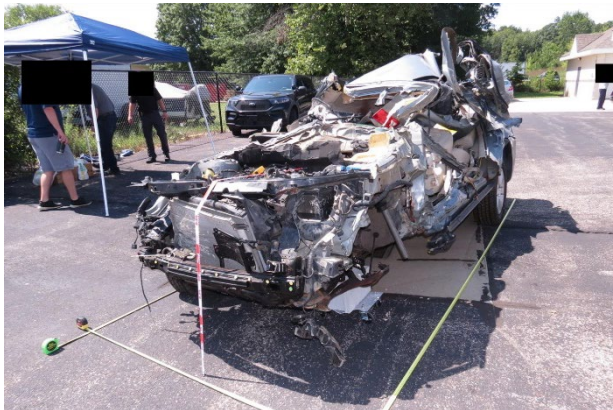
The Hyundai's top, front, right, and left planes were damaged in the crash sequence. All the vehicle's structures above the estimated 112 cm (44 in) clearance height of the trailer sheared and were displaced rearward during the underride (Figure 9). The hood separated from the hinges and was pushed back and up into the windshield and instrument panel. The A- to D-pillars sheared on the lower edge of the trailer. The deformed roof and separated components remained imbedded in the trailer interior and around the trailer's right-side frame (Figure 10). The collision deformation classification (CDC) assigned to the damage pattern was 12FDGW9. The crash dynamics were beyond the scope of the WinSMASH program. The damage pattern was rated severe.

Figure 9. Left front oblique view of Hyundai

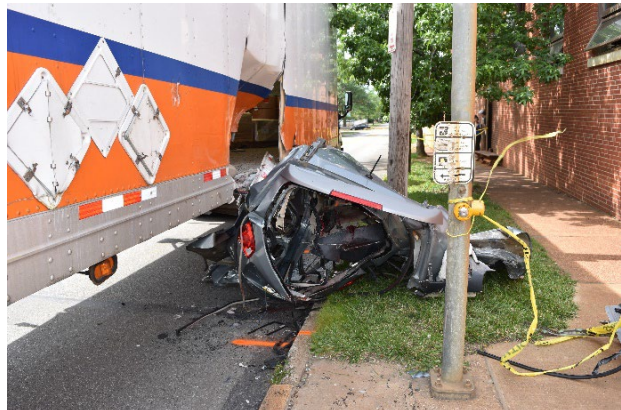
Figure 10. The separated greenhouse of the Hyundai removed from trailer (On-scene police image)

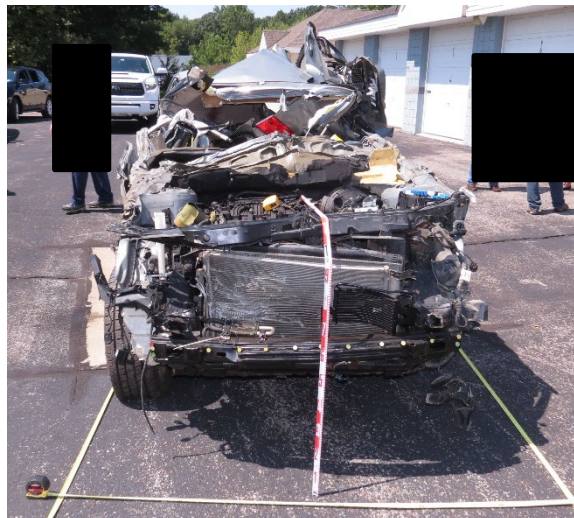
The front plane (Figure 11) sustained overlapping damage from its impact to the Scion's back plane (Event 2) and then from the light pole located near the vehicle's final rest (Event 4). A crush profile of the combined damage pattern was measured across the front bumper reinforcement bar. The residual crush was C1= 2 cm (0.8 in), C2 = 8 cm (3.2 in), C3 = 11 cm (4.3 in), C4 = 12 cm (4.8 in), C5 = 11 cm (4.3 in), C6 = 6 cm (2.4 in). The maximum crush was 12 cm (4.8 in) and was located 12 cm (4.8 in) right of centerline. The estimated direct contact damage from the Event 2 vehicle-to-vehicle impact involved the center and right aspects of the front plane. The CDC assigned to the damage pattern was 12FZEW1. For reference purposes, the barrier equivalent speed of this damage was 20 km/h (12 mph).

The direct contact damage from the light pole (Event 4) was an estimated 26 cm (10 in) wide and was located at the front-left corner beyond the end of the bumper reinforcement. The impact force fractured the left-front wheel rim and separated it from the axle. The CDC was 12FLEE3. Analysis of the corner impact could not be performed because the damage was beyond the scope of the WinSMASH program.

Figure 11. Front view of the Hyundai

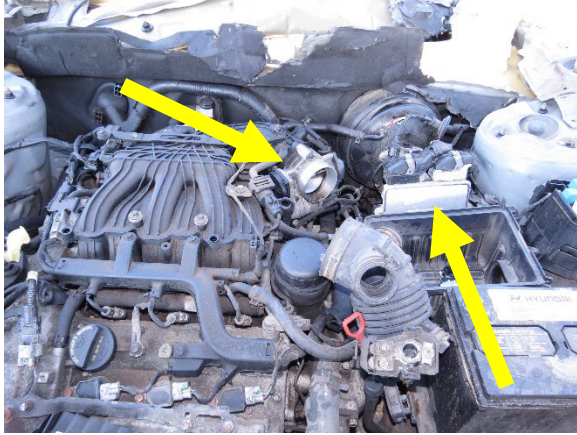
Due to the manufacture date, the Hyundai did not have an event data recorder. It had a PCM located in the left central aspect of the engine compartment (Figure 12). Delphi manufactured the module on February 7, 2009.¹ At the SCI investigation, representatives from Delphi retrieved hexadecimal data from the PCM using a proprietary scan tool (Figure 13). The retrieved hexadecimal data were translated to a readable format and shared to all parties involved in the investigation. After review, it was determined that the translated data were not useful for the purposes of crash reconstruction. A time history of when the data were recorded was not provided or could not be determined. The data neither supported nor refuted the reported unintended acceleration.

The throttle body was examined during the inspection. The butterfly valve was found in the closed position. The spring-loaded valve was manually exercised at inspection and was operational. It closed via spring pressure.

Figure 12. Overhead view of the engine compartment showing the PCM (right arrow) and throttle body (left arrow)

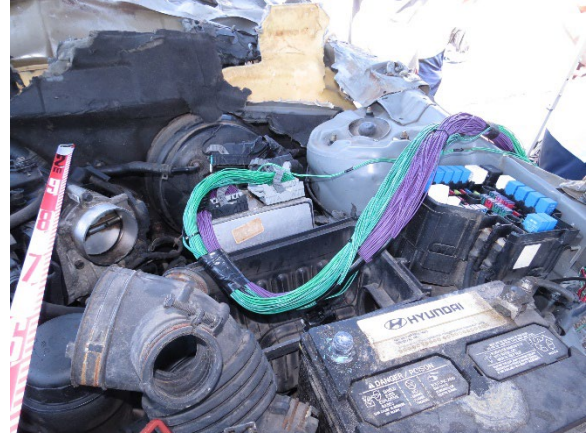
Figure 13. Image of the Hyundai's PCM during the proprietary imaging

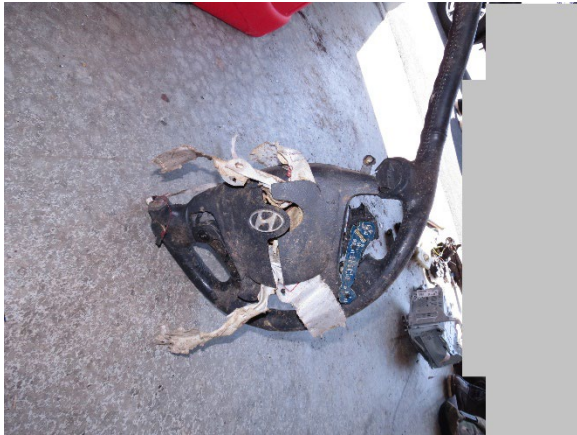
The Hyundai had dual-stage driver's and passenger's frontal air bags, front seat-mounted side impact air bags, and roof side rail-mounted IC air bags for the front and second row. During Event 1 the frontal air bags did deploy, but they were ripped out of the vehicle during the underride event. The deployed base/tether section of the driver's frontal air bag was found with the separated steering wheel (Figure 14). The deployed passenger's frontal air bag was found in

Figure 14. Image of the Hyundai's deployed driver's frontal air bag and deformed steering wheel rim

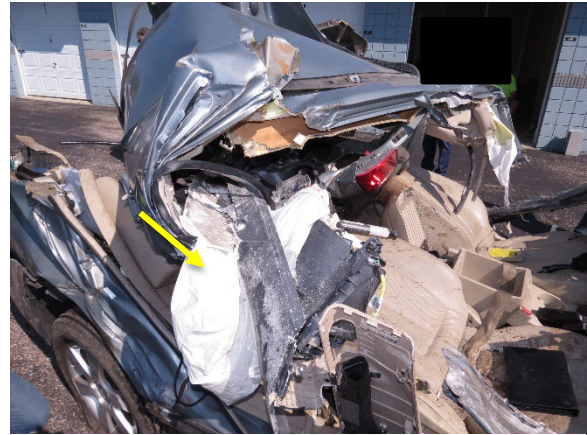
the debris of the second-row-right seat position (shown in Figure 15). The seat-mounted and IC air bags did not deploy.

Figure 15. Image of the Hyundai's deployed passenger's frontal air bag separated from the instrument panel

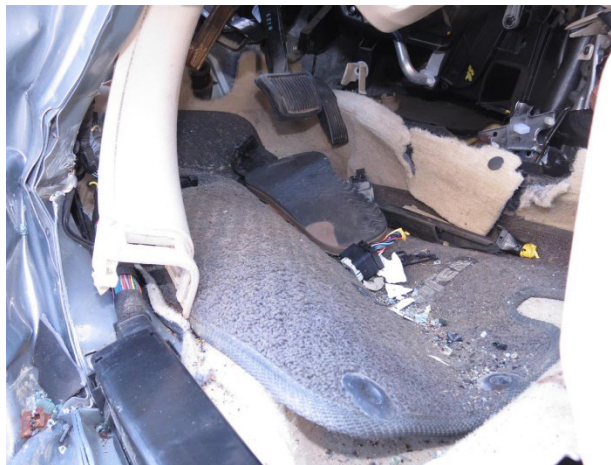
Observation of the driver's toe pan area (Figure 16) revealed evidence that the driver was probably misapplying his foot to the pedals. There was no evidence of intrusion within the toe pan and the foot controls remained operational.

Figure 16. Driver's toe pan and foot controls

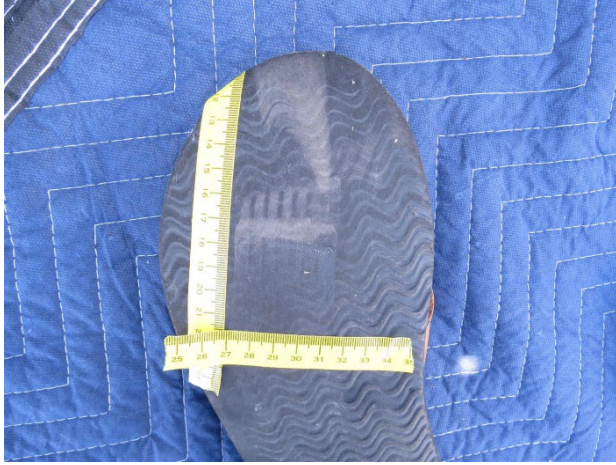
Figure 17. The driver's right footwear with pedal imprint

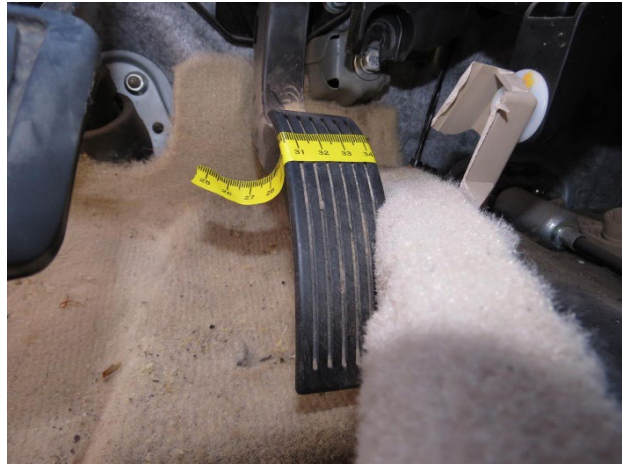
Figure 18. Image of the Hyundai's accelerator pedal

measuring 10 cm (3.9 in) across the top, 7 cm (2.7 in) tall and 8 cm (3.1 in) across the bottom. The accelerator pedal was rectangular and measured 12 cm (4.7) tall and 4 cm (1.6 in) wide.

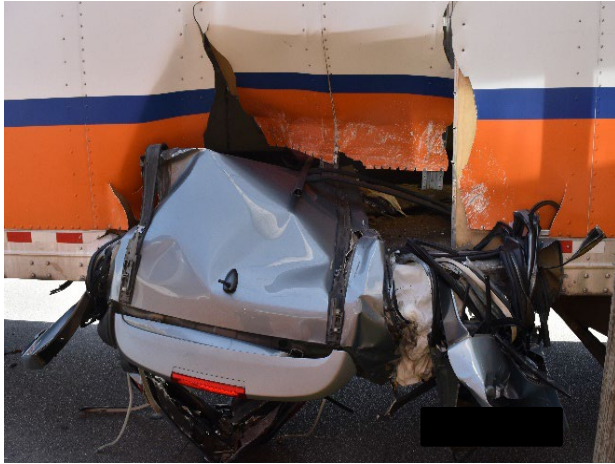
Figure 20. Right view of the trailer damage (On-scene police image)

The trailer VIN was not documented by the police. The 16.2 m (53.0 ft) trailer was struck on the center aspect of its right plane approximately 7 meters (21 feet) from the front of the trailer. The roof rack from the Hyundai pierced the trailer's wall and dispersed glass and metal fragments into the trailer, displacing one of the trailer's loads forward and to the left. The hood and everything from the belt line up was pushed up against the exterior frame rail of the trailer (Figure 20). A deep fracture ran laterally across the bottom of the trailer caused by the A-, B-, C-, and D-pillars cutting across during the underride sequence (Figure 21). The estimated truck damage classification was 03RTFRB.

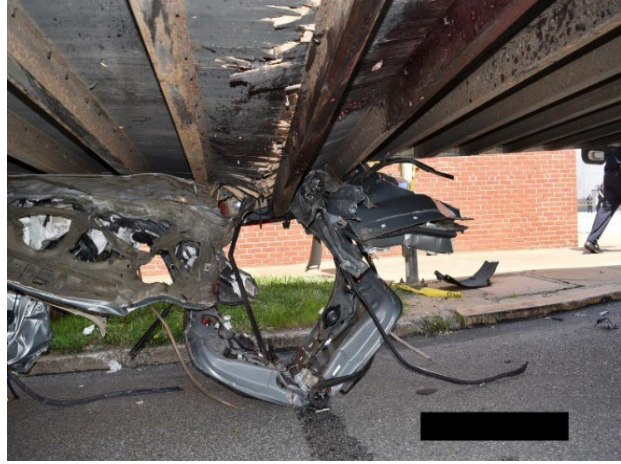
Figure 21. Trailer exterior damage looking from the left plane (On-scene police image)

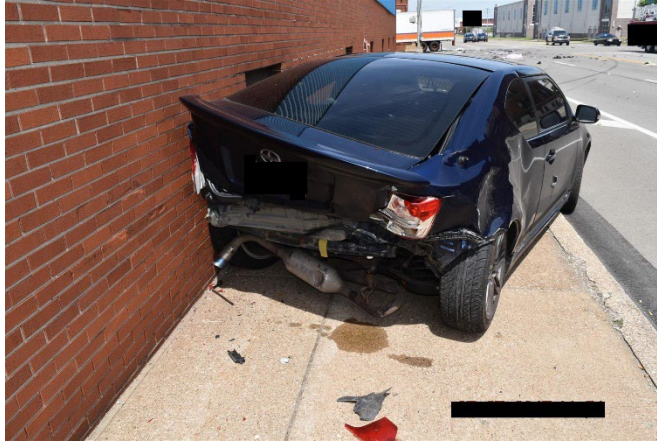
Figure 22. Facing east, showing final rest position of the Scion and rear impact with Event 2 (On-scene police image)

The Scion (Figure 22) was struck on its back plane/right and center aspect by the Hyundai (Event 2). The estimated CDC of the impact damage was 05BZEW2. The impact's force displaced the vehicle west and caused the Scion to rotate clockwise approximately 180 degrees as it separated from the impact. The Scion departed the road's north side and impacted a commercial building's brick wall with its left-rear corner (Event 3). The estimated CDC of this impact damage was 07BLEN99.
