DOT HS 813 516

**Special Crash Investigations:
Remote Move-Over-Law Crash
Investigation;
Vehicle: 2017 Ford Explorer;
Location: Texas;
Date: January 2020**

**Special Crash Investigations
Remote Move-Over-Law Crash Investigation
Case Number: CR20006
Vehicle: 2017 Ford Explorer
Location: Texas
Crash Date: January 2020**

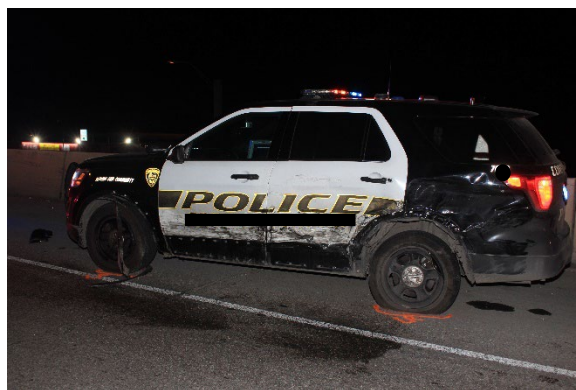
*Figure 1. Police image, the 2017 Ford Explorer
(1st vehicle struck)*

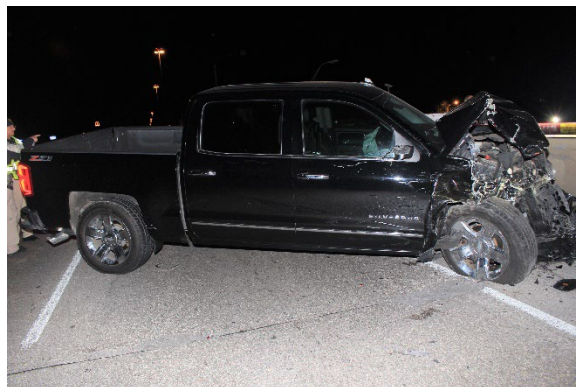
*Figure 2. Police image,
the 2017 Chevrolet Silverado*

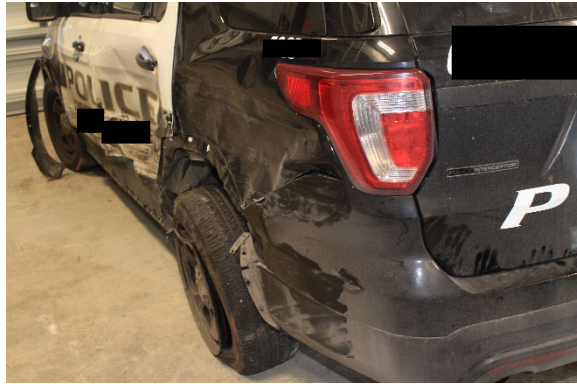
This Ford sustained damage to the left side (Figure 4) from the impact from the front of the Chevrolet (Event 1). Direct damage was noted on the left quarter panel, rear wheel, and both doors. The estimated collision deformation classification (CDC) for this damage pattern was 06LZEW2.

Figure 4. Police image of the 2017 Ford Explorer (first vehicle struck by the Chevrolet)

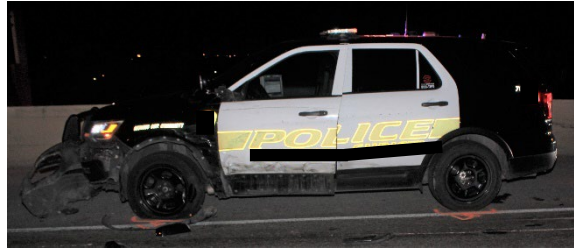
This vehicle sustained damage to the left side from the impact with the Chevrolet (Event 2). There was direct damage to both doors, the fender, front wheel and tire, and front bumper fascia (Figure 5). The estimated CDC for this damage was 06LYES1.

Figure 5. On-scene police image, the 2016 Ford Explorer

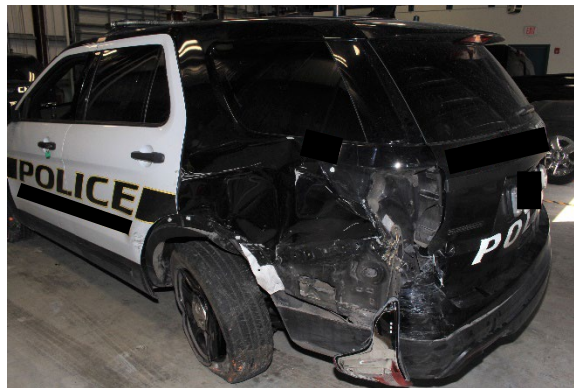
This vehicle sustained damage to the left rear corner and left side from the impact with the Chevrolet (Event 3). There was direct damage to the rear bumper fascia, tailgate, left brake and turn lamp assembly, quarter panel, left rear tire and wheel, and the left rear door (Figure 6). The estimated CDC for this damage was 07BLEE8.

Figure 6. Police image, the back left corner of the 2017 Ford Explorer

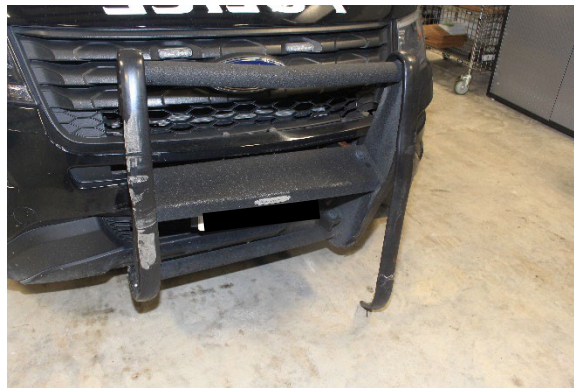
There was additional damage to the push bar mounted to the front end (Figure 7) from the impact with the back end of the F-250 (Event 5). The estimated CDC for this impact was 12FZEN1.

Figure 7. Police image, push bar contact on the 2017 Ford Explorer

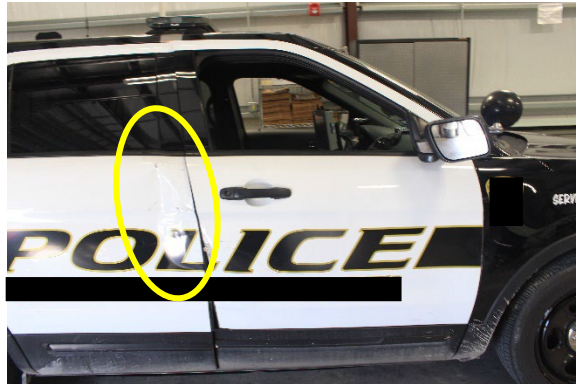
Damage was also noted on the right-side doors (Figure 8) from contact with the first police officer (Event 4) and the traffic barrier. The estimated CDC for this event was 03RPEN1.

Figure 8. Police image, right side damage to the 2017 Ford Explorer

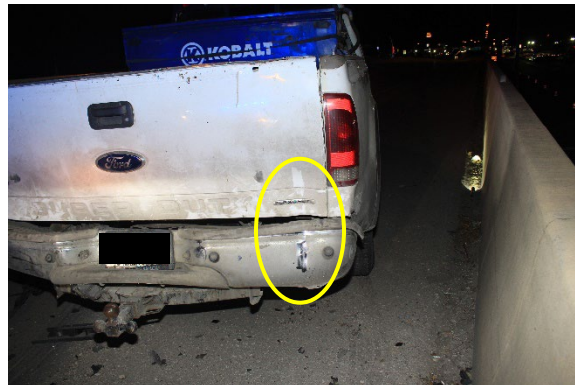
The Ford sustained damage to the back plane (Figure 9) from the impact with the 2017 Explorer (Event 5). The bumper and tailgate were directly damaged and the estimated CDC for this damage pattern was 06BREN1. The back and left sides were also damaged (Figure 10) from the impact with the front end of the Chevrolet (Event 6). The back bumper, tailgate, left brake and turn lamp assembly, and left bed wall were damaged. The estimated CDC for this damage was 06BLEE4.

Figure 9. Police image, back plane, right aspect, damage from contact with the push-bar of the 2017 Explorer

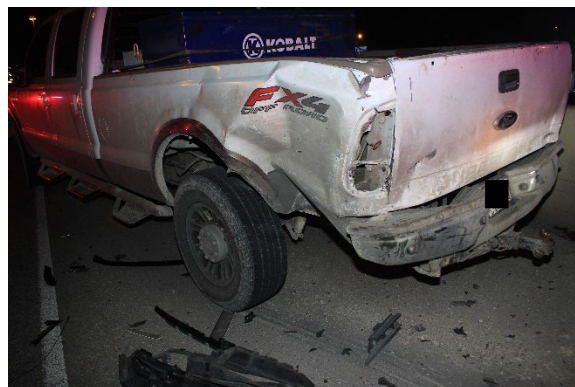
Figure 10. Police image, back and left plane damage from impact with the Chevrolet

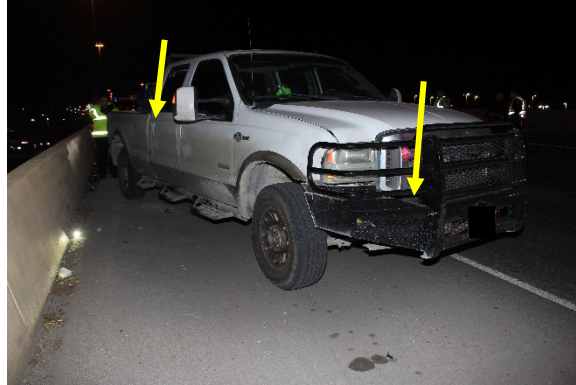
During the Ford's forward and right displacement, its right plane struck the second and third officers (Events 7 and 8, Figure 11). According to court reports, the second officer was struck by the right rear door and fell over the bridge wall. A small dent and wipe mark were evidence of the contact. The third officer was likely struck by the front right corner and fell to the pavement. The CDCs for these impacts were 03RPE91 (Event 7) and 12F9E91 (Event 8), where each "9" represents an unknown area for that position classification.

Figure 11. Police image, front right oblique view of the Ford F-250 and the probable area of non-motorist contact (Events 7 & 8)

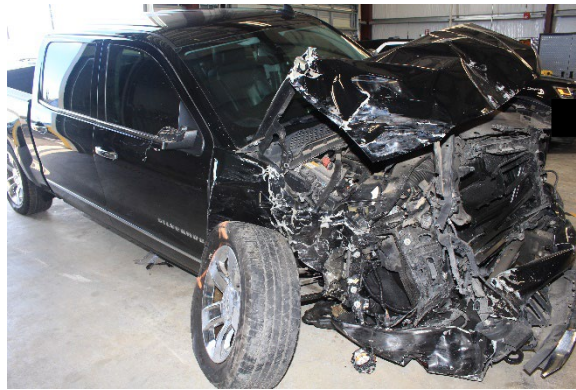
The Chevrolet sustained damage to the front end (Figure 12) from the impacts with the four vehicles. All structures of the front plane sustained direct contact damage, as well as damage to the hood and right fender. The four CDCs assigned to Events 1, 2, 3, and 6 were 12F9E999 (“9” represents unknown value). Overlapping damage prevented any separation in the coding for the four events.

Figure 12. Police image, front end damage of the Chevrolet
