DOT HS 813 517

**Special Crash Investigations:
Remote Move-Over-Law Crash
Investigation;
Vehicle: 2004 Jeep Grand Cherokee;
Location: Pennsylvania;
Crash Date: July 2021**

Special Crash Investigations
Remote Move-Over-Law Crash Investigation
Case Number: CR21019
Vehicle: 2004 Jeep Grand Cherokee
Location: Pennsylvania
Crash Date: July 2021

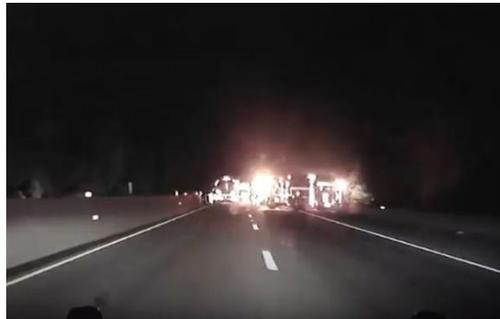
Figure 1. Westerly view of the fire truck blocking the right lane and shoulder of the interstate. Image obtained from the police in-car dash cam.

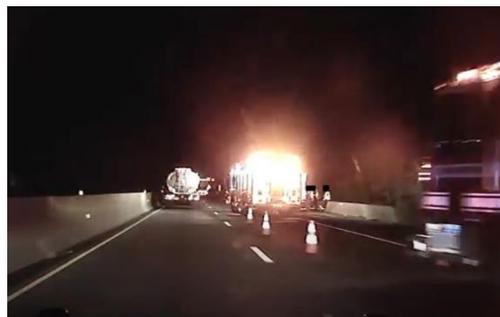
Figure 2. Westerly view of the positions of the fire truck, traffic cones, and the firefighters. Image obtained from the police in-car dash cam.

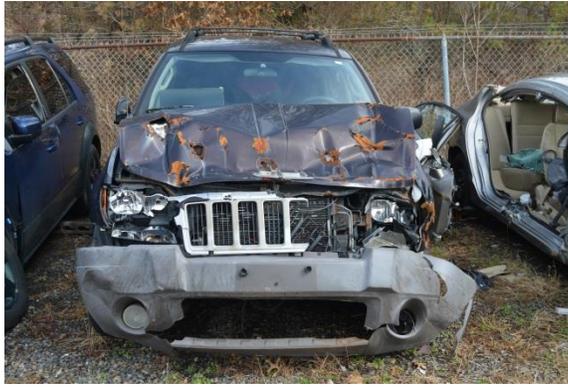
The front of the Jeep sustained damage from impacts with three people (Events 1, 2, and 4) and the back of the Nissan (Event 5). The three impact events with the firefighters involved the front of the Jeep and probably the front bumper and hood. Although not supported by residual damage due to the subsequent Event 5 impact, these impacts were probably distributed across the front with the following estimated Collision Deformation Classifications (CDC):

The Event 5 impact masked the damage that resulted from the first three events (Figures 3 and 4). The Jeep struck the back of the parked and disabled Nissan on the right shoulder of the interstate. The damage was distributed across the full width of the Jeep's front and involved the bumper, grill, headlight assemblies, hood, and the left front fender. The bumper beam was crushed rearward approximately 15 cm (6 in) and the hood face was displaced 15–20 cm (6–8 in) rearward. The 12 o'clock direction of force impact from Event 5 resulted in a CDC of 12FDEW1.

Figure 3. Frontal damage to the 2004 Jeep Grand Cherokee

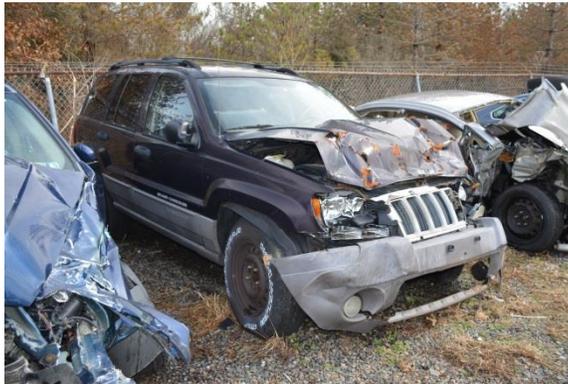
Figure 4. Front right oblique view of the frontal damage to the 2004 Jeep Grand Cherokee

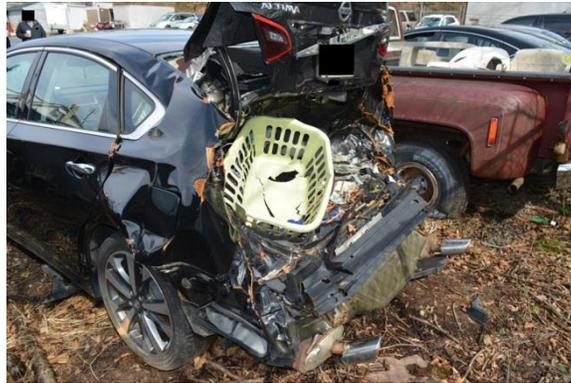
The Nissan Altima disabled from a previous crash was parked on the right shoulder at the time of this crash. The back of the Nissan sustained an unknown extent of damage. The Jeep subsequently struck the back of the Nissan (Event 5, Figures 5 and 6) following its impacts with the three firefighters. The Nissan sustained additional damage of a greater severity than its previous crash. This impact crushed the bumper beam approximately 15 cm (6 in), separated the bumper fascia, crushed both quarter panels forward with induced damage extending into the upper D-pillars, jamming the rear doors closed. The trunk lid, that was previously opened, was crushed further forward into the backlight, disintegrating the glazing. The estimated CDC for this Event 5 damage was 06BDEW4.

Figure 5. Back damage to the Nissan Altima following the Event 5 crash with the Jeep

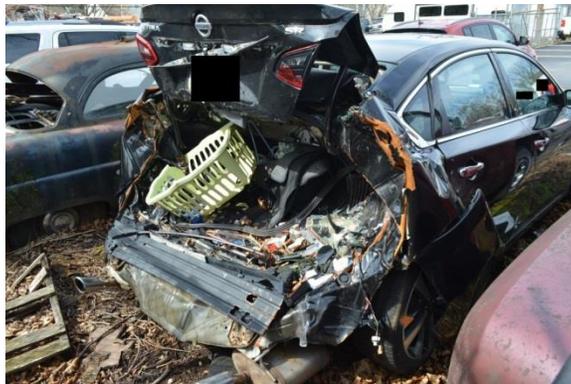
Figure 6. Back right view of the Event 5 damage to the Nissan
