DOT HS 813 541

Special Crash Investigations: On-Site Driver Air Bag Inflator Rupture Investigation; Vehicle: 2010 Ford Fusion; Location: Florida; Crash Date: June 2021

Special Crash Investigations
On-Site Driver Air Bag Inflator Rupture Crash Investigation
Office of Defects Investigation
Case No.: CR21018
Vehicle: 2010 Ford Fusion
Location: Florida
Crash Date: June 2021

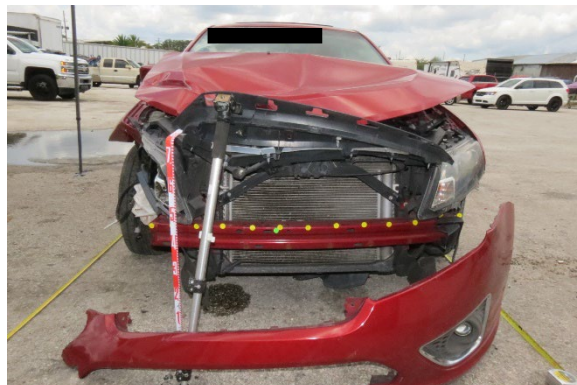
The Ford sustained damage to the front end (Figure 5), with direct damage to the bumper fascia, bumper beam, hood, and right fender. The direct damage started 5 cm (2.0 in) to the right of the vehicle's centerline and extended right 77 cm (30.3 in). The Field L was 114 cm (44.9 in). Crush measurements were documented along the bumper beam with the maximum crush measuring 2 cm (0.8 in) occurring 17 cm (6.7 in) left of the center point. The residual crush profile was: C1 = 2 cm (0.8 in), C2 = 2 cm (0.8 in), C3 = 2 cm (0.8 in), C4 = 1 cm (0.4 in), C5 = 1 cm (0.4 in), C6 = 0. The collision deformation classification (CDC)² for this impact was 01FZEW1. The missing vehicle algorithm of the WinSMASH was used to calculate the Ford's total delta V as 19 km/h (11.8 mph). The longitudinal and lateral velocity changes were -18 km/h (-11.2 mph) and -6 km/h (-3.7 mph). The results were borderline but considered reasonable.

Figure 5. Ford front end damage

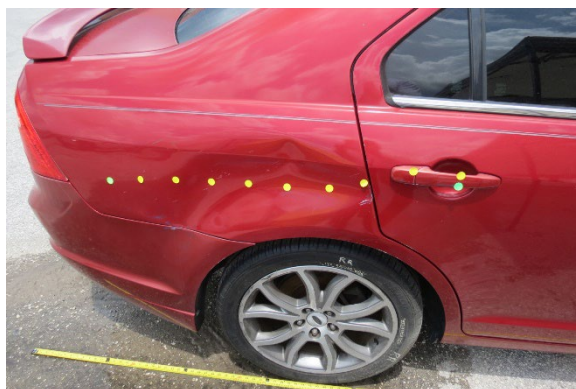
The Ford also sustained direct damage to the right rear door and quarter panel (Figure 6) as the vehicles side-slapped after the initial impact. The direct damage began 32 cm (12.6 in) forward of the right rear axle and extended rearward 89 cm (35.0 in). The Field L was 89 cm (35.0 in). Crush measurements were documented on the right quarter panel and the maximum residual crush was 2 cm (0.8 in) which occurred 23 cm (9.1 in) rear of the right rear axle. The CDC for this impact was 03RZMW1.

Figure 6. Ford right side damage from side-slap

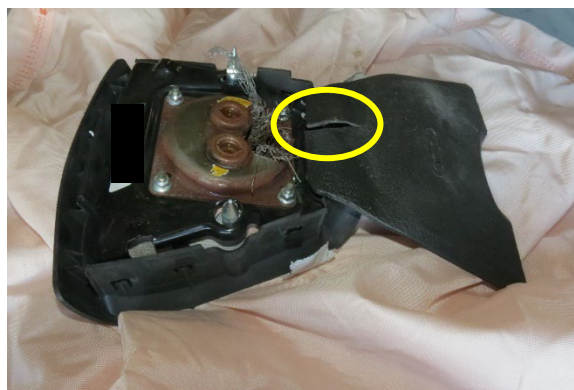
Figure 7. Cut on bottom flap of air bag module

configuration constructed of pliable vinyl, with a horizontal tear seam in the middle. The top flap was 19 cm (7.5 in) wide at the top and 17 cm (6.7 in) wide at the bottom, and 7 cm (2.8 in) high. The bottom flap was 15 cm (5.9 in) at the top and 9 cm (3.5 in) at the bottom and 14 cm (5.5 in) high. There was no damage to the top flap but the bottom flap sustained a 6 cm (2.4 in) vertical cut that started at the bottom of the flap (Figure 7).

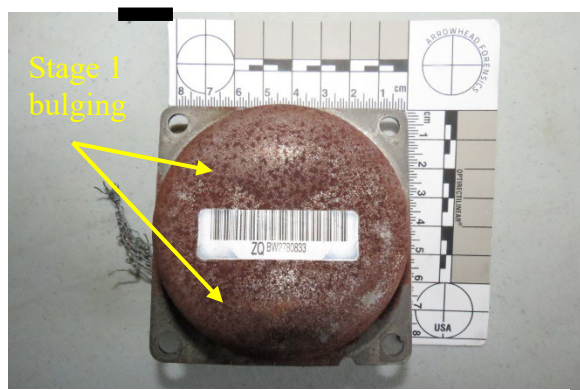
The driver frontal air bag inflator was manufactured by Takata and according to a Takata representative present at the vehicle inspection, was original equipment (Figure 8). The inflator was housed in the hub of the steering wheel and was divided into two sections for Stage 1 and Stage 2 deployment (Figure 9). Both sections contained a majority of ammonium nitrate pellets (propellant) mixed with small darker colored balls of a calcium sulfate desiccant (drying agent). The two sections were encased in a metal mesh filter and each section was separated by two horizontal metal dividers that fit against the perimeter of the inflator and around the vertical squibs. The inflator was mounted in the steering wheel hub, in line with the steering column, with the stage 2 side facing the instrument panel. The stage 1 side faced the driver. The inflator was 7.5 cm (3.0 in) in diameter and 4.5 cm (1.8 in) in height. The original height of the inflator was 3.4 cm (1.3 in) but the detonation of the propellant caused both the top and bottom to bulge (Figure 10).

Figure 8. Stage 1 side of air bag inflator...note bulging of top side metal

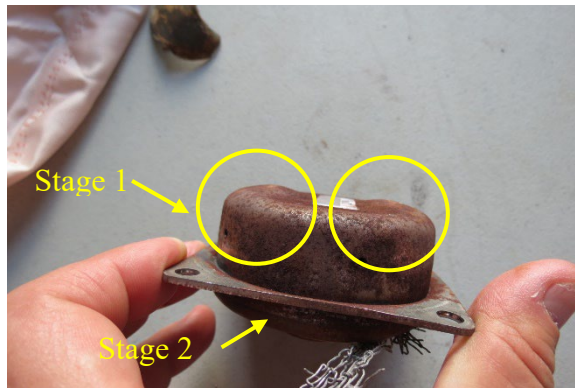
Figure 10. Side view of inflator...note the bulging on the stage 1 (bigger) side

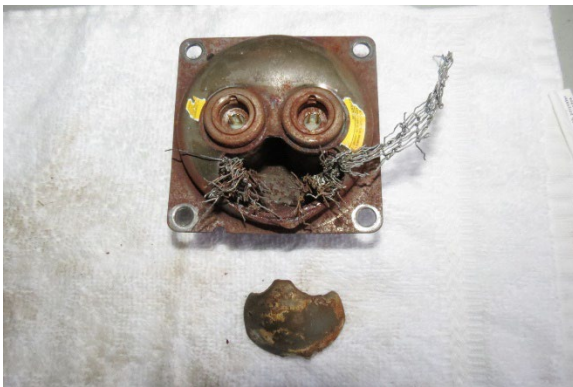
Figure 11. Ruptured air bag inflator and fragment, stage 2 side

During the deployment sequence of the air bag, the stage 2 side of the inflator ruptured (Figure 11). The stage 2 side was oriented toward the instrument panel and the fragment was projected toward the driver's abdomen. This fragment (Figure 12) was approximately 4 cm (1.6 in) long and 3 cm (1.2 in) wide and struck the driver and became embedded in his abdomen. Normally flat, the fragment bowed due to the rupture. The inflator rupture also involved sections of the mesh filter and horizontal divider and projected them into the driver's floor mat (Figures 13 and 14).

It is the investigator's opinion that the force/pressure of the stage 1 detonation could not be contained within the inflator and the horizontal divider was projected through, rupturing on the stage 2 side of the inflator.

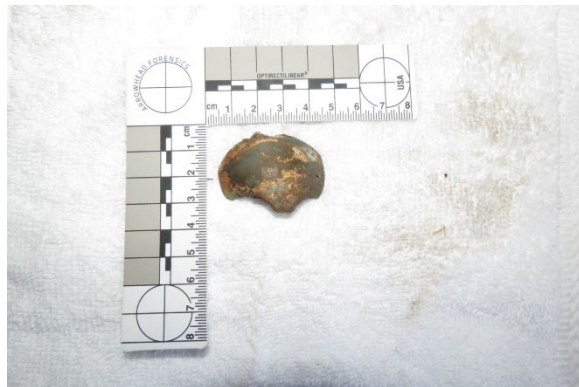
Figure 12. Ruptured fragment from stage 2 side of air bag inflator

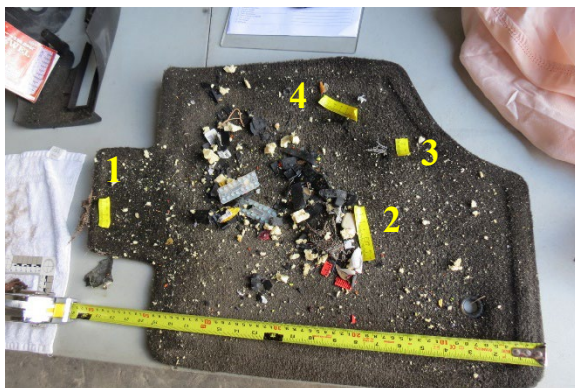
Figure 13. Inflator mesh filter (1, 2 and 3) and horizontal divider (4) embedded in the floor mat

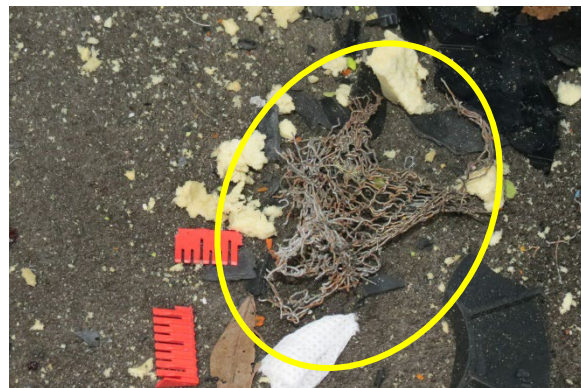
Figure 14. Closeup of mesh filter embedded into floor mat

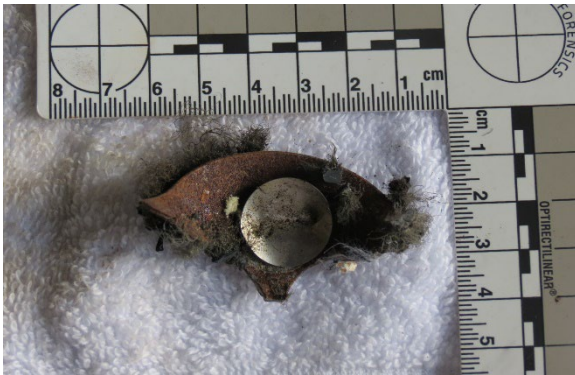
The inflator's horizontal divider (Figure 15) was projected out of the inflator downward. One half of it went through the floor mat and became embedded into the floor carpeting (Figure 16).

Figure 15. Inflator's horizontal divider

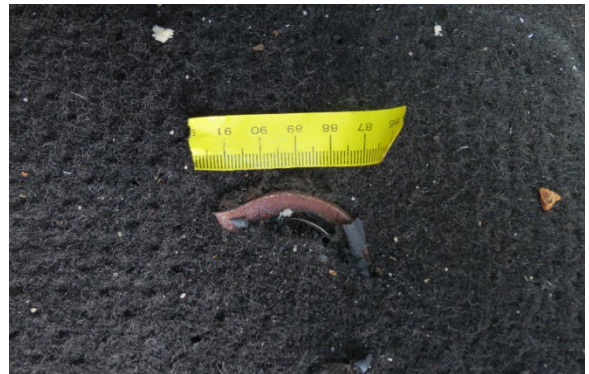
Figure 16. Inflator's horizontal divider embedded in floor carpeting
