DOT HS 813 549

**Special Crash Investigations:
On-Site Child Restraint System
Crash Investigation;
Vehicle: 2020 Honda Accord;
Location: Indiana;
Crash Date: September 2021**

Special Crash Investigations
On-Site Child Restraint System Crash Investigation
Case Number: CR21024
Vehicle: 2020 Honda Accord
Location: Indiana
Crash Date: September 2021

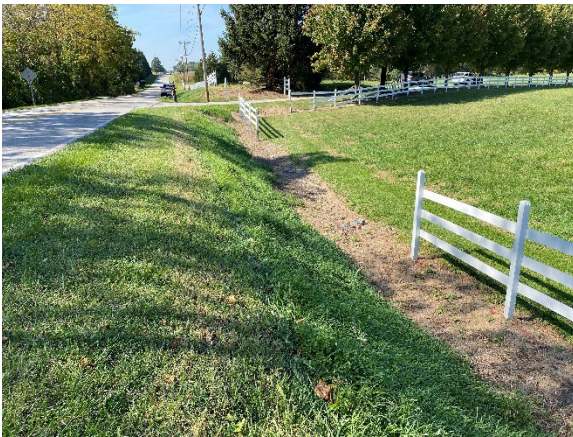
The Honda's front struck and penetrated the wooden post-and-rail fence (Event 1, Figure 4). The 12 o'clock direction of force fractured six fence posts and damaged 10.4 m (34.1 ft) of the wood rail fence. The engagement with the fence was distributed across the full end-width of the vehicle but did not impede the vehicle's trajectory or result in a recordable EDR event. The Honda continued its off-road trajectory and traveled an additional 19.7 m (64.6 ft) through the pasture area approaching a driveway into the property north of the road. The vehicle's front struck and penetrated the post-and-rail fence that paralleled the driveway (Event 2, Figure 5) resulting in overlapping damage to the Honda's front. Fence components penetrated the vehicle's windshield and entered the passenger compartment, striking the driver and child passenger (Event 3). Nearly simultaneous to the Event 2 fence impact, the Honda's lower frontal structure and undercarriage struck the driveway embankment (Event 4) resulting in the EDR-recorded Event Record 1. The EDR recorded a maximum longitudinal delta V of -45 km/h (-28 mph) at 300 milliseconds after time zero with a lateral component of -7 km/h (-4 mph), which occurred at 235 milliseconds. The embankment impact was non-horizontal and applied a vertical component to the vehicle's velocity change. This impact actuated the driver's pretensioners and deployed the driver's frontal air bag (stage 1), driver knee air bag, right outboard seat-mounted side-impact air bag, and right inflatable curtain (IC) air bag.

Figure 4. View of the Event 1 (fence) impact area

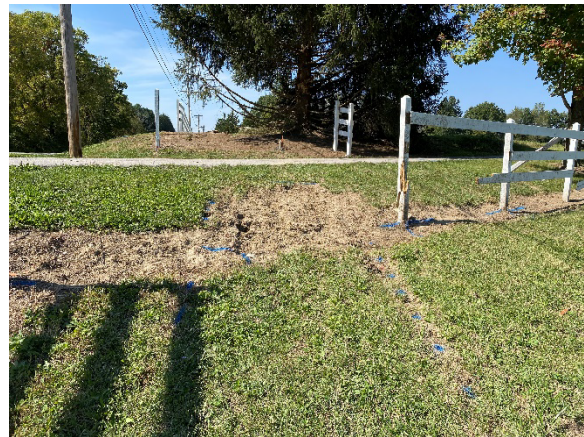
Figure 5. View of the Event 2 (fence) and Event 4 (embankment) area

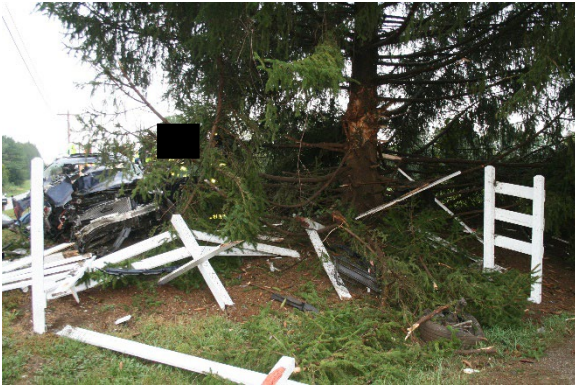
Figure 6. On-scene image showing Event 5 (fence) and Event 6 (tree) provided by local law enforcement

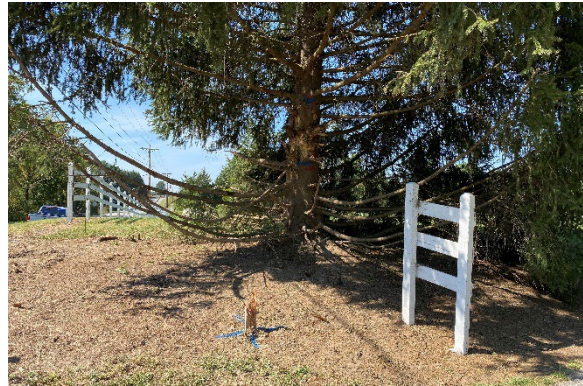
Figure 7. View of the Event 5 (fence) and Event 6 (tree) area during the SCI scene inspection

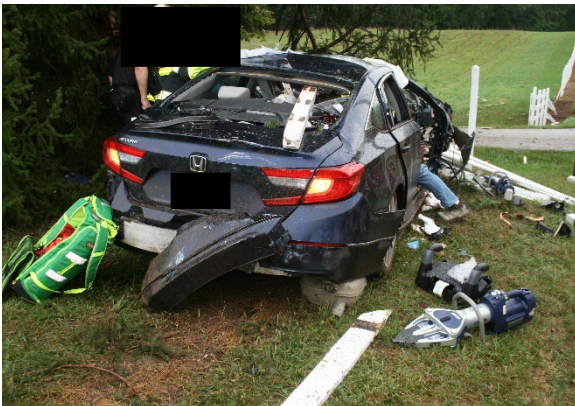
As a result of the offset right tree impact, the Honda rotated clockwise and fell to the ground approximately 4 m (13 ft) west of the tree impact. Before coming to rest, the Honda's undercarriage struck the post-and-rail fence (Event 7, Figure 7). The back undercarriage area struck the ground (Event 8) as the vehicle came to rest on top of the fractured fence, facing in a southeasterly direction, approximately 180° opposite of its initial pre-crash heading (Figure 8 and 9).

Figure 8. On-scene image showing the Event 7 (fence) and Event 8 (ground) area provided by local law enforcement

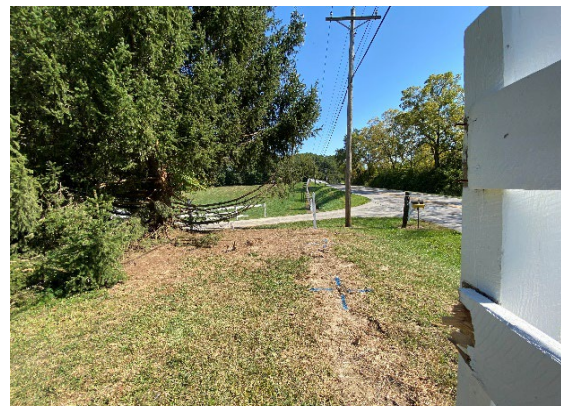
Figure 9. View of the Event 7 (fence) and Event 8 (ground) area facing opposite of the pre-crash heading

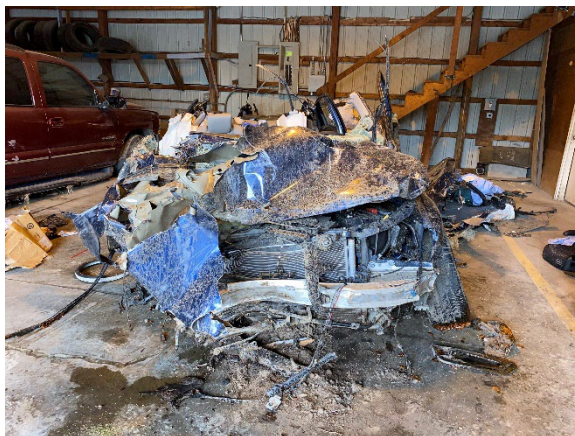
The Honda sustained overlapping damage to the front and undercarriage areas from the eight impact events during the crash sequence. The frontal impact events (Event 1 and 2) were distributed across the vehicle's front bumper and hood face (Figure 11). Although the damage

could not be isolated by event, the bumper beam sustained damage that resulted in the following documentation. The Field L was 156 cm (61.4 in) that extended from corner to corner. The crush profile was documented as follows: C1 = 0 cm, C2 = 5 cm (2.0 in), C3 = 13 cm (5.1 in), C4 = 21 cm (8.3 in), C5 = 21 cm (8.3 in), C6 = 0 cm. The collision deformation classification¹ (CDC) for both events was 12FDEW99.

Figure 11. Front view of the Honda Accord

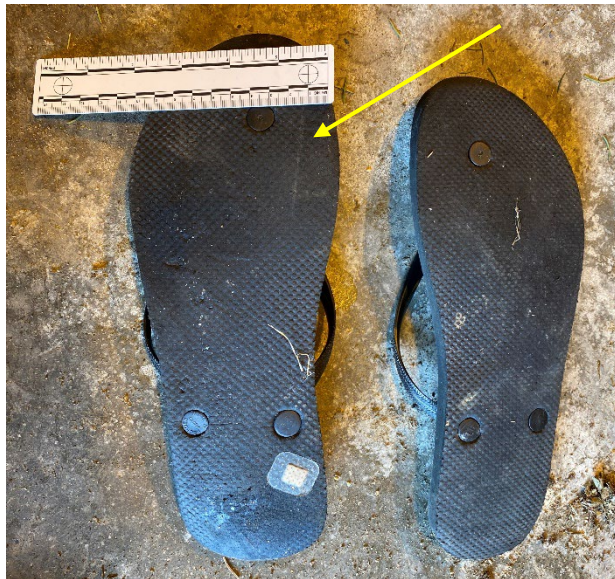
The data trends showed the Honda was traveling at high speed through the pre-crash recording with the accelerator pedal depressed. As the vehicle departed the road and struck the fence, a left steer was initiated. Between the embankment impact (AE1) and tree impact (AE2), the accelerator pedal was depressed to 99 percent, the steering wheel was turned left an additional 160°, and the brake was applied. The driver’s sandals were found in the left footwell during the SCI inspection. Examination revealed the right sandal had an impression from the accelerator pedal, shown by the yellow arrow in Figure 12, which was indicative of crash-induced loading while the foot displaced the pedal to the floor.

Figure 12. Driver’s sandals showing right sandal with an impression from the accelerator pedal

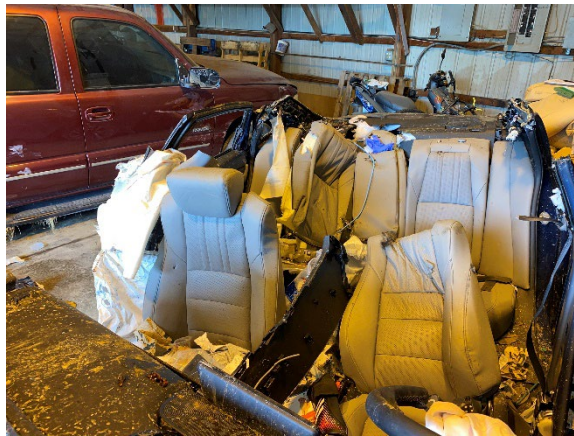
The Honda's interior (Figure 13) sustained damage that included intrusions due to impact forces, exterior debris (fence components) entering the Honda during the crash sequence, and occupant contacts. The driver's seatback was ripped by a fence component that penetrated through the windshield. The driver's lower extremities engaged the deployed knee air bag, the lower instrument panel, and the substructures below. Firefighters placed a hydraulic ram against the lower instrument panel structure to aid in the extrication of the driver, causing further damage. The accelerator pedal was displaced left 5 cm (2.0 in) due to impact forces and probable driver loading. The second-row center and right seating positions also sustained damage from fencing impact. All intrusions are documented as follows.

Figure 13. Interior view of the Honda showing damage

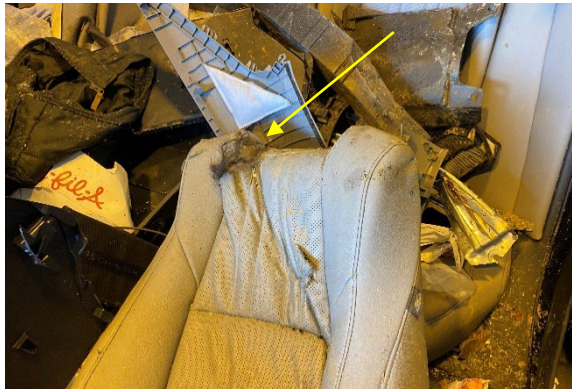
During Event 3, a fence post and railing fragments penetrated through the windshield and struck the driver's right facial area. A clump of her hair was embedded into the top aspect of the driver's seatback (Figure 14). The fence post from this event struck the child secured in the CRS in the second-row-left position. After striking the child, the fence post disintegrated the backlight and came to final rest partially extruding from the passenger compartment area. Figure 15 shows the fence post at final rest.

Figure 14. View of the driver's hair in the driver's seat back from intruding fence post

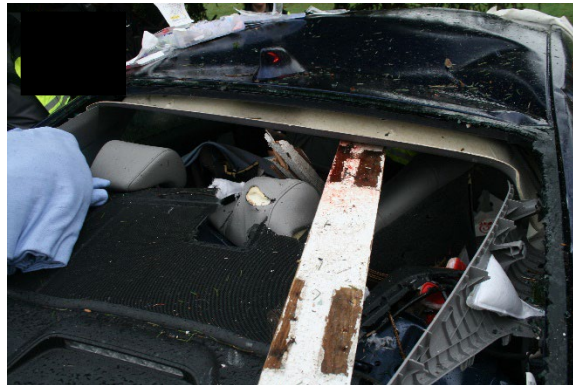
Figure 15. View of fence post at final rest partially extruding from the Honda's rear window

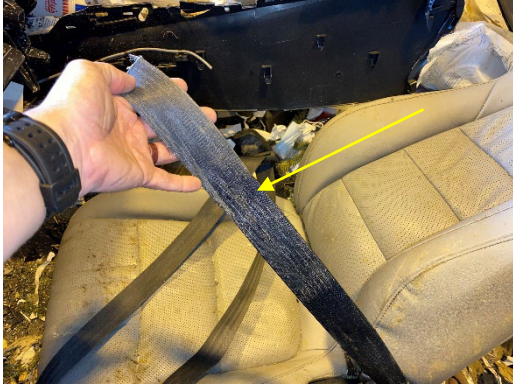
The driver's seat belt was found lying on the driver's seat at the time of the SCI inspection. Rescue personnel cut the driver's belt webbing at the lap belt. Loading evidence that consisted of longitudinal striations on the lap belt webbing was present along the driver's seat belt indicative of use by the driver (Figures 16 and 17). The driver had abrasions and contusions on her body indicative of her submarining the seat belt. Based on images of the driver, the lap belt appeared to have been worn high on the abdomen above the umbilicus at the time of the crash. This, in combination with her being obese, contributed to her submarining the seat belt. There was no evidence to support malfunction or failure of the driver's seat belt at the time of the SCI inspection.

Figure 16. View of the driver's seat belt showing loading evidence from the B-pillar D-ring

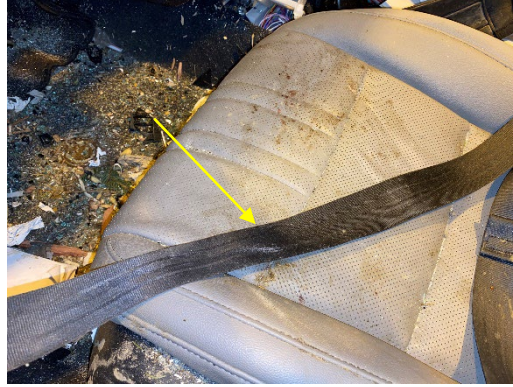
Figure 17. View of the driver's seat belt showing loading evidence

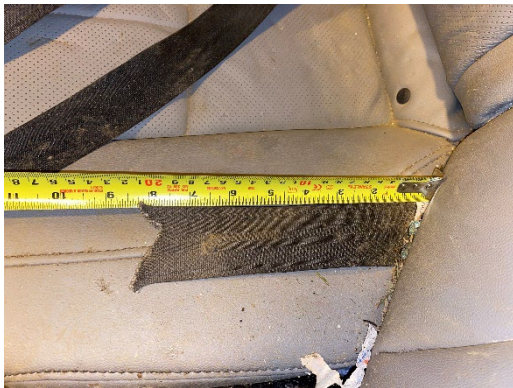
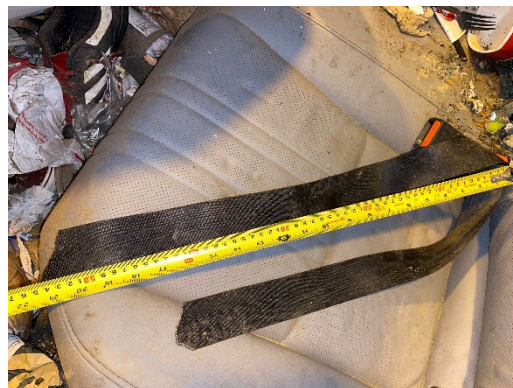
Figure 18. View of the second-row-left seat belt showing the extracting cuts

Figure 19. View of the second-row-left seat belt showing the extracting cuts

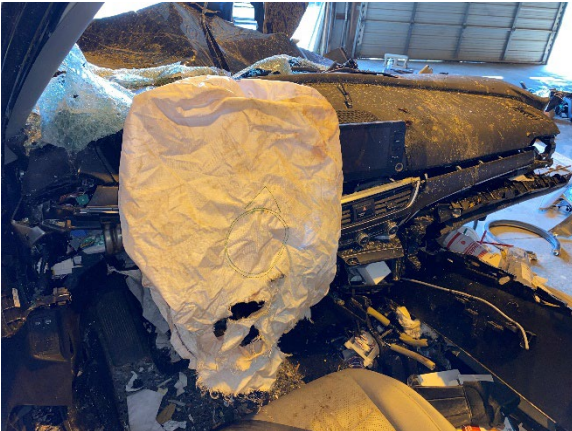
The driver's frontal air bag deployed through the steering wheel-mounted module. Components from the fractured fence penetrated the windshield and contacted and tore the air bag fabric at the lower center area. Due to the severity of the crash, damage to the Honda's interior, and extrication efforts no discernable driver contacts were visible on the air bag.

Figure 20. View of the driver's deployed frontal air bag in the Honda

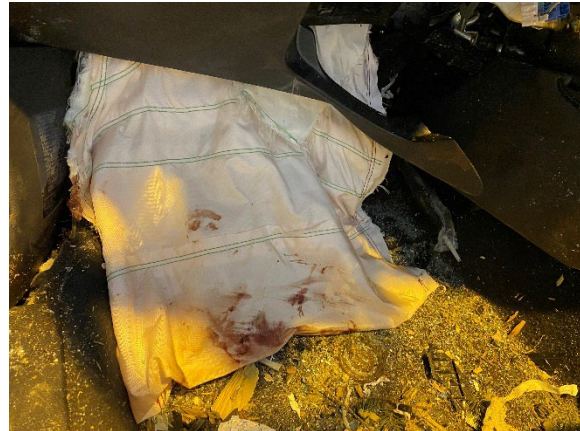
The driver's knee air bag (Figure 21) deployed through a single cover flap in the lower instrument panel and knee bolster. The rectangular air bag measured 58 cm (22.8 in) by 45 cm (17.7 in). The driver's lower extremities contacted and loaded the deployed knee air bag; however, as noted above, no specific contact evidence was discernable on the air bag.

Figure 21. View of the deployed driver knee air bag in the Honda

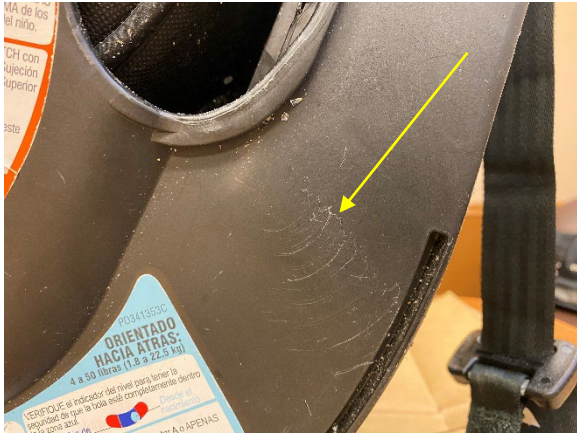
The first responders evaluated the child in the CRS and determined he was deceased. They cut the vehicle's seat belt webbing and removed the child from the vehicle while still in the CRS. Stress marks were found on the polymer surface at the left aspect of the forward-facing belt path (Figure 25) indicative of loading against the belt system.

Figure 25. View of the left side of the CRS showing the front facing belt route stress damage

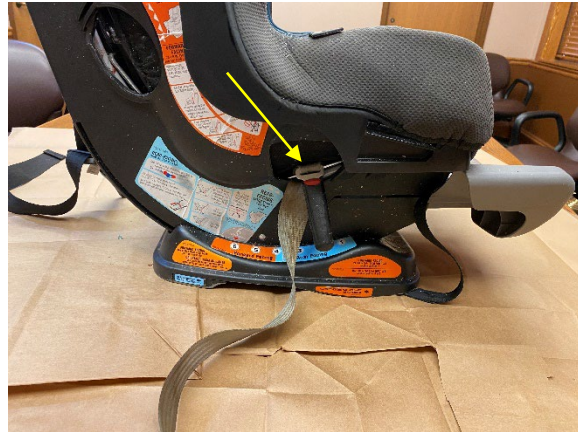
Figure 26. Right side view of the CRS showing the LATCH clip wedged under the metal routing bar

The connectors of the lower anchor straps were located at the right side of the CRS. The right lower anchor connector was wedged into the metal routing bar (Figure 26) showing the lack of use during this crash sequence.

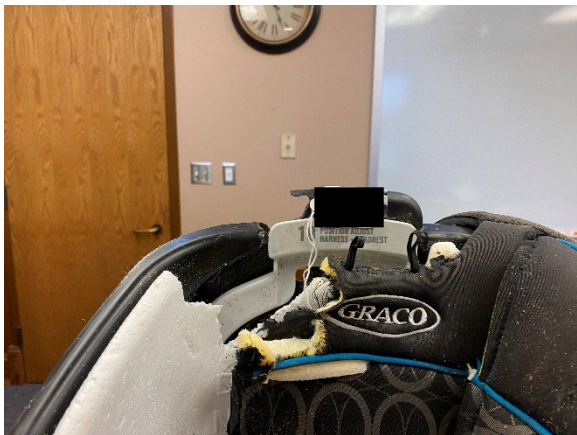
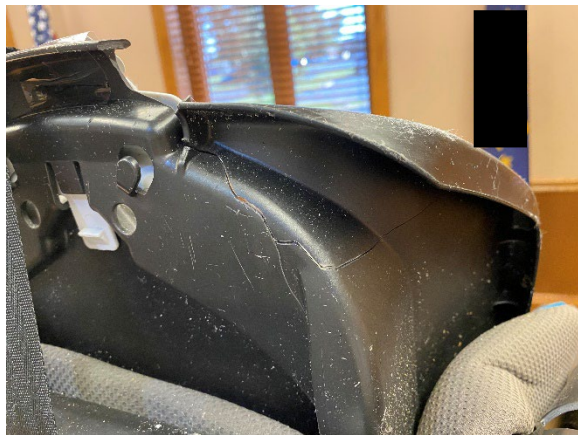
The CRS's upper right aspect was damaged by impact from the intruding fence post (Figures 27 and 28). The fabric liner of the CRS was torn, and the polymer shell was fractured to the right of the child's head.

Figure 27. Front view of the damage to the CRS by the fence post

Figure 28. Rear view of the damage to the CRS by the fence post
