DOT HS 813 571

**Special Crash Investigations:
Remote Move-Over-Law Crash
Investigation;
Vehicle: 2006 GMC TC6500
Wrecker/Nonmotorists;
Location: Montana;
Crash Date: October 2020**

Special Crash Investigations
Remote Move-Over-Law Crash Investigation
Case Number: DS21007
Vehicle: 2006 GMC TC6500 Rollback Wrecker/Nonmotorists
Location: Montana
Crash Date: October 2020

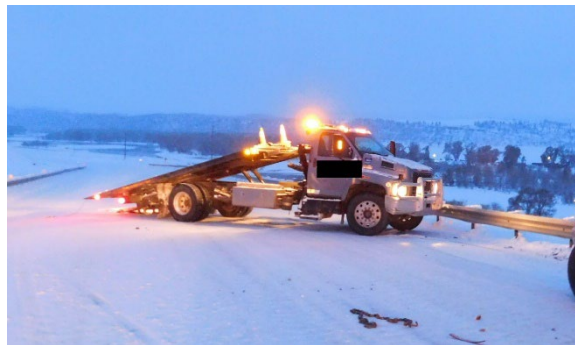
The vehicle had a roof level overhead LED light bar with amber/white lighting, roof-mounted amber marker lights, amber marker lights along the bed, 4-way amber flashers, and standard head lamps and tail lamps. All the lighting was active at the time of the crash (Figures 5).

Figure 5. 2006 GMC TC6500 wrecker lighting, looking north (police photo)

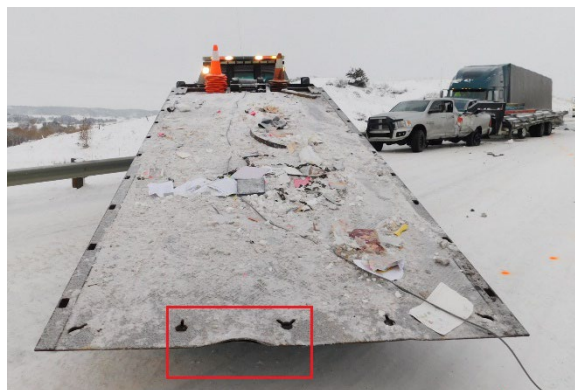
Figure 6. 2006 GMC TC6500, bed damage, looking southeast (police photo)

The unoccupied GMC was parked in the left travel lane with the bed in the inclined position. The disabled U-Haul trailer was positioned near or on the lower lip. The tow cable was in the spooled out position. As the Ram pickup struck the trailer, the trailer was displaced forward and struck the lower edge of the inclined tow deck (Figure 6). The estimated truck deformation classification (TDC) for the GMC was 06BYLWA. There was damage to the right door that appears to have been caused by debris during the crash sequence. The GMC was displaced forward in the crash and struck the guardrail with its front plane. The TDC for this impact was 12FRLW1.

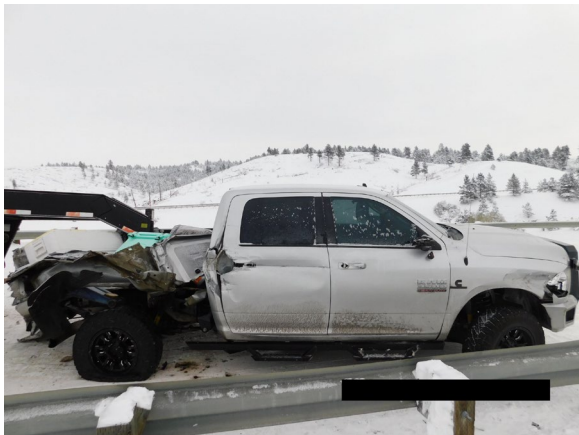
The Ram sustained moderate right plane damage to the right door and right bed from the impact to the left corner of the East trailer attached to the Volvo tractor (Figure 7) in event 1. The TDC for this impact was 12RZEW2.

Figure 7. Right plane damage, 2016 Ram 3500 (police photo)

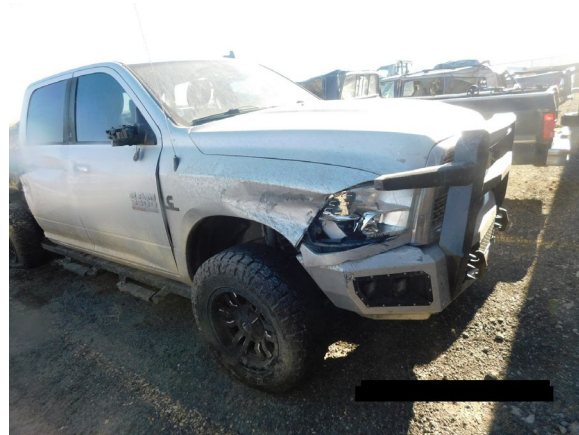
The Ram sustained minor front to right plane damage (Figure 8) from the impact to the left tire of the Volvo's trailer in Event 2. The direct damage began at the left front bumper corner and extended to the left. The damage continued along the right plane. The estimated TDC for this impact was 12FREE4.

Figure 8. Front plane damage, 2016 Ram 3500 (police photo)

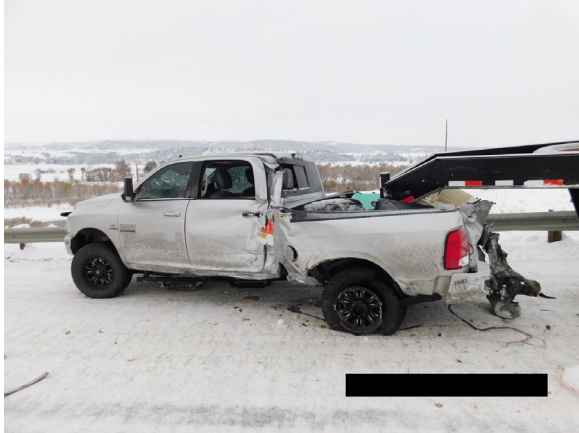
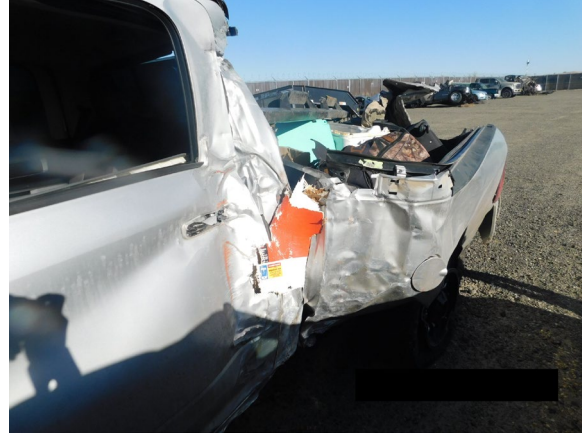
The Ram sustained moderate left plane damage from the impact to the U-Haul trailer during Event 4 (Figures 9 and 10). Portions of the trailer were embedded in the gap between the cabin and bed. The estimated TDC for this impact was 11LZEW3. The Ram appears to have struck or run over tow truck operator 2 on the way to the Ram's final rest during Event 7. The Ram came to rest with the right plane in contact with the tractor trailer. The TDC for this impact was 12RTLWA. The coupler hitch for the trailer was deformed but remained attached to the truck bed.

Figure 9. Left plane damage, 2016 Ram 3500 (police photo)

Figure 10. Left plane damage, 2016 Ram 3500 (police photo)

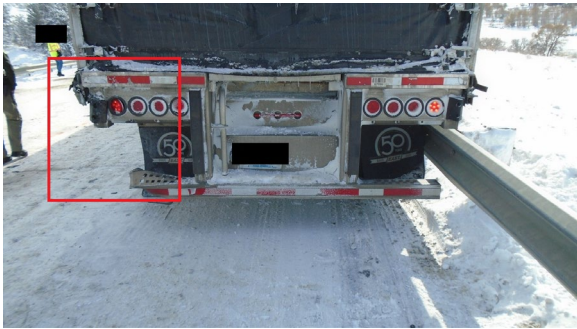
The east trailer sustained minor back plane damage from the first impact with the Travalong trailer (Figure 11) in Event 1. The TDC for this impact is 06BLLEA. The tractor sustained minor left plane damage from the impact with the Travalong trailer (Figure 13) in Event 2. The TDC for this impact is 07LYES1. The tractor and trailer sustained right plane damage from two impacts to the right guardrail (Figure 12) in Events 3 and 8. The TDC based on final appearance for these impacts is 12RDLS1. The tractor sustained minor damage from the last impact with the Dodge in Event 9. The TDC was 06LYLS1.

Figure 11. Back-plane damage, 2019 East trailer (police photo)

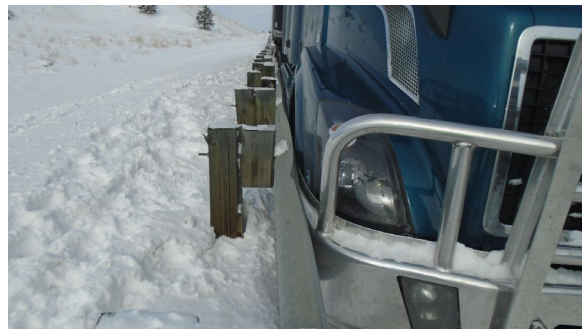
Figure 12. Right plane damage, 2016 Volvo VNL tractor (police photo)

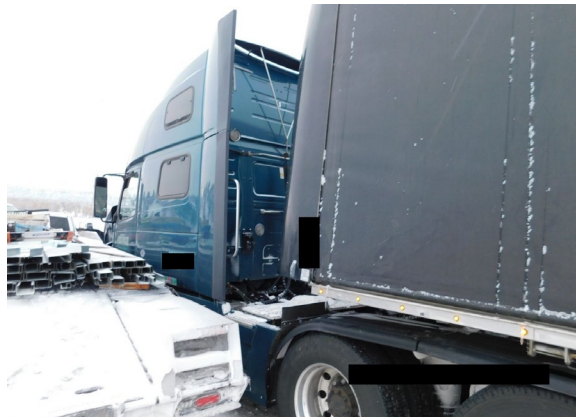
Figure 13. Left plane damage, 2016 Volvo VNL tractor (police photo)

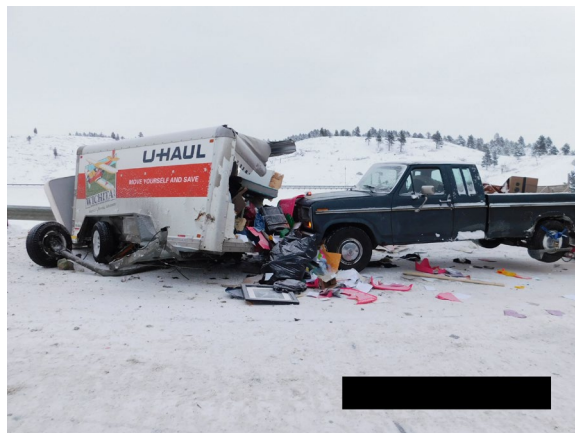
The vehicle was towing a 1985 Ford pickup (Figure 15). The displaced U-Haul trailer appeared to have contacted the front plane of the towed vehicle in Event 6. The TDC for this impact was 06BDFWA.

Figure 15. 1985 Ford pickup being towed by 2002 Chevrolet C7, looking northeast (police photo)
