DOT HS 813 596

**Special Crash Investigations:
On-Site Reported Unintended
Acceleration Crash
Investigation;
Vehicle: 2011 Kia Sorento;
Location: Georgia;
Crash Date: July 2020**

Special Crash Investigations
On-Site Reported Unintended Acceleration Crash Investigation
Office of Defects Investigation
Case No: CR21029
Vehicle: 2011 Kia Sorento
Location: Georgia
Crash Date: July 2020

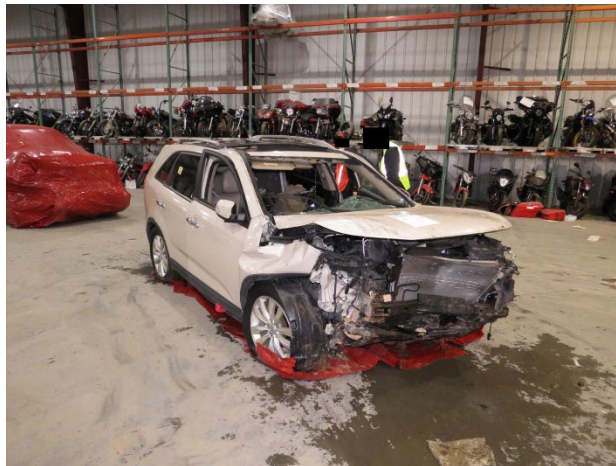
Figure 1. Right front oblique view of the Kia

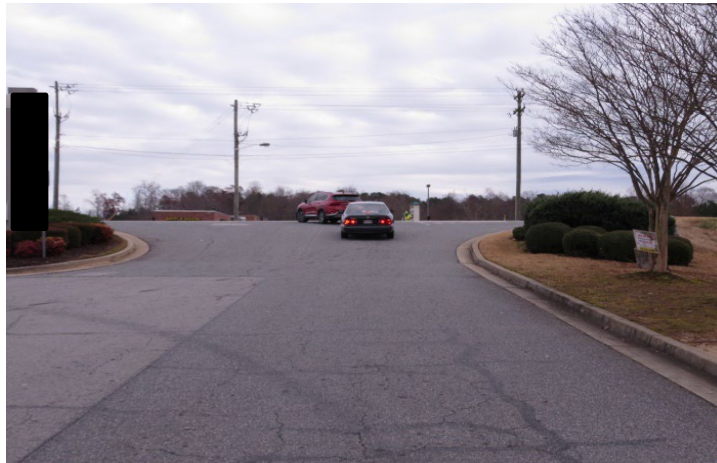
Figure 2. Trajectory view looking east at the gas station/grocery store parking lot entrance/exit

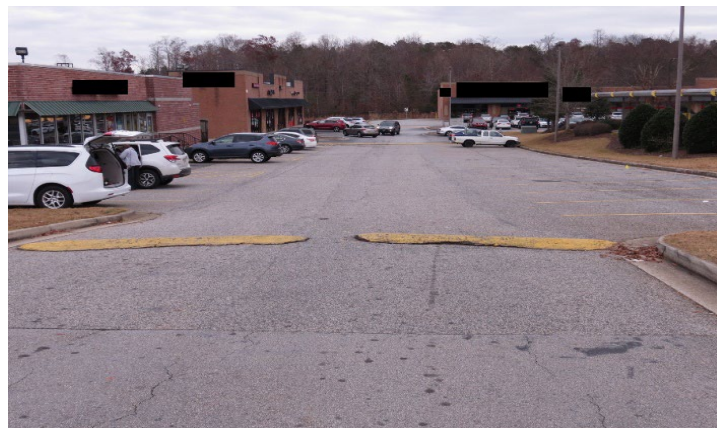
Figure 3. Looking east at the strip mall entrance/exit

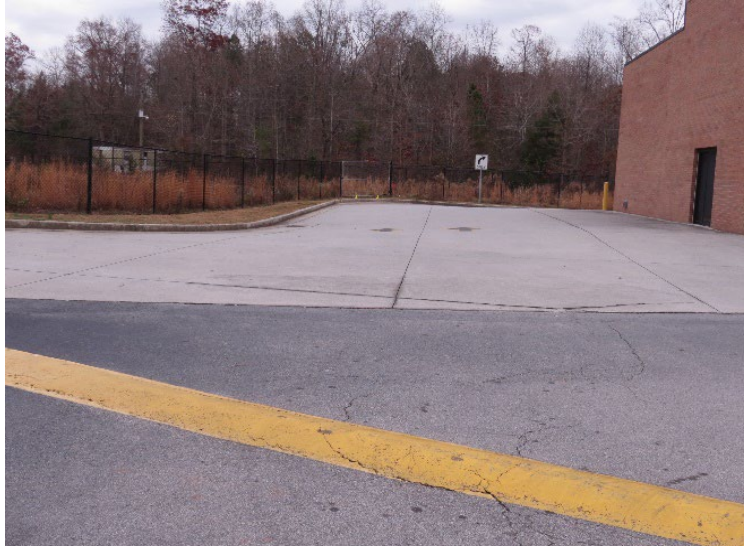
Figure 4. East trajectory view of the Kia toward the retention pond

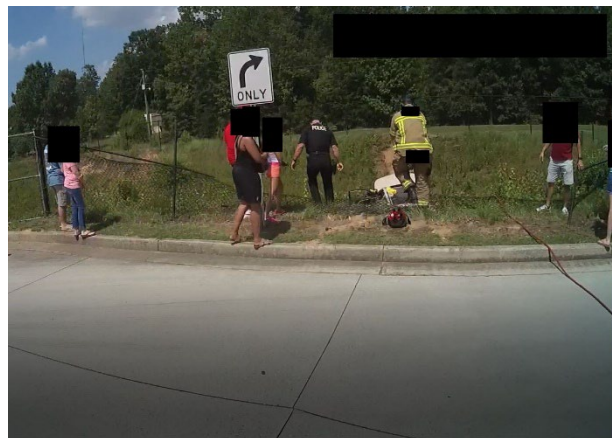
Figure 5. East looking on-scene law enforcement image at the retention pond

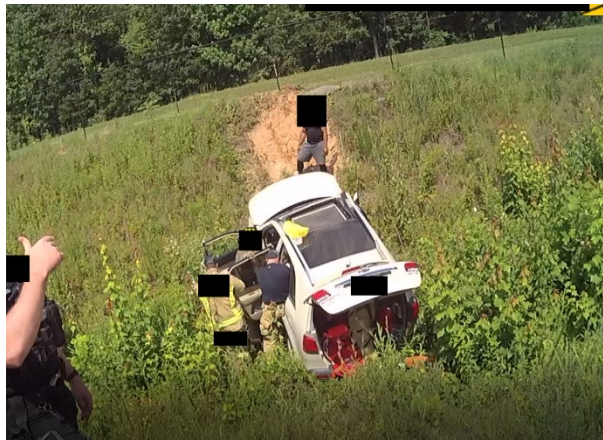
The Kia gouged up the embankment approximately 2 m (6 ft) before rolling down the embankment towards the bottom of the dry retention pond, coming to rest below the point of impact (Figure 6).

Figure 6. East looking on-scene law enforcement image of the Kia at final rest

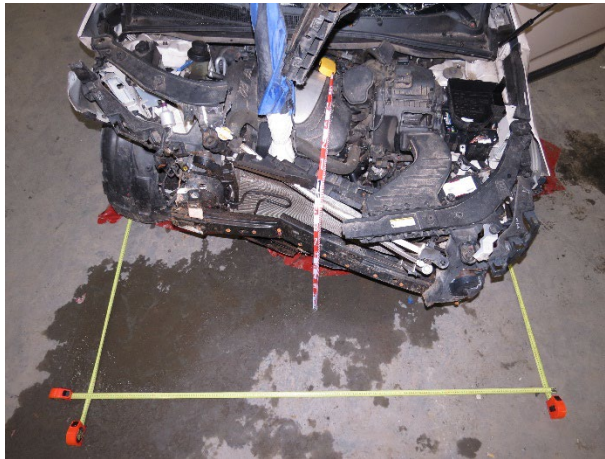
The Kia sustained minor damage from contact with the Toyota (Event 1), estimated minor damage from contact with the curb and fence (Events 2, 3, 4, and 5), and severe damage from impact with the embankment of the retention pond (Event 6; Figures 8 and 9).

Figure 8. Front view of the Kia

The collision deformation classification (CDC) assigned to the damage pattern for the Event 1 impact with the Toyota was 12FDEW1 and overlapped with the impact damage from Event 6. The front tires struck the curb (Events 2 and 3), resulting in rim damage to both wheels with CDCs of 12FLWN3 and 12FRWN3. The Kia's front plane struck the fence (Event 4) with an estimated CDC of 12FDEW1. As the Kia continued forward, the right rear wheel struck the curb (Event 5), resulting in rim damage with the corresponding CDC of 12FRWN9. The Kia's front

undercarriage and end plane struck the embankment of the retention pond (Event 6) with a CDC of 12FDEW2. Due to the vehicle’s estimated vault trajectory and the angle of the embankment, there was a non-horizontal component to this impact.

The impact damage to the front plane was measured across the front bumper reinforcement. The width of the direct contact damage measured 117 cm (46.1 in). The residual crush profile was C1 = 6 cm (2.4 in), C2 = 9 cm (3.5 in), C3 = 20 cm (7.9 in), C4 = 30 cm (11.8 in), C5 = 29 cm (11.4 in), C6 = 26 cm (10.2 in). Maximum crush was located 18 cm right of center and measured 30 cm (11.8 in). The left wheelbase was reduced by 3 cm (1.2 in). The right wheelbase was reduced by 20 cm (7.9 in). For comparative purposes, the severity of the impact was calculated by the barrier algorithm of the WinSMASH program. The total change in velocity (delta V) was 34 km/h (21 mph). The longitudinal and lateral components were -34 km/h (-21 mph) and -6 km/h (-4 mph). The calculated result was considered borderline and low, in part due to the non-horizontal nature of the impact.

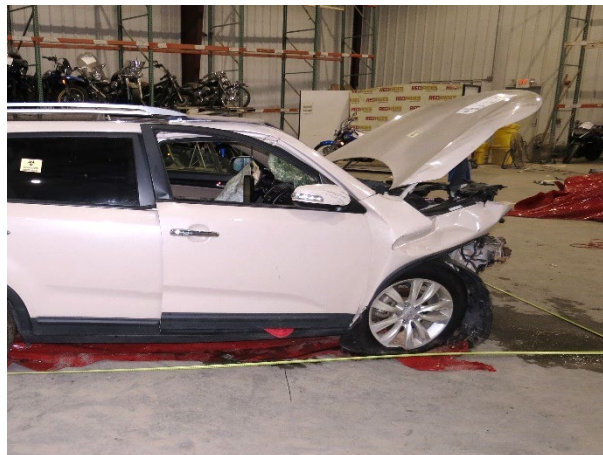
Figure 9. Right side view of the Kia

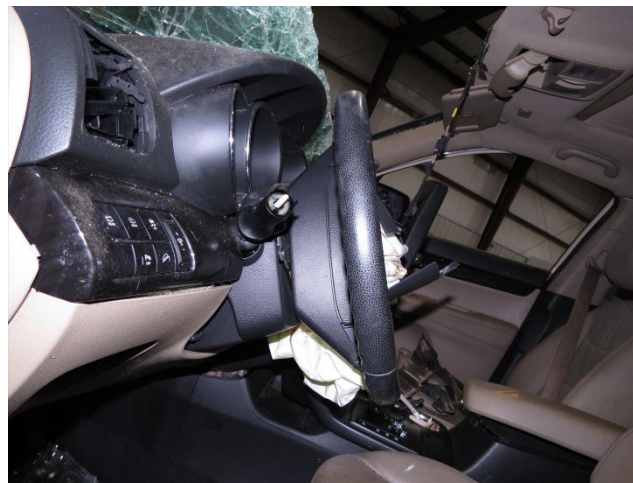
The interior damage was minor with the right portion of the instrument panel intruding 2 cm (0.8 in). The firewall forward of the driver's foot controls intruded an estimated 15 cm (6 in). The driver was belted with the seat adjusted between the forwardmost and middle track positions. The driver significantly loaded the steering wheel-mounted airbag and the steering wheel rim, compressing the column forward into the instrument panel (Figure 10).

Figure 10. Compression of the steering column from driver loading

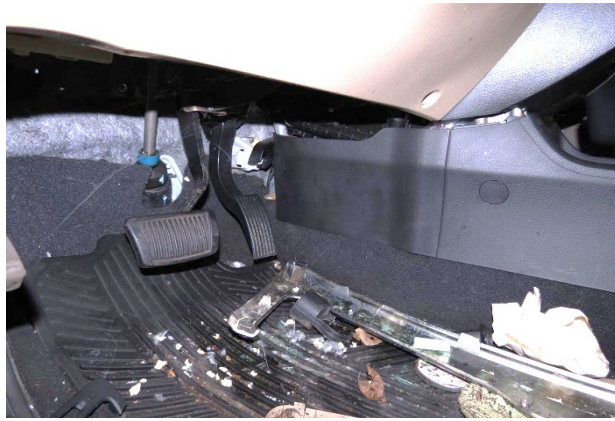
Due to the complaint of this vehicle being a reported sudden unintended acceleration incident, the foot controls (Figure 11) were documented and examined in detail. With the seat being 4 cm (1.6 in) rearward of full forward, the brake pedal was located 48 cm (18.9 in) from the upholstery seam of the seat and the accelerator pedal was 51 cm (20.1 in) from the seat. The brake pedal was trapezoidal in shape with 11 cm (4.3 in) measured across the top and 9 cm (3.5 in) on the bottom with a height of 6 cm (2.4 in). The accelerator pedal was rectangular in shape and measured 4.5 cm by 10 cm (1.8 by 3.9 in). The center of the pedals were offset by 15 cm (5.9 in). At inspection, the brake pedal was jammed due to intrusion of the firewall. The accelerator pedal was at idle, actuated its full range, and returned by spring pressure. The pedal did not contact the floor pad or floor mat. The accelerator pedal was identified by the part number 32700-1U000. The floor mat was an OEM weather mat of a rubberized material with grips on the bottom. The mat was not connected to the OEM contact points in the vehicle (Figure 12); however, due to the grips on its underside, the mat would not slip.

Figure 11. Foot controls of the Kia

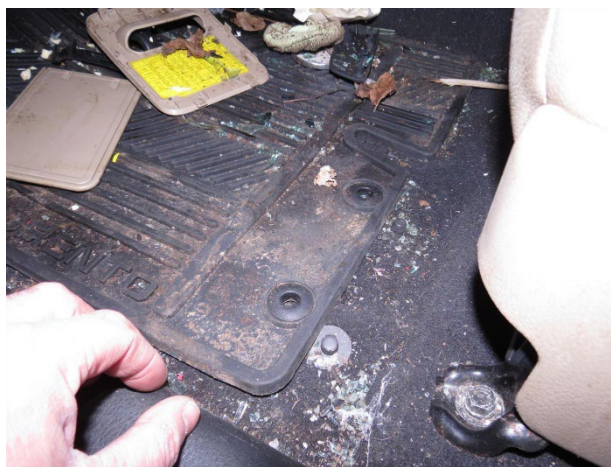
Figure 12. Driver's floor mat in the Kia

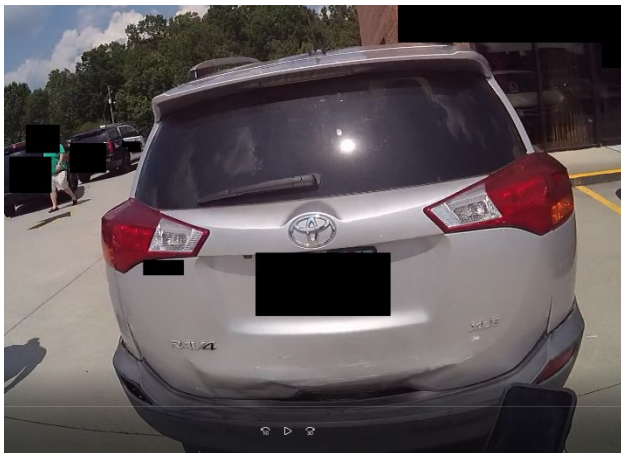
The Toyota's exterior damage consisted of minor impact damage to the rear bumper fascia and the lift gate door with no apparent residual crush (Figure 14). The CDC assigned to the damage pattern was 06BDEW1. During the on-scene police investigation, the Toyota was driven from its controlled final rest position at the top of the grade near the strip mall entrance down to the lower area of the strip mall where the police completed their documentation (as reflected in the above images).

Figure 14. Police image of damage to the rear of the Toyota from impact by the Kia

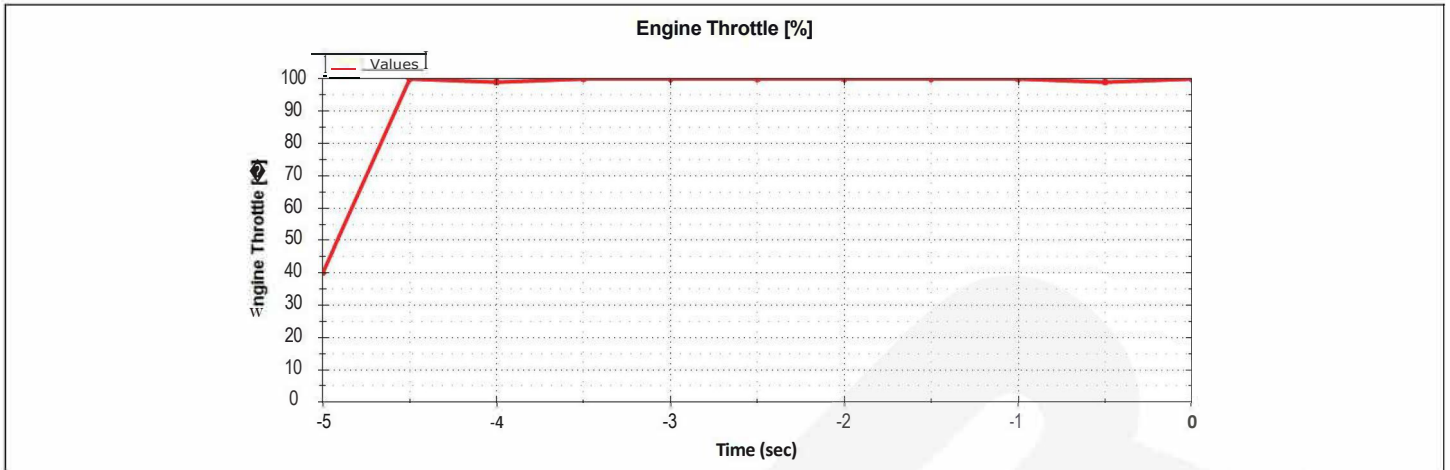
Engine Throttle

The data trends showed that the engine throttle was at or near 100 percent for approximately 4.5 seconds leading up to the crash. There was no recorded driver brake application. The SCI team's crash reconstruction determined from this EDR pre-crash data that the Kia's movement through the strip mall parking lot approaching the retention pond occurred after the Toyota had separated from the Kia.
