DOT HS 813 606

**Special Crash Investigations:
On-Site Child Safety Seat Crash
Investigation;
Vehicle: 2003 Toyota Camry;
Location: Virginia;
Crash Date: October 2021**

**Special Crash Investigations
On-Site Child Safety Seat Crash Investigation
SCI Case Number: CR21026
Vehicle: 2003 Toyota Camry
Location: Virginia
Crash Date: October 2021**

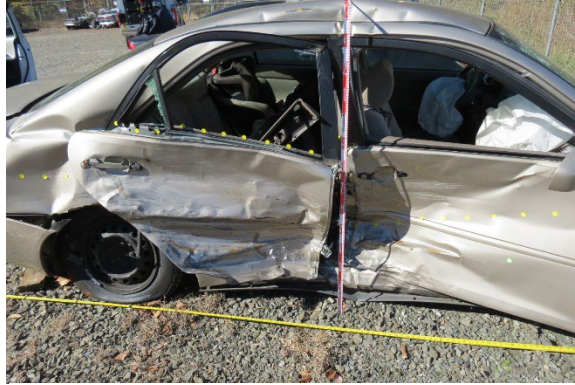
The right side of the Toyota sustained direct damage during the impact (Event 1) with the front of the Subaru. The direct contact damage began 90 cm (35.4 in) rear of the right front axle and extended 233 cm (91.7 in) rearward. The maximum engagement occurred at the location of the right B-pillar and resulted in a hinge failure of the right rear door. The latch/striker remained intact. Crush measurements were taken on the front door at the mid-door level. For reference purposes, the right rear door fascia was repositioned on the vehicle during the SCI inspection. Due to the gap between the door fascia and door structure, crush measurements were taken at the belt line, which reflected a more accurate representation of the total crush (Figure 6). The combined length of the direct contact and induced damage (Field L) was 270 cm (106.3 in). The maximum residual crush was 33 cm (13.0 in), located 164 cm (64.6 in) aft of the right front axle. The sill height was 16 cm (6.3 in), the height of the maximum crush was 30 cm (11.8 in), and the door sill differential was 5 cm (2.0 in). The crush values were C1 = 3 cm (1.2 in), C2 = 11 cm (4.3 in), C3 = 14 cm (5.5 in), C4 = 33 cm (13.0 in), C5 = 19 cm (7.5 in), C6 = 2 cm (0.8 in). The damage algorithm of the WinSMASH program calculated the total delta V as 27 km/h (16.8 mph). The longitudinal and lateral velocity changes were -14 km/h (-8.7 mph) and -23 km/h (-14.3 mph). These results fit the parameters of the program and the results were considered low. The collision deformation classification for this impact was 02RZAW3 (60°).

Figure 6. Right-side damage to the Toyota

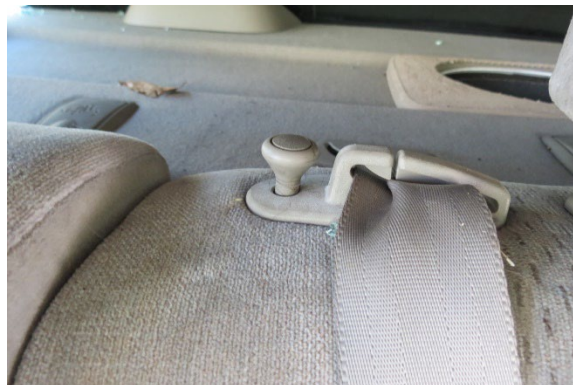
The 7-year-old passenger in the second-row center was seated in a backless booster CRS and was restrained by the vehicle's lap and shoulder seat belt. The 7-year-old loaded the seat belt in response to the 2 o'clock direction of force impact. The belt webbing was gathered and pinched in the seat belt guide on top of the seatback and the sliding latch plate (Figures 7 and 8). Load marks were also noted on the belt webbing and latch plate.

Figure 7. Second-row, middle seat pinched webbing at top of the belt guide

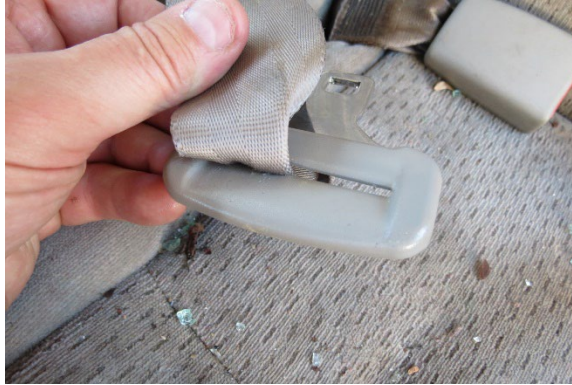
Figure 8. Second-row, middle seat pinched webbing and load mark on the latch plate belt guide

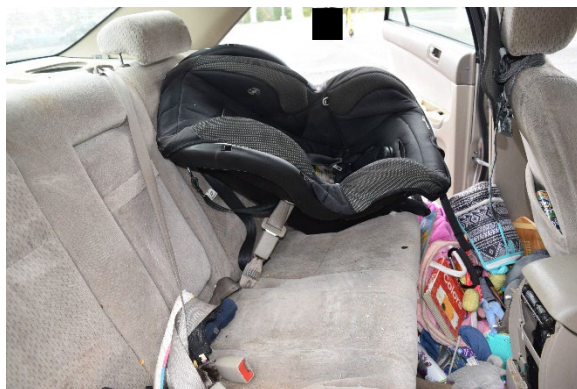
The police crash report also stated the bottom of the seat was displaced at a near 45° angle (Figure 10) with the upper portion canted toward the direction of force (approximately 60°). The CRS was not firmly secured by the vehicle's seat belt. Also, the Styrofoam on the left side of the CRS' head area was fractured, though it is unknown if this was from previous damage.

Figure 10. On-scene police image of the second-row left CRS prior to removal post-crash

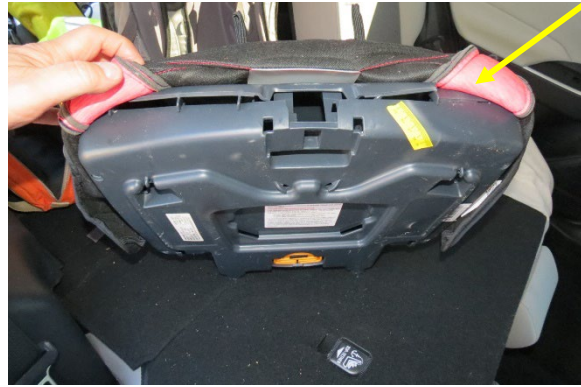
Inspection of the booster seat revealed a separation of the bottom portion from the top, a stress mark, and tearing of the plastic at the front of the seat (Figure 12). Stress marks were also noted on the left and right sides of the seat (Figure 13). There were no load marks on the belt guides of the booster seat. The top half of the right armrest was fractured and separated, and the remaining portion was cracked. This breakage probably occurred as the 7-year-old was displaced right and forward as a result of the crash.

Figure 12. Separation of seating surface from the booster seat base

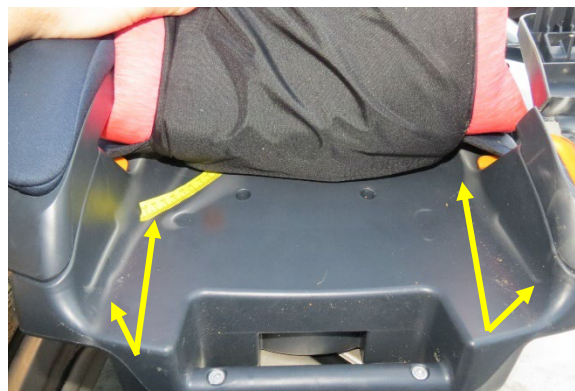
Figure 13. Stress marks on top of the booster seat

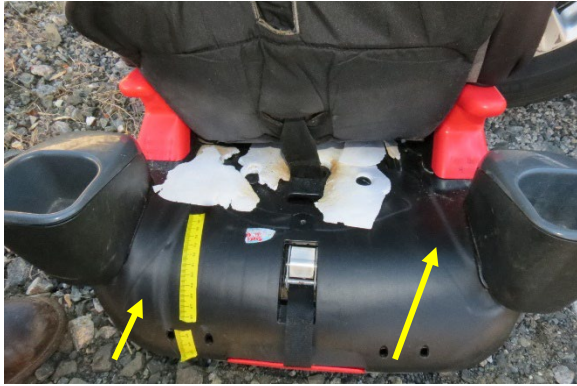
Inspection of the CRS revealed the buckles, hardware, and retainer clip to be undamaged and in good working order and the shoulder straps were routed through the top slots in the cover and the slots below the top level on the back rest. Stress marks were noted on both sides of the top of the seat and a tear of the plastic was noted on the left front of the seat (Figure 15). Significant cracking and breakage was noted on the bottom of the plastic base (Figure 16), which became separated from the upper base panel on the left side. These were due to the intrusion from the right door and possibly lateral movement of the booster seat at the middle position. The collar of Styrofoam padding at the head area was fractured in two places.

Figure 15. Front/top of CRS seat stress marks on the right and left sides

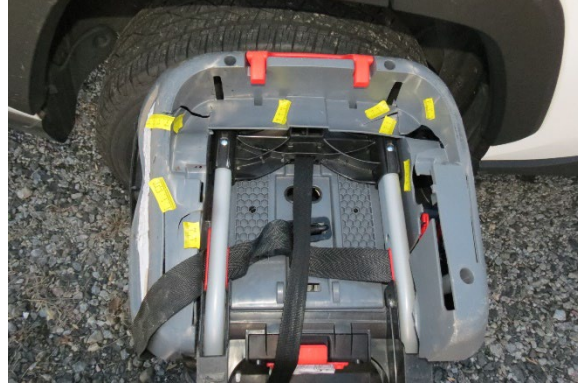
Figure 16. Broken and cracked plastic bottom of the second-row right CRS

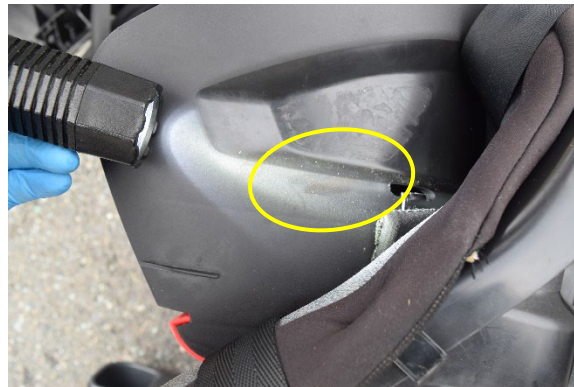
Stress marks were also found on both CRS sides, just above each armrest and at the top left of the backrest. The top right of the backrest exhibited an abrasion, possibly from contact with the right C-pillar. The police crash report also noted that the left side of the CRS also exhibited a scuff (Figure 17), possibly made by the shoulder of the second-row, middle passenger.

Figure 17. Scuff on the left exterior of the headrest

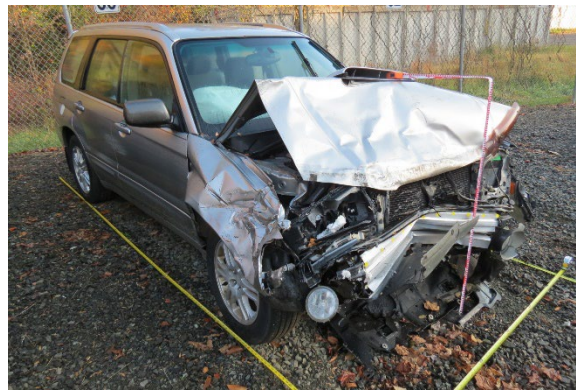
The Subaru (Figure 18) sustained frontal damage that was distributed across the entire end width of the vehicle from the crash with the Toyota. The direct contact damage was 155 cm (61.0 in), and crush measurements were taken on the front bumper bar and the maximum residual crush was 22 cm (8.7 in) which occurred 46 cm (18.1 in) left of the right end of the bumper bar. The crush values were C1 = 2 cm (0.8 in), C2 = 16 cm (6.3 in), C3 = 22 cm (8.7 in), C4 = 22 cm (8.7 in), C5 = 19 cm (7.5 in), C6 = 17 cm (6.7 in). The damage algorithm of the WinSMASH program calculated the total delta V as 30 km/h (18.6 mph). The longitudinal and lateral velocity changes were -29 km/h (-18.0 mph) and 10 km/h (6.2 mph). These results fit the parameters of the program and the results were considered reasonable. The CDC for this impact was 11FDEW1 (340°).

Figure 18. Front/right of the Subaru

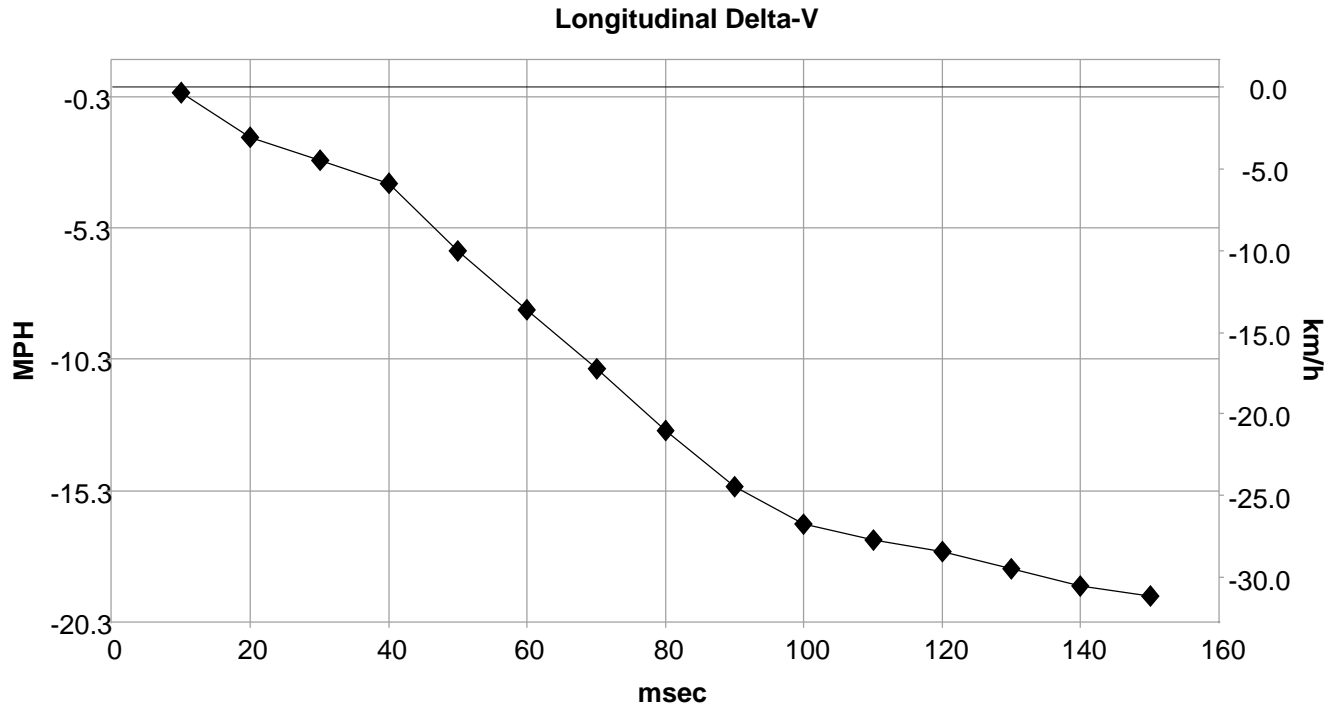
Longitudinal Crash Pulse (Most Recent Frontal/Rear Event, TRG 3 - table 1 of 2)

Max Longitudinal Delta-V (MPH [km/h])	-19.4 [-31.2]
---------------------------------------	---------------
