DOT HS 813 608

**Special Crash Investigations:
On-Site Reported Lane Keeping
Assist Issue/Air Bag Non-
Deployment Investigation;
Vehicle: 2020 Kia Niro;
Location: California;
Crash Date: November 2021**

Special Crash Investigations
On-Site Reported Lane Keeping Issue/Air Bag Non-Deployment Investigation
Office of Defects Investigation
Case Number: DS22004
Vehicle: 2020 Kia Niro
Location: California
Crash Date: November 2021

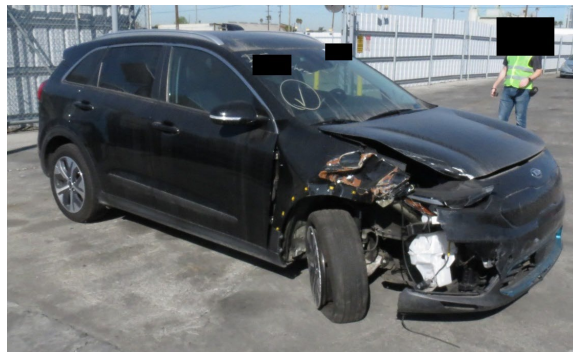
Figure 1. 2020 Kia Niro, front-plane damage

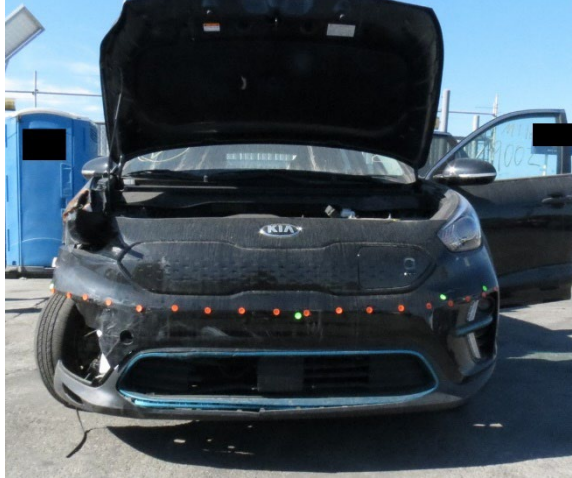
Figure 2. 2020 Kia Niro, front-plane damage

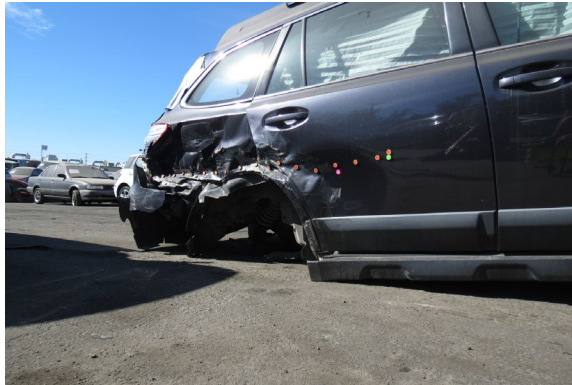
Figure 3. 2012 Subaru Outback, right-plane damage

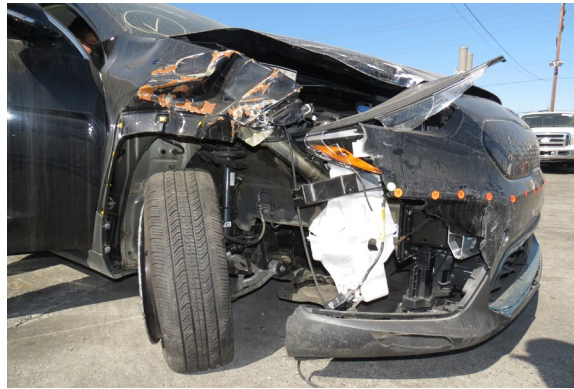
The Kia sustained light front-plane damage from the impact with the right plane of the Subaru (Figure 9). The direct damage associated with this impact appears to begin at the front right bumper corner and extended 35 cm (13.7 in) to the left. A portion of the fascia at the right bumper corner was torn away. The direct damage extended 61 cm (24.0 in) along the right side. The field L extended from bumper corner to bumper corner and measured 160 cm (62.9 in). Nineteen measurements were taken at the bumper level using the Nikon total station and the AutoCrush tool calculated six crush measurements as follows: C1=0 cm, C2=0 cm, C3=0 cm, C4=0 cm, C5=0 cm, C6=5 cm (1.9 in). The collision deformation classification (CDC) was 12FREE3.

Figure 9. 2020 Kia Niro front-right damage

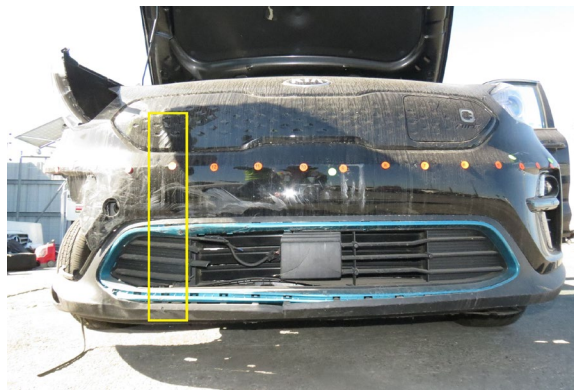
There was a narrow impact pattern associated with the no parking sign (Figure 10). The CDC was 12FREN1.

Figure 10. 2020 Kia Niro front-plane damage (pole impact highlighted)

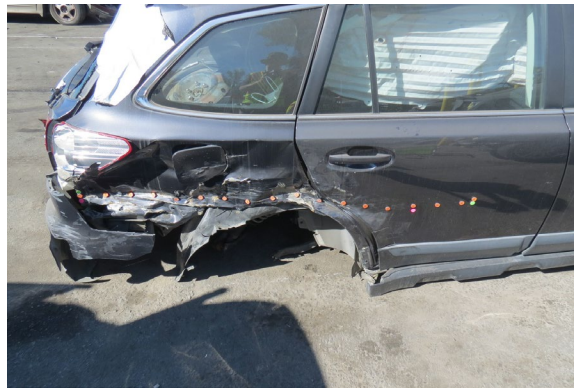
The Subaru sustained light right-plane damage from the impact with the front plane of the Kia (Figure 12). The direct damage began 222 cm (87.4 in) aft of the right front axle and extended 140 cm (55.1 in) rearward. The Field L began 197 cm (77.5 in) aft of the right front axle and extended 160 cm (62.9 in) rearward. Eighteen measurements were taken at bumper level using the Nikon total station and the AutoCrush tool calculated crush measurements as follows: C1=14 cm (5.5 in), C2=13 cm (5.1 in), C3=8 cm (3.1 in), C4=5 cm (1.9 in), C5=0 cm, C6=0 cm. The maximum crush was located at the right rear bumper corner and measured 15 cm (5.9 in). The CDC was 12RZEW2.

Figure 12. 2012 Subaru Outback, right plane damage

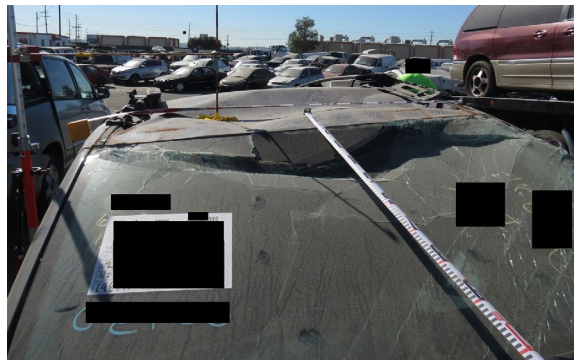
Figure 13. 2012 Subaru Outback, roof damage

The vehicle sustained moderate top plane damage from the rollover (Figure 13). The direct damage began at the front hood edge and extended rearward 225 cm (88.5 in) onto the roof. The damage width was 127 cm (50.0) extending from roof side rail to roof side rail. The maximum crush was located on the roof and measured 8 cm (3.1 in). The CDC was 00TYDO2.

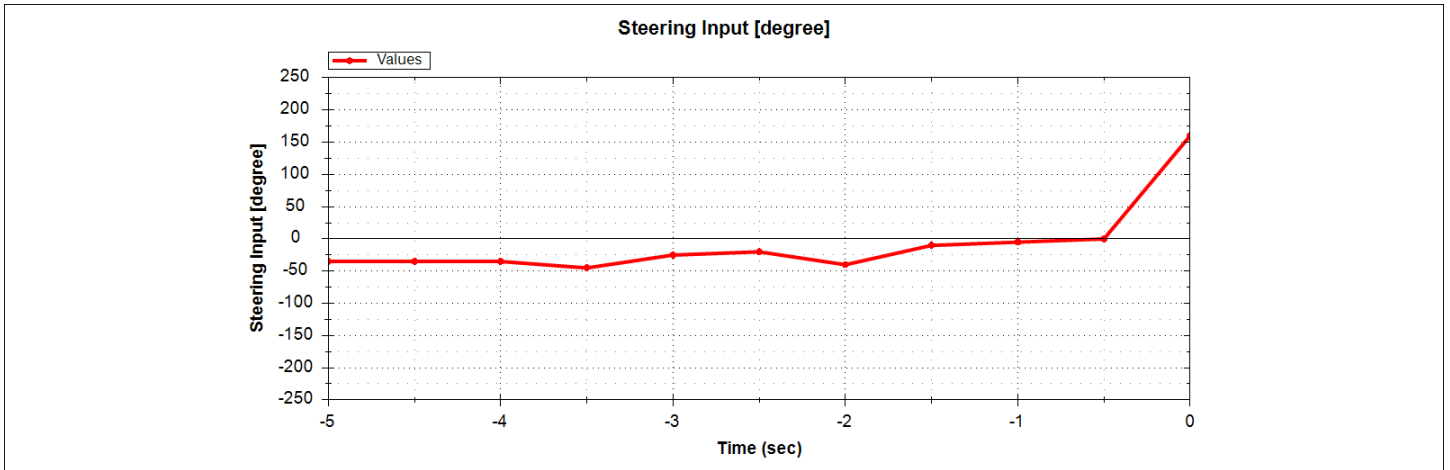
mph) with a right steering input of -35^2 to the right 5 seconds prior to impact. The steering input was all gradual to the right until time 0. At -2.5 seconds, the acceleration pedal dropped to 0 percent. At -2.0 seconds, the driver braked. At time 0, stability control engaged, and the steering input changed to 160 to the left.

Num	Time (sec)	Steering Input [degree]
1	-5.0	-35
2	-4.5	-35
3	-4.0	-35
4	-3.5	-45
5	-3.0	-25
6	-2.5	-20
7	-2.0	-40
8	-1.5	-10
9	-1.0	-5
10	-0.5	0
11	0.0	160
