U.S. Department
of Transportation

**National Highway
Traffic Safety
Administration**

DOT HS 813 635

**Special Crash Investigations:
On-Site Ambulance Crash Investigation;
Vehicle: 2016 Mercedes-Benz Sprinter
Type II Ambulance;
Location: Texas;
Crash Date: April 2021**

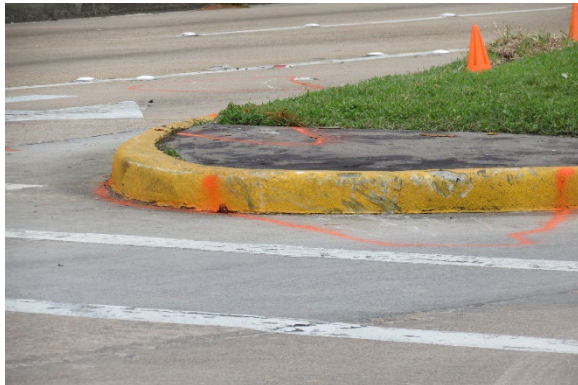
Figure 4. West median tip, struck by right rear top of the ambulance

The ambulance sustained damage to the top right rear corner as it struck the apex of the median curb (Event 3). The roof, D-pillar, and right rear door were directly damaged (Figures 7 and 8), and both doors came open due to the impact. The WinSMASH program could not be used to determine velocity change since non-horizontal impacts are out of scope for the program. Furthermore, damage to the roof and pillar overlapped by the rollover damage (Event 2). The right maximum vertical and lateral crush damage were both located at the right D-pillar and measured 35 cm (13.8 in) and 17 cm (6.7 in), respectively. The CDC assigned for this damage 00TBZW4.

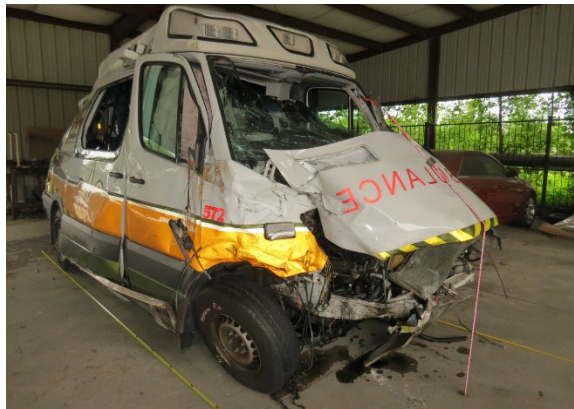
The ambulance sustained direct damage to the front and right planes during impact with the Toyota. The front plane damage extended across the entire front plane (Figure 6) width of 173 cm (68.1 in). The field L was 136 cm (53.5 in). Crush measurements were taken on the bumper beam and the maximum residual crush was 46 cm (18.1 in) and was located 23 cm (9.1 in) right of vehicle's centerline. The crush values were: C1 = 11 cm (4.3 in), C2 = 30 cm (11.8 in), C3 = 45 cm (17.7 in), C4 = 46 cm (18.1 in), C5 = 29 cm (11.4 in), C6 = 8 cm (3.1 in). The damage algorithm of the WinSMASH program calculated the total delta V as 31 km/h (19 mph). The longitudinal and lateral velocity changes were calculated as -20 km/h (12 mph) and -24 km/h (15 mph). The analysis of the impact fit the parameters of the program and the results were considered low. The collision deformation classification¹ (CDC) assigned to this damage pattern was 02FDEW3.

Figure 6. Front end and right-side damage

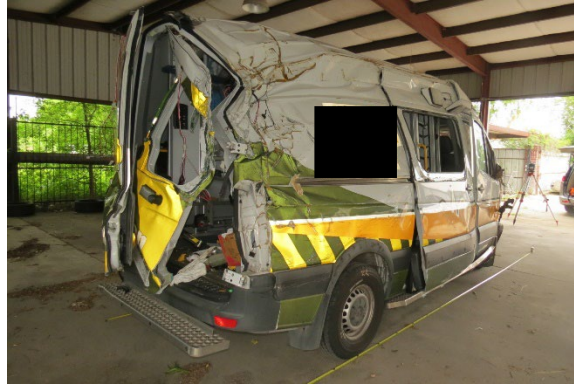
The entire right side of the ambulance was directly damaged during the rollover (Event 2) and rotation on the median and street. Maximum lateral and vertical crush damages overlapped from Event 3. The WinSMASH program could not be used to determine velocity change for this impact because rollovers are out of scope for the program. The CDC assigned to this damage was 00RDAO99.

Figure 7. Right/back rollover damage

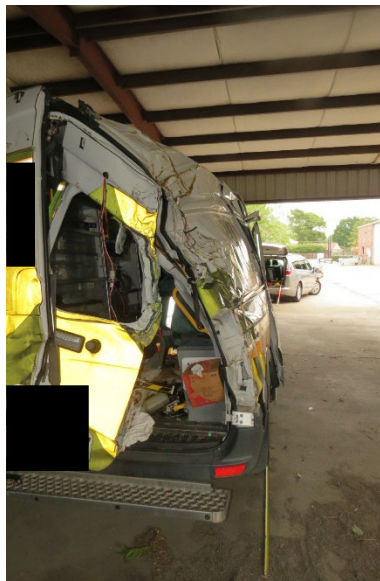
Figure 8. Right/top rollover damage

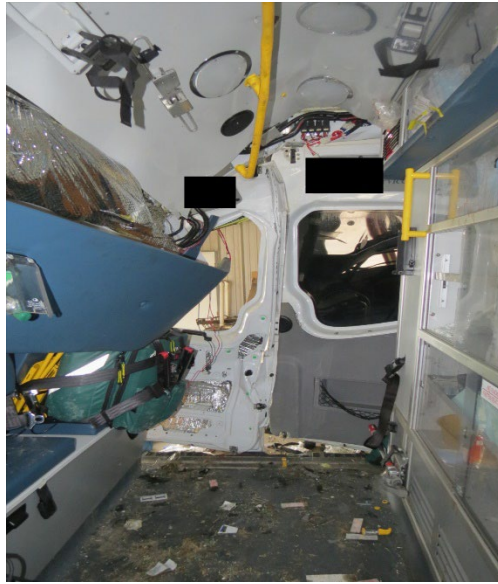
Inspection of the patient compartment revealed significant intrusion damage to the right plane/top rear corner (Figure 9). The top of the D-pillar intruded 35 cm (13.8 in) vertically and 17 cm (6.7 in) laterally. The right-side panel intruded laterally 22 cm (8.7 in) and the right-side sliding door was jammed shut. On the back plane, the right rear door opened during the rollover due to a hinge separation (Figures 10 and 11). The left door was jammed shut and was mechanically pried opened by rescue personnel (Figure 12). The longitudinal grab handle on the ceiling (see Figure 9) was possibly contacted by the patient and/or cot. Otherwise, there was no other evidence of discernable occupant contact in the patient compartment. Areas of contact and blood evidence were observed on the left cabinets and on the ceiling.

Figure 9. Intrusion damage to the right rear of the patient compartment

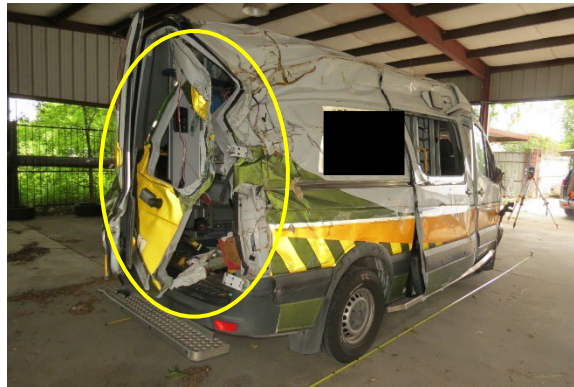
Figure 10. Right rear door separation

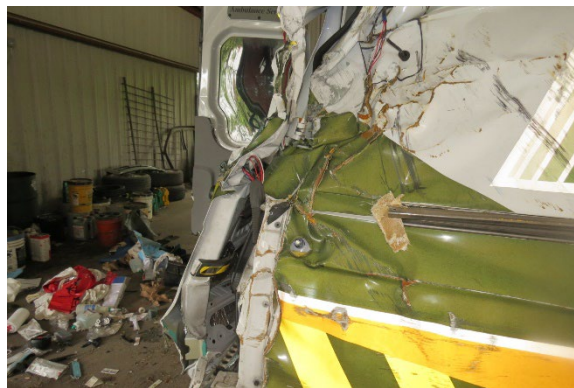
Figure 11. Right rear door hinge separation

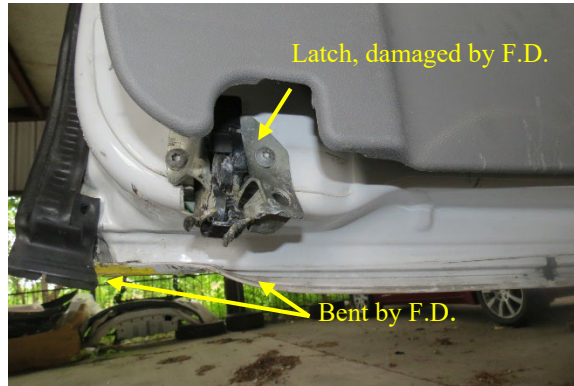
Figure 12. Left rear door latch (note bottom of door bent upward by rescue personnel to access latch)

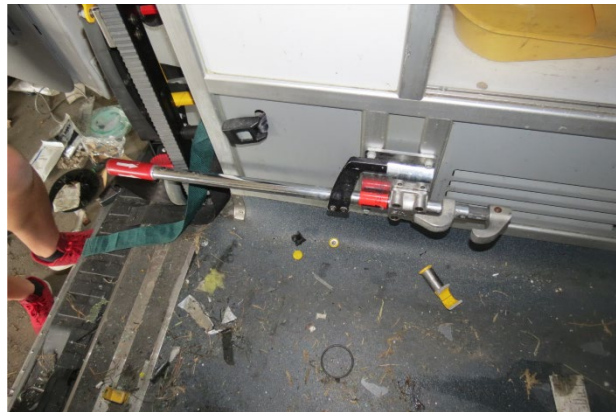
Figure 13. Rail clamp cot fastener system with fractured pin

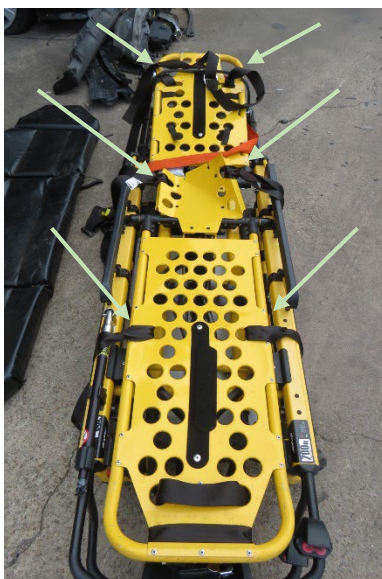
Inspection of the patient cot revealed that all restraint straps were anchored to the mattress platform (Figure 16). The owner's manual stated that proper restraint strap anchor points were on the actual cot frame (Figure 17). Furthermore, the lower leg restraints were anchored closer to the center of the cot than the proper location shown in the owner's manual. Further inspection revealed the left side of the middle section of the platform was pulled from its mounting during the crash sequence (Figure 18).

Figure 16. Cot mattress platform (note restraints anchored to the mattress platform)

SCI inspection revealed that all cot restraints were anchored to the mattress support platforms of the cot, not to the cot's frame as shown by the owner's manual. The lower and upper body platforms were not damaged, but the left top aspect of the mid-body platform was deformed

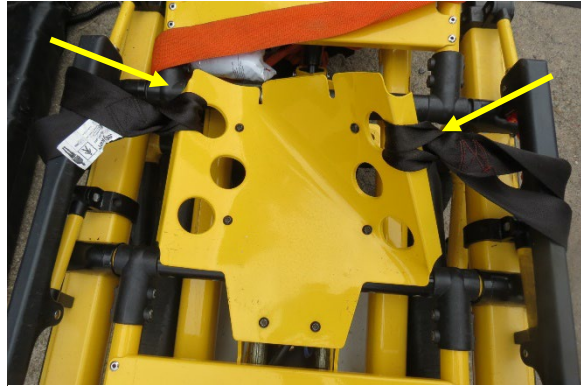
Figure 18. Middle of cot (note restraint anchor points and damage to the mattress platform)

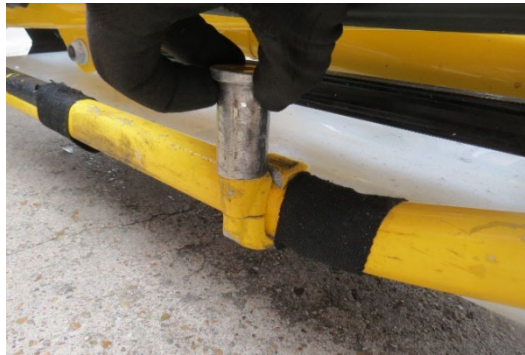
The patient cot locking pin bracket on the tubular frame fractured (Figures 19 and 20) and separated from the cot during the crash sequence. This pin normally secured the cot to the rail clamp in the back of the patient compartment. The separation from the rail clamp allowed the cot to move freely about the compartment during the crash sequence as it hinged vertically while the forward aspect of the cot remained engaged with the antler bracket.

Figure 19. Fractured locking pin from the cot frame (placed back on frame for reference)

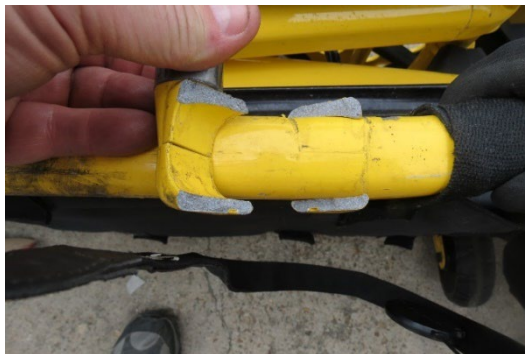
Figure 20. Fractured locking pin bracket

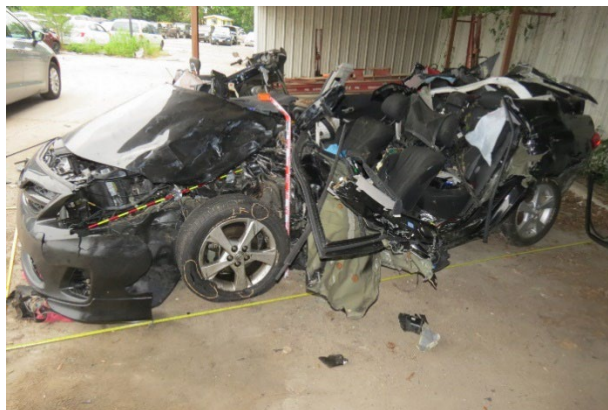
The Toyota sustained direct damage to the left side during impact with the ambulance (Figure 21, Event 1). The direct damage began 102 cm (40.2 in) forward of the left rear axle and extended 212 cm (83.5 in) forward. The field L was 213 cm (83.9 in). Crush measurements were taken at the mid-door level and maximum residual crush was 47 cm (18.5 in), occurring 212 cm (83.5 in) forward of the left rear axle. The crush measurements values were: C1 = 37 cm (14.6 in), C2 = 47 cm (18.5 in), C3 = 37 cm (14.6 in), C4 = 42 cm (16.5 in), C5 = 33 cm (13.0 in), C6 = 26 cm (10.2 in). The damage algorithm of the WinSMASH program calculated the Toyota's total delta V as 71 km/h (44 mph). The longitudinal and lateral velocity changes were -54 km/h (-34 mph) and 46 km/h (29 mph). The analysis of the impact fit the parameters of the program and the results were reasonable. The CDC for this damage pattern was 11LYAW4.

Figure 21. Event 1 involving the Toyota's left plane damage

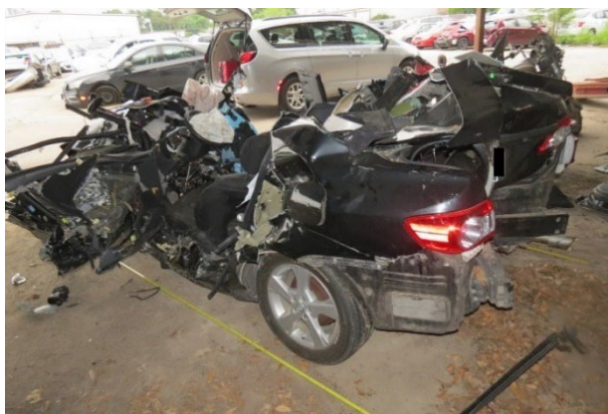
The Toyota sustained direct damage on its left plane during the sideswipe impact with the vertical standpipe (Event 4). The direct damage began 50 cm (19.7 in) rear of the left rear axle and extended 131 cm (51.6 in) forward. The WinSMASH program could not be used on this impact because sideswipes are out of scope for the program. Furthermore, due to overlapping damage from the initial impact, no damage was measured. The CDC for this damage pattern was 06LZEW1.

The Toyota sustained direct damage to its back end during the impact with the tree (Figure 22, Event 5). The direct damage began 37 cm (14.6 in) right of the left rear bumper beam end and extended 32 cm (12.6 in) to the right. The field L was 89 cm (35.0 in). Crush measurements were taken on the bumper beam and maximum residual crush was 35 cm (13.8 in) occurring 52 cm

Figure 22. Events 4 and 5 involving the Toyota's left and rear plane damage
