DOT HS 813 636

**Special Crash Investigations:
On-Site Rollover Crash
Investigation;
Vehicle: 2021 Hyundai Santa Fe;
Location: North Carolina;
Date: March 2022**

Special Crash Investigations
On-Site Rollover Crash Investigation
Case Number: CR22008
Vehicle: 2021 Hyundai Santa Fe
Location: North Carolina
Crash Date: March 2022

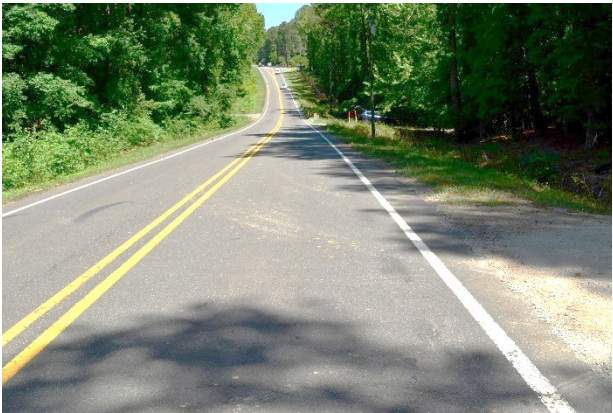
Figure 2. Facing north and view of path of travel and roadway departure

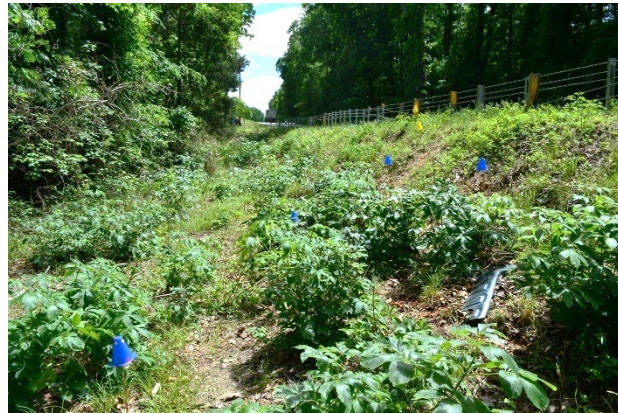
Figure 3. Facing south and the lookback at final rest and roadway departure. The blue cones represent final rest, and the yellow cones represent path of travel

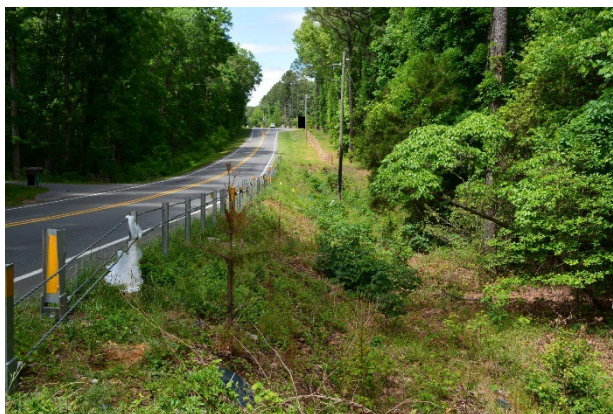
Three cable barrier systems (CBS) (Figure 4) bordered the right side of the roadway. According to the Federal Highway Administration, “The cable barrier system used by North Carolina consists of three steel 19-millimeter (0.74-inch)-diameter cables with steel supporting posts a maximum of 5 meters (16.4 feet) apart. The bottom cable height is 54 cm (21 inches) from the ground; the top cable height is 84 cm (33.1 inches) from the ground. Anchor post brackets and breakaway anchor angles secure each end of the cable run. The maximum distance between anchors is 600 meters (1,968.5 feet). The cable tension is controlled by spring turnbuckles located near each end of the cable run.”¹ The barrier cables were designed to overlap each other. The first CBS was constructed of three offset cable anchor I-beam posts 78 cm (30.7 in) tall with 10 cm (3.9 in) flanges and a 15 cm (5.9 in) web. The posts were positioned with the web perpendicular to the roadway and welded to the top of the cable anchors that were cemented to the ground. The first anchor post was in line with the barrier and was followed by the offset

Figure 4. Facing north at the sections of the cable barriers

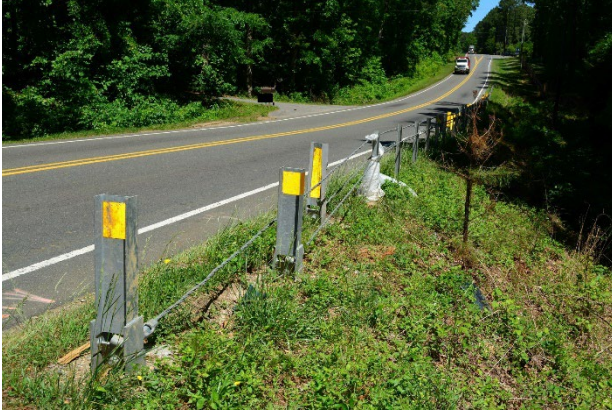
The front plane of the Hyundai struck the field side of the first barrier's second anchor post (Event 1, Figure 5). As the vehicle traveled forward and left, the top cable engaged the surface of the hood (Event 2), and the bottom two cables engaged the left side of the Hyundai (Event 3). An estimated 14 posts were displaced from the ground. As the posts gave way and the vehicle continued traveling forward and left, the tension in the cables increased causing the Hyundai to redirect towards the embankment (Figure 6) until tripping over the side into a rollover event (Event 4). The Hyundai rolled three-quarter-turns, coming to rest on its left side with the front facing the northwest.

Figure 5. Facing north and the forward section of the first CBS, the second post from the left is the first object struck for Event 1

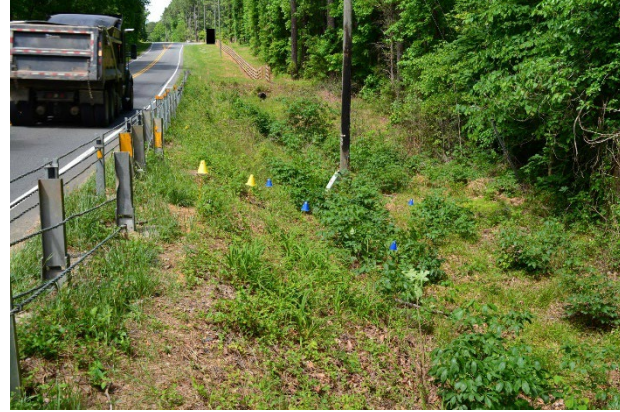
Figure 6. Facing north and looking down at the path of travel for Event 4 and separation from the CBS

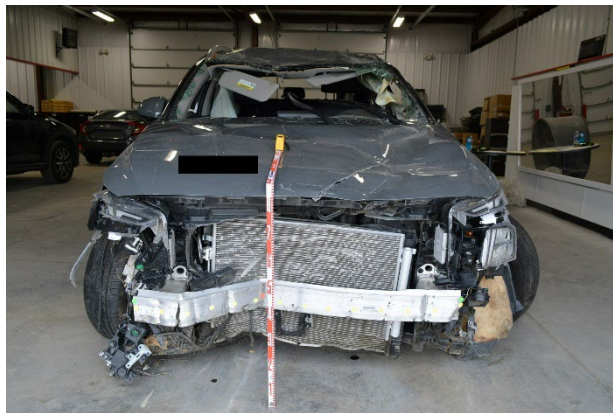
The Hyundai sustained damage across the front plane from the initial contact with the cable barrier posts (Event 1, Figure 8). The direct contact damage was measured across the entire 122 cm (48.0 in) bumper bar. The direct contact damage from Event 1 also involved the bumper fascia, the headlight components, and the front wheel assemblies. Some of the forces associated with this event were absorbed by the front tires and suspension and led to the separation of the left front tire CV joint from the front gear box. The left wheelbase measured 255 cm (100.4 in) and the right 269 cm (105.9 in). The residual crush was measured with a Nikon total station and the resultant profile was: C1= 7 cm (2.8 in), C2= 15 cm (5.9 in), C3= 23 cm (9.1 in), C4= 30 cm (11.8 in), C5= 16 cm (6.3 in), C6= 10 cm (3.9 in). Maximum crush was located 17 cm (6.7 in) right of the center of the bumper and was 30 cm (11.8 in). For comparative purposes, the severity of impact was calculated by the barrier algorithm in the WinSMASH program. The total change in velocity (delta V) was 29 km/h (18 mph). The longitudinal and lateral components were -28 km/h (-17.9 mph) and 5 km/h (3.1 mph). The calculated result was considered borderline due to the yielding properties of the guardrail impact. The Collision Deformation Classification² (CDC) assigned to the damage pattern for Event 1 is 12FDEW2.

Figure 8. Damage to the front bumper from the CBS anchor posts

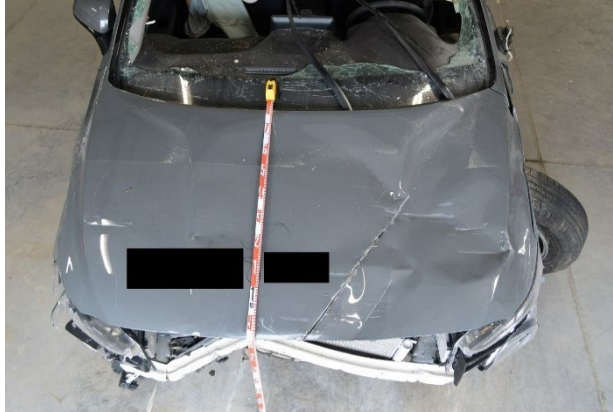
As the Hyundai traveled forward, the top cable of the CBS cut into the hood (Event 2, Figure 9). The cable contacted the centerline of the hood cutting diagonally to the left A-pillar through the sheet metal for 55 cm (21.7 in) with a continued 14 cm (5.5 in) of surface scraping. The CDC assigned to this event is 00TFCN2.

Figure 9. View of the damage to the hood from Event 2

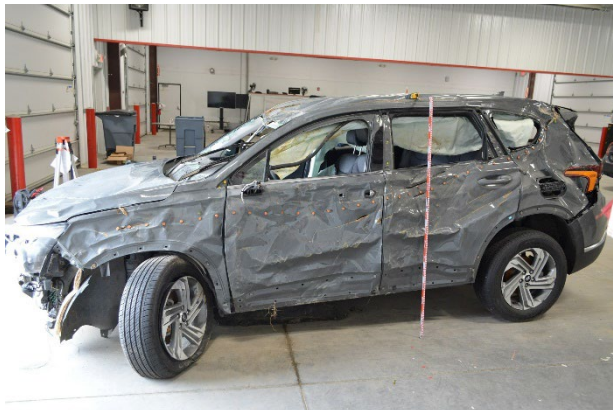
The Hyundai sustained moderate damage during the side impact with the cable barrier (Event 3). The middle and bottom cables contacted the front side panel 57 cm (22.4 in) above and 10 cm (3.9 in) forward of the left front axle and wrapped diagonally 318 cm (125.2 in) across the left side of the Hyundai, breaking the belt line at the C-pillar and ending at the top of the D-pillar (Figure 10) 50 cm (19.7 in) rearward of the left rear axle. Due to the nonlinear nature of the damage, the crush measurements were excluded from this report but are available in the coded data. That maximum crush was 7 cm (2.7 in) and located 80 cm (31.5 in) forward of the left rear axle. There were a mix of deep gouges not associated directly to the cable abrasions linked to the cable posts, still attached to the cables that were pulled across the side sheet metal. The glazing on the left rear and second left rear windows were disintegrated from the cables, cutting across the vehicle. It was also noted during the SCI investigation the rear section of the left IC that covered the left rear window was contacted by the cable/post and punctured. The CDC assigned to this event is 10LDAW2.

Figure 10. Left side of the Hyundai and the damage associated to Event 3

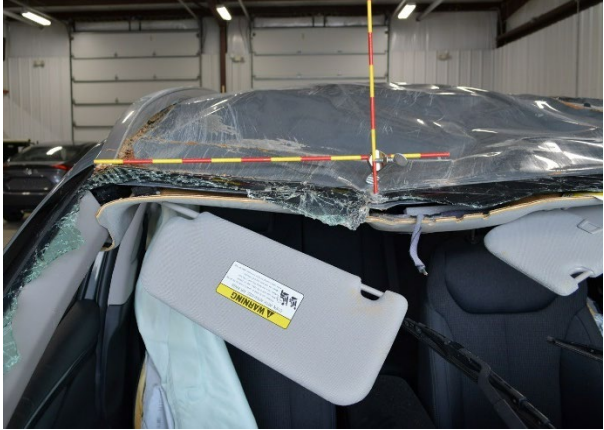
The Hyundai sustained moderate damage during the three-quarter-turn rollover (Event 4). The Hyundai landed on its top roof header, crushing the forward greenhouse space 7 cm (2.8 in) vertically (Figure 11). There were several heavy surface abrasions (Figure 12) across the entire vehicle as well as minor trim damage. The left side mirror was missing from the vehicle, but the right mirror was intact. These abrasions and mirror damages are attributed to the rollover event. The CDC assigned to this event is 00TPDO3.

Figure 11. Crush damage to the windshield header

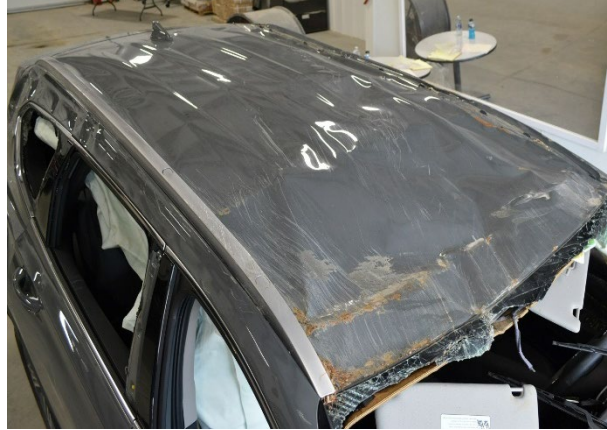
Figure 12. Surface abrasions to the roof

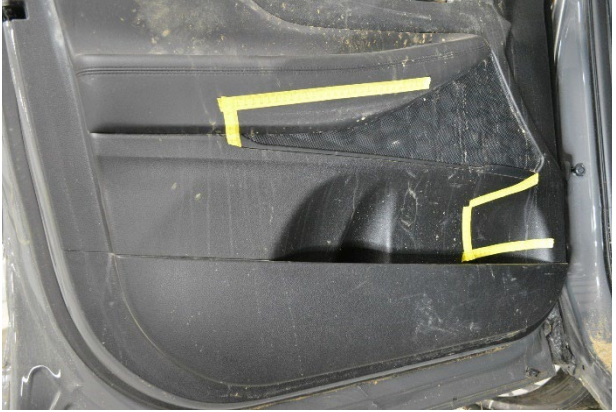
There was minor interior damage associated to intrusion, air bag deployment, and occupant contacts (Figures 13, 14, 15, and 16). There was a 7 cm (2.8 cm) intrusion of the roof into the front passenger's space (Figure 17). The driver contacts included scuffs to the polymer knee bolster/lower instrument panel areas as well as the left door panel. The front passenger's contacts included scuffs to the lower instrument panel and the right side of the center console. The rear passenger contacts included scuffs to the driver's seatback. Debris and mud from the crash site were evident on the interior of the entire left A-pillar and headliner (Figure 18). The front passenger's IC air bag had been cut by EMS. There was no interior damage to the rear cargo space of the Hyundai.

Figure 13. Contacts to the driver's door

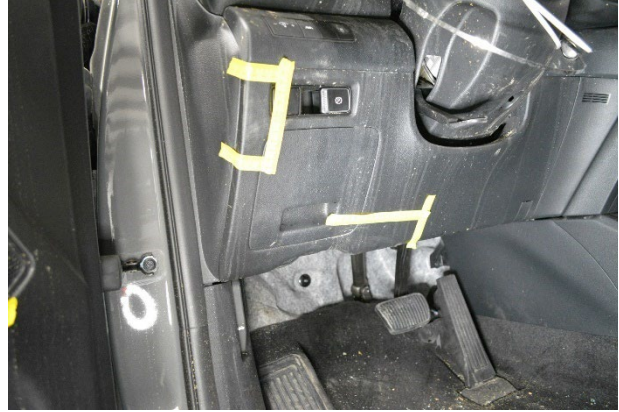
Figure 14. Contacts to the driver's knee bolster

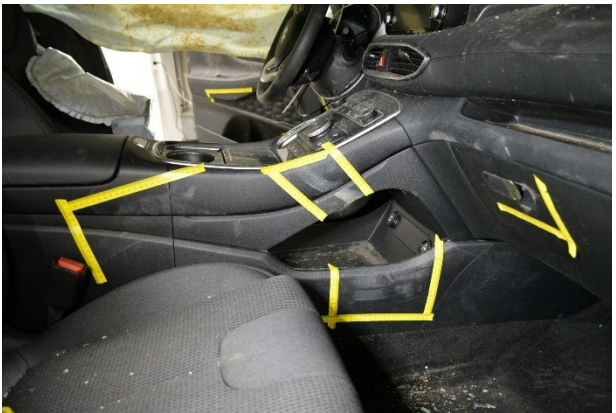
Figure 15. Front passenger's contacts

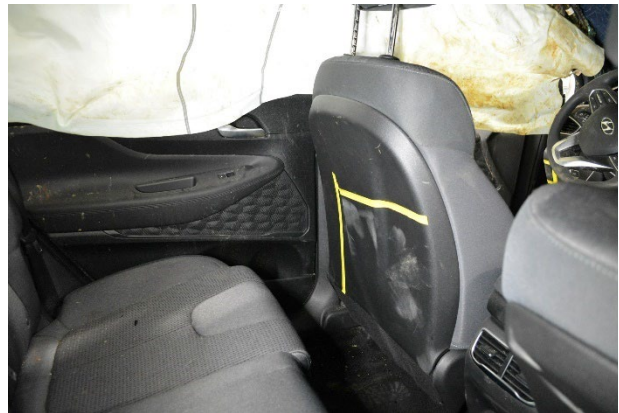
Figure 16. Left rear passenger's contacts

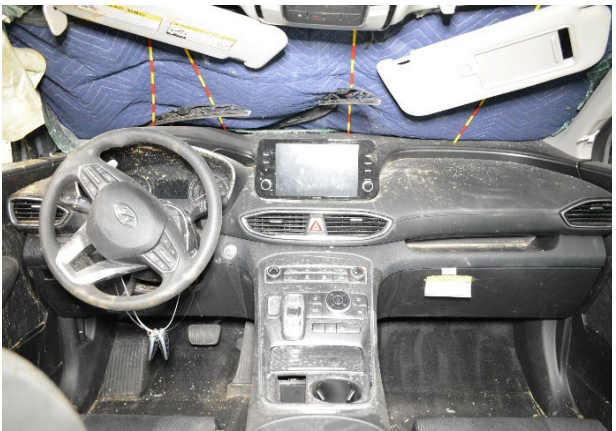
Figure 17. Overview of crush to the first row

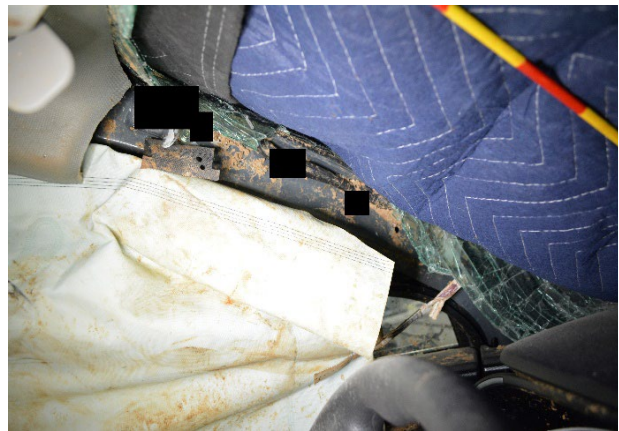
Figure 18. Debris on the driver's A-pillar

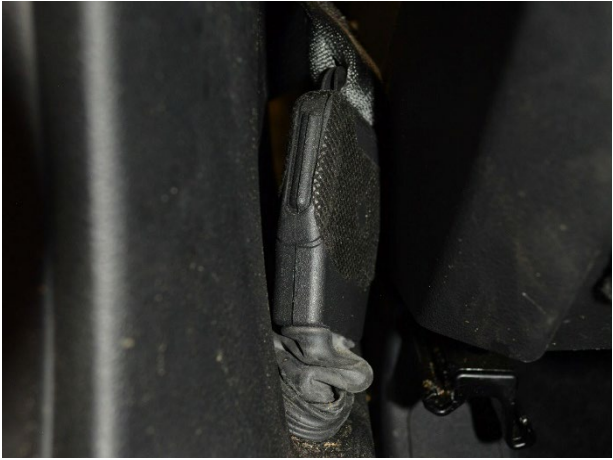
crash. The Hyundai had retractor and lower anchor pretensioners for both front positions (Figures 19 and 20) that had actuated.

Figure 19. Driver's actuated anchor pretensioner

At the time of the SCI inspection, it was observed that the driver's seat belt had been cut post-crash by EMS personnel. The cut webbing edges were consistent with being cut while under occupant loading. The webbing and latch plate showed signs of frictional abrasion from occupant loading during the crash events.

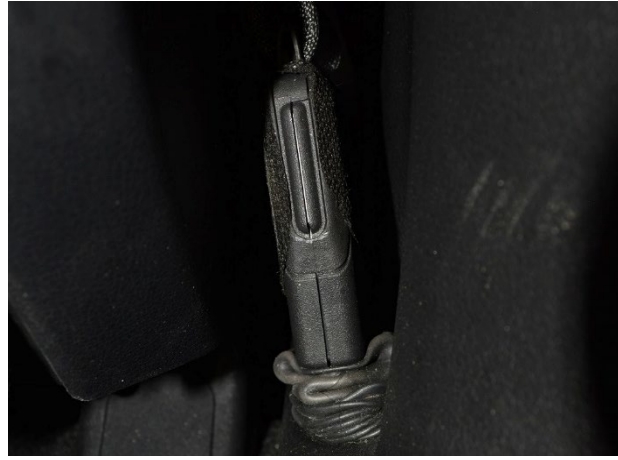
Figure 20. Front passenger's actuated anchor pretensioner

The front passenger's seat belt was found with the retractor locked and hanging loose from the D-ring. There was nothing remarkable about the seat belt. Friction burns in the webbing polymer were found on the latch plate.

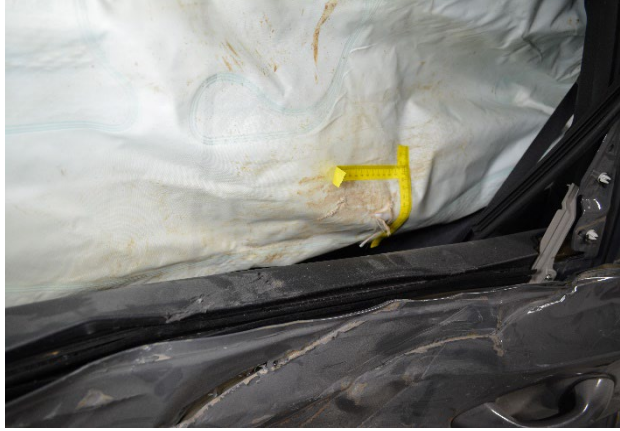
The Hyundai had dual-stage driver's and passenger's frontal air bags, outboard seat-mounted side impact air bags, and IC air bags. Both outboard seat-mounted side impact air bags and both IC air bags deployed as a result of the crash forces. The frontal air bags did not deploy. At the time of the SCI investigation, it was observed that the left IC air bag that deployed for seating position 11-21 had been penetrated by one of the cable barrier posts in the left rear seating position. There was a deep gouge along the sill of the left door that aligned with the puncture (Figure 21). The puncture did not appear to affect the performance of the air bag, although inflation would have been reduced over time.

Figure 21. Exterior view of the left rear passenger's IC
