**Special Crash Investigations:  
Remote Move-Over-Law Crash  
Investigation;  
Vehicle: 2015 Ram  
5500/Nonmotorist;  
Location: Colorado;  
Crash Date: July 2021**

**Special Crash Investigations**  
**Remote Move-Over-Law Crash Investigation**  
**Case No. DS22001**  
**Vehicle: 2015 Ram 5500/Nonmotorist**  
**Location: Colorado**  
**Crash Date: July 2021**

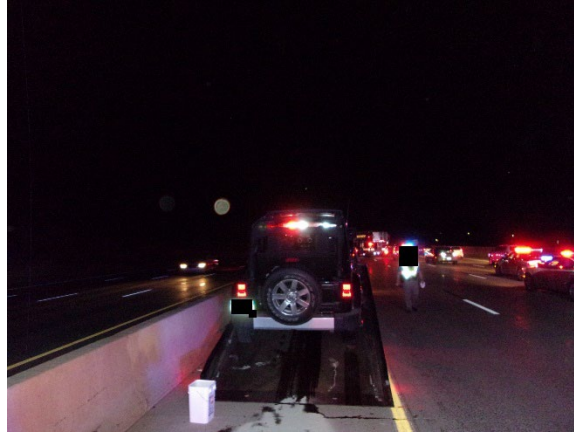
Prior to this crash, the disabled Jeep was parked on the southbound left shoulder. The Ram 5500 driver responded and parked the tow truck on the left shoulder with its emergency lights activated, which included a tow bed-mounted LED light bar with rear-facing red, amber, and white lamps; tow bed amber marker lights; roof mounted amber lights; and headlight/running lights. Additionally, the lights for the disabled Jeep were illuminated. The tow truck driver exited the Ram 5500 and began recovering the disabled Jeep. He was wearing a black work vest with vertical silver reflective stripes, black shirt, dark-blue jeans, and black and gray work gloves. The rollback bed was deployed and the Jeep was partially loaded (Figure 4).

*Figure 4. Loaded disabled Jeep, looking south (police photo)*

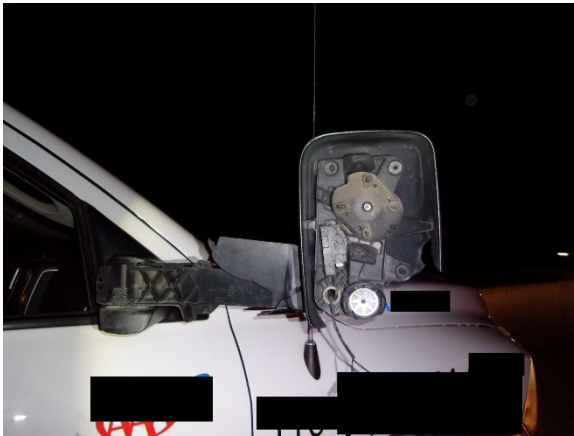
The Ram 5500 sustained minor damage to its right mirror from the impact with the Ram 1500's left mirror (Figures 5 and 6). The truck deformation classification was 06RPGN2.<sup>3</sup>

*Figure 5. Damage to the Ram 5500's right mirror (police photo)*

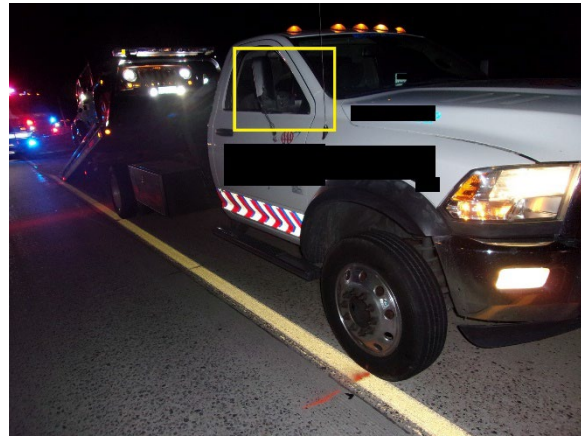
*Figure 6. Oblique view of damage to the Ram 5500's right mirror (police photo)*

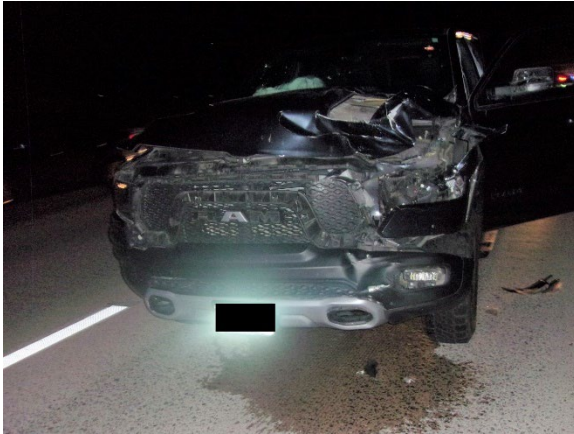
The Ram 1500 sustained moderate front-plane damage from the impact with the tow truck driver (Figure 7). The damage began at the left-front bumper corner and extended to the right. There was damage to the hood that appeared to be wrapping type damage from the impact with the tow truck driver's head and torso. The collision deformation classification was 12FYEW1. (CDC)<sup>4</sup> The vehicle sustained minor damage to the left mirror and side glass from the impact with the Ram 5500's right mirror (Figure 8). The CDC was 12LPGN2.

*Figure 7. Front-plane damage to the Ram 1500 from impact with tow truck driver (police photo)*

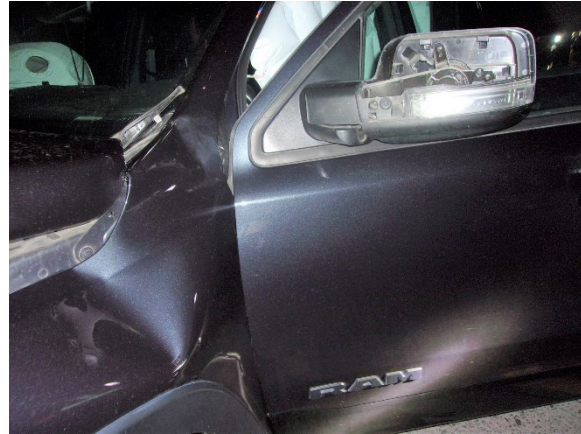
*Figure 8. Impact damage to the Ram 1500's left mirror (police photo)*
