DOT HS 813 638

**Special Crash Investigations:  
Remote Move-Over-Law Crash  
Investigation;  
Vehicle: 2017 Dodge Charger  
Pursuit;  
Location: Colorado;  
Crash Date: May 2021**

**Special Crash Investigations**  
**Remote Move-Over-Law Crash Investigation**  
**Case No. DS22008**  
**Vehicle: 2017 Dodge Charger Pursuit**  
**Location: Colorado**  
**Crash Date: May 2021**

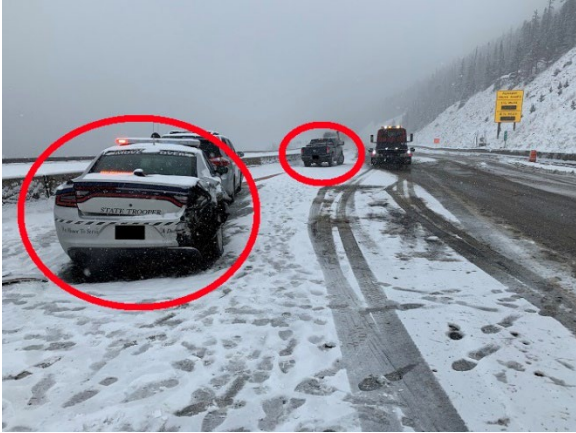
The crash occurred in the morning in May 2021 in the westbound lanes of a divided east/west Interstate highway in Colorado (Figure 1). The vehicles involved were a 2020 Ram 2500 and a fully marked 2017 Dodge Charger Pursuit State Patrol vehicle (Figure 2). The crash occurred at the site of a prior crash involving a Toyota Sienna of an unknown model year. Conditions were daylight, cloudy, and snowing with ice and snow accumulation covering the roadway and lane lines. The westbound roadway had three southbound lanes and a concrete Jersey barrier divided the eastbound and westbound roadways. The posted speed limit was 80 km/h (50 mph).

*Figure 1. Crash site looking west, 2017  
Dodge Charger Pursuit in foreground, 2020  
Ram 2500 in background (police photo)*

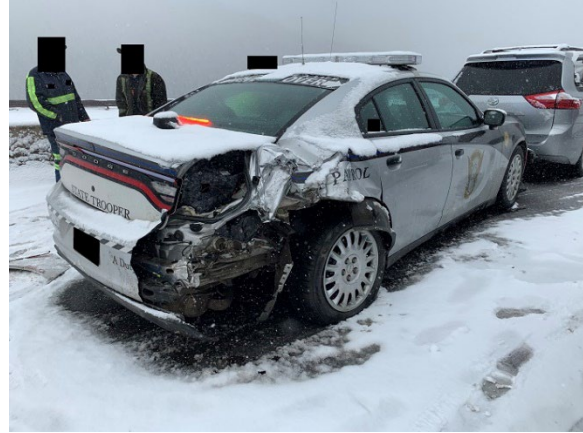
*Figure 2. 2017 Dodge Charger Pursuit  
looking southwest (police photo)*

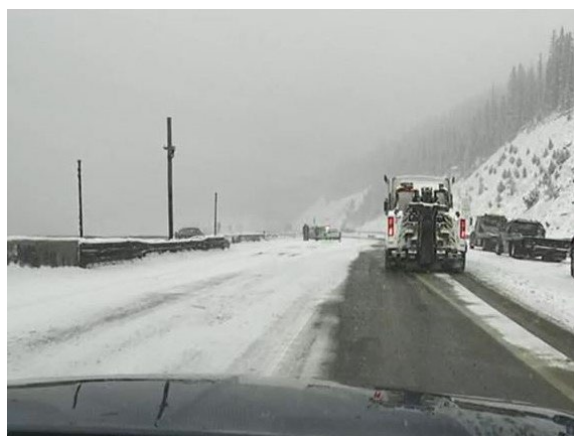
*Figure 3. Crash site looking west from the Ram's pre-crash approach (police dashcam snapshot)*

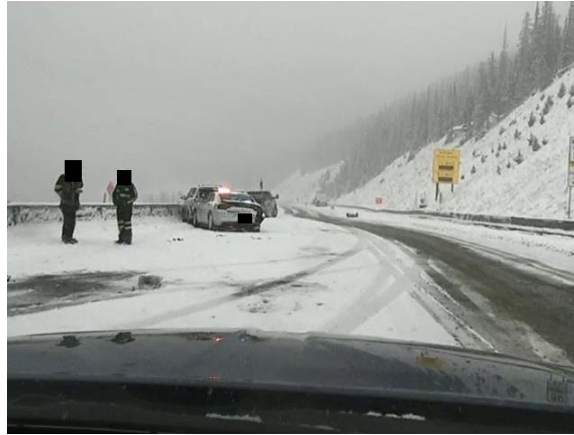
The Ram's left plane struck the Dodge's back plane (Event 1) (Figure 4). A police diagram showed the area of impact was in the middle lane, approximately 6 m (19.6 ft) north of the concrete barrier. Impact forces pushed the Dodge approximately 6 m (19.6 ft) west where it came to rest facing west in the left lane just behind the Toyota Sienna. The Ram traveled westbound for approximately 30 m (98.4 ft) and came to rest facing west in the left lane. No secondary impacts to vehicles or nonmotorists occurred following the vehicle-to-vehicle impact.

*Figure 4. Area of impact (Event 1) looking west (police dashcam snapshot)*

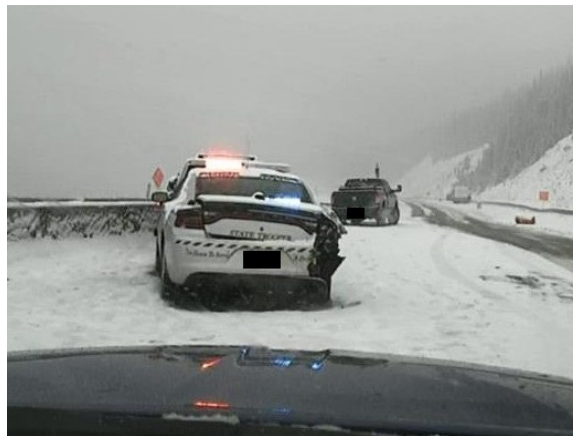
The Dodge Charger Pursuit was a fully marked State Patrol vehicle with several emergency lighting features. The police report said the Dodge was parked “with emergency lights activated protecting a crash scene ahead.” On-scene police photos and a dashcam video from a responding police officer’s vehicle captured the Dodge at final rest with its emergency lighting activated (Figure 5). The vehicle had an unknown brand and model roof-mounted LED light bar with red, white, and blue lights. At the time of the crash, the roof-mounted light bar had flashing rear-facing red lamps and forward-facing blue lights activated. The vehicle had a rear dash-mounted light bar with red and blue LED lights that was flashing red on the left side and blue on the right side. It had rear-facing white LED lights integrated into the taillight ribbon on the trunk that were activated. The vehicle’s 4-way amber-colored flashers were not activated. The Dodge had black and white reflective tape distributed across the back bumper.

*Figure 5. Rear-facing emergency lighting, roof (red) and rear dash (blue) light bars, 2017 Dodge Charger looking west (police dashcam snapshot)*

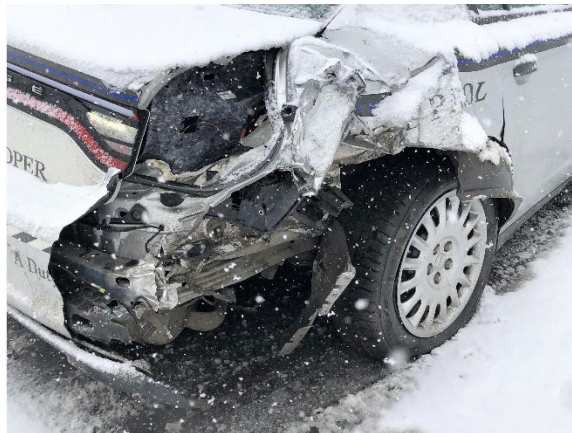
The Dodge had direct and induced damage to the back and right planes. The back plane sustained direct damage in the right sector, bumper corner area. The impact appeared to have been a narrow corner engagement with direct damage extending forward on the right plane from the back right bumper corner to the trailing edge of the right-rear wheel well. The right taillight was missing, and the right aspect of the back bumper fascia was fractured and missing. The right-rear quarter-panel was crumpled forward and the right-rear wheel appeared to have been displaced forward in a restricted position. The estimated collision deformation classification (CDC) for the Dodge in Event 1 was 06BREE6 (Figure 6).

*Figure 6. Vehicle damage, 2017 Dodge Charger (police photo)*

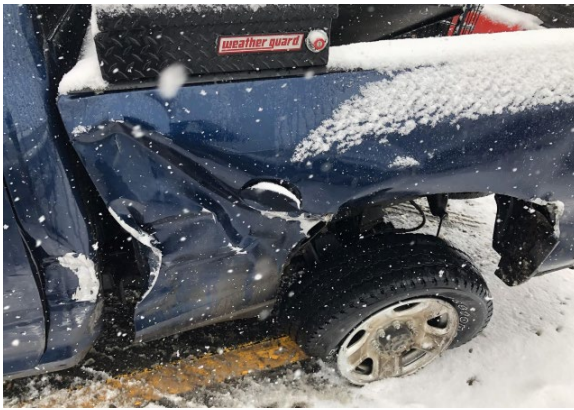
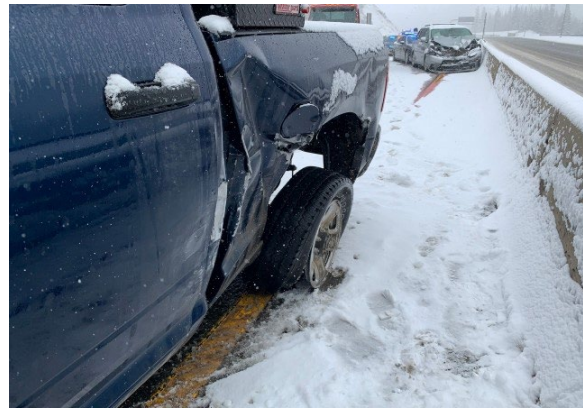
The Ram had minor severity crush to the left plane (Figures 7 and 8). Direct damage extended from the back bumper corner to the second-row door just forward of the C-pillar. Vertically, damage extended from the frame to the cargo bed's top edge. The left-rear wheel was fractured and the tire was cut and de-beaded. The estimated CDC for the Ram in Event 1 was 11LZEW2.

*Figure 7. Left plane damage, 2020 Ram 2500 (police photo)*

*Figure 8. Left plane damage, 2020 Ram 2500 (police photo)*
