**Special Crash Investigations:  
Remote Move-Over-Law Crash  
Investigation;  
Vehicle: 2018 Pierce Fire Truck;  
Location: Colorado;  
Crash Date: January 2022**

**Special Crash Investigations**  
**Remote Move-Over-Law Crash Investigation**  
**Case No. DS22006**  
**Vehicle: 2018 Pierce Fire Truck**  
**Location: Colorado**  
**Crash Date: January 2022**

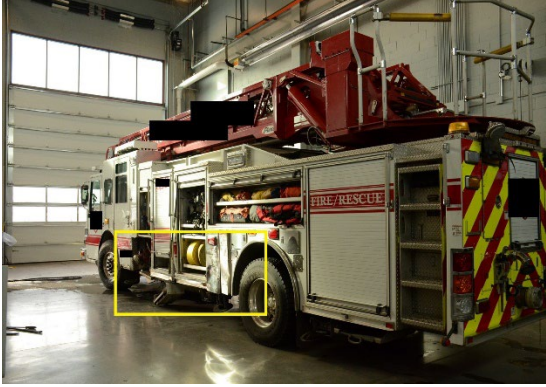
*Figure 1. Struck vehicle, 2018 Pierce Manufacturing aerial fire truck, damaged area highlighted in yellow (fire department photo)*

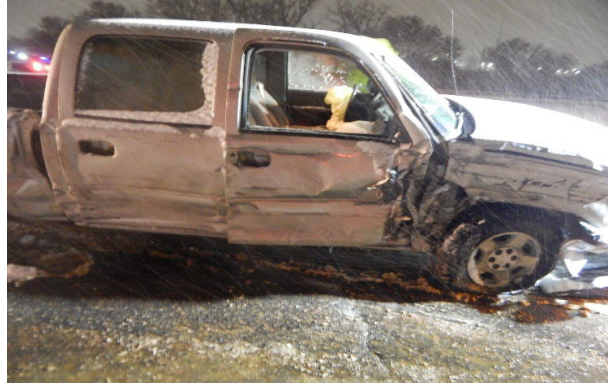
*Figure 2. Striking vehicle, 2005 Chevrolet*

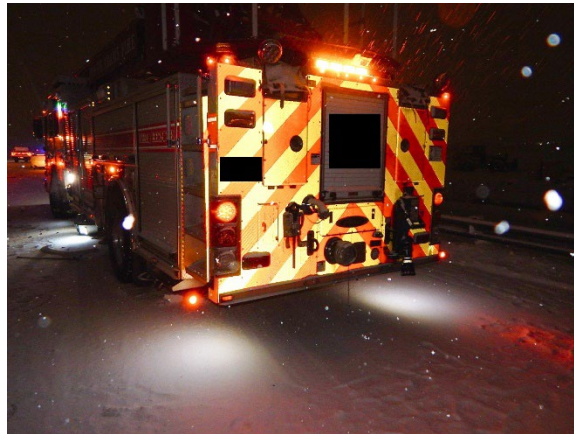
The Pierce had emergency lights visible from the rear (Figure 4), including: an amber and red center mounted LED traffic directing light; dual white LED deck lights; dual white scene lights; red LED marker lights; and LED light sets with stop, tail, and backup and directional lights in a common bezel. The front and side emergency and running lights were activated.

*Figure 4. 2018 Pierce fire truck rear lighting (fire department photo)*

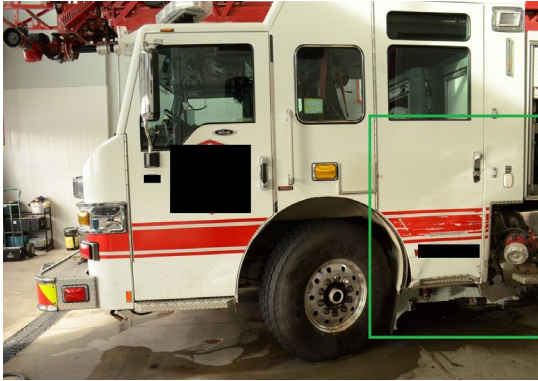
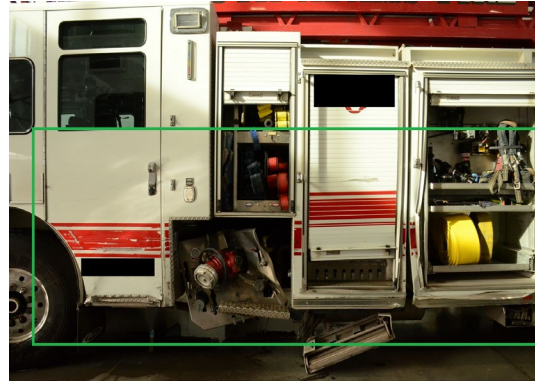
*Figure 5. 2018 Pierce fire truck left-plane damage (fire department photo)*

*Figure 6. 2018 Pierce fire truck left-plane damage (fire department photo)*

The Pierce had moderate left-plane damage that included the frame forward of the left-rear wheel, both roll up doors, second-row passenger door, and left-front wheel (Figures 5 and 6). There was also damage to various hydraulic and water piping and controls. The truck deformation classification was 06LZEW2.

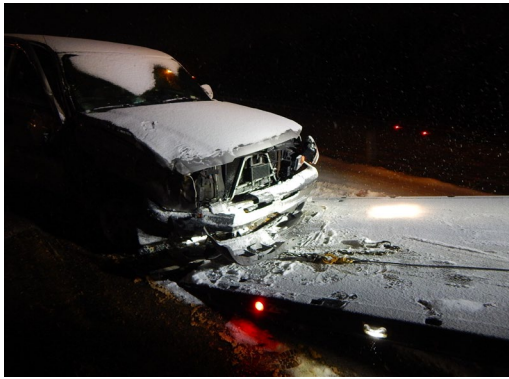
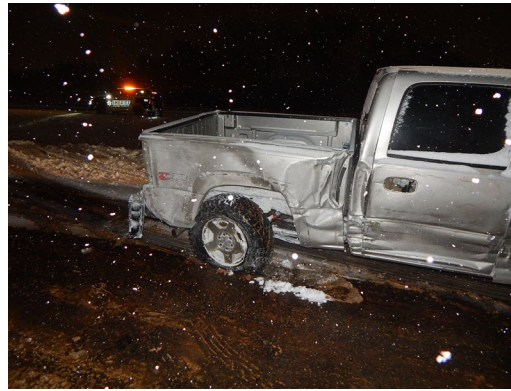
Based on the police report and photos, the Chevrolet had direct damage to the front plane at the right bumper corner. It extended rearward along the right plane (Figures 7 and 8) to the right-front fender, both right doors, and cargo bed. The right-rear wheel was displaced rearward. The collision deformation classification<sup>1</sup> was 12FRAE9.

*Figure 7. 2005 Chevrolet Silverado front-plane damage (fire department photo)*

*Figure 8. 2005 Chevrolet Silverado right-plane damage (fire department photo)*

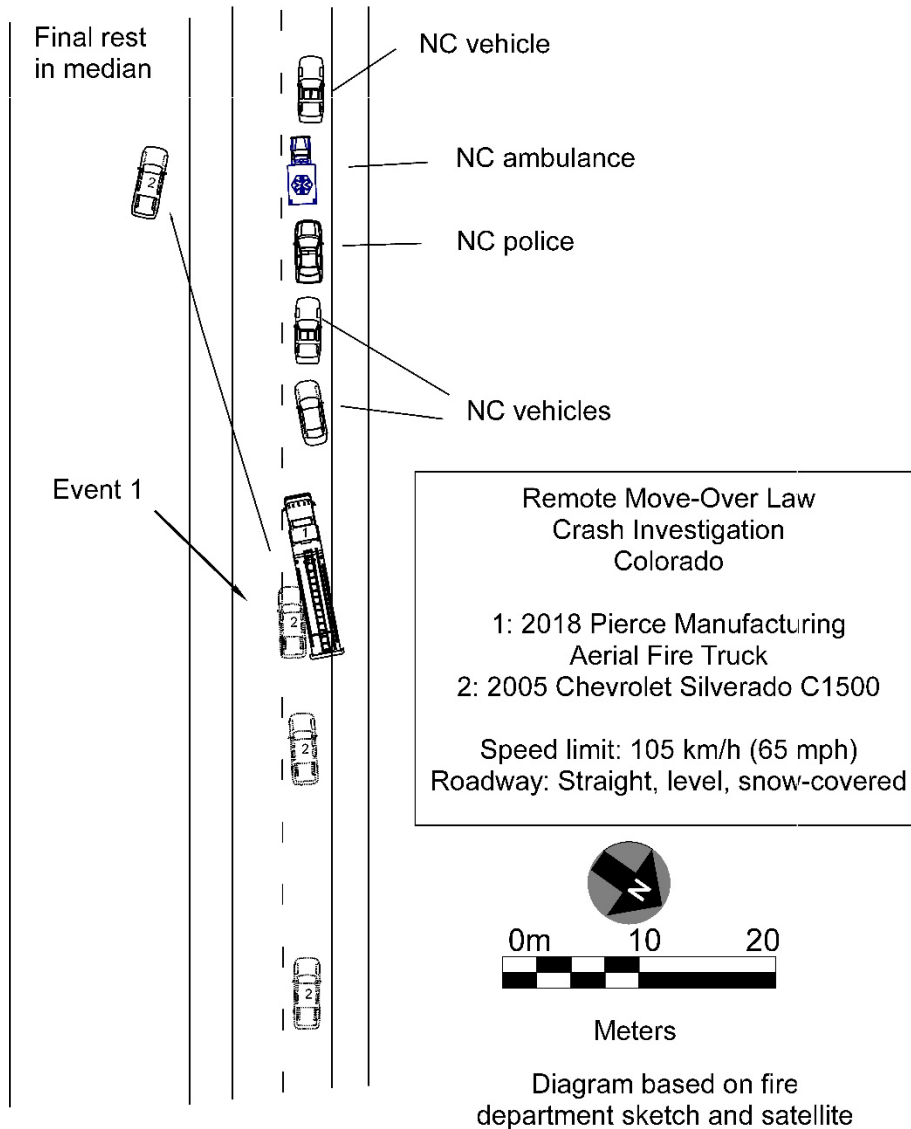
# Crash Diagram

The Chevrolet's front plane struck the Pierce's left plane and displaced it forward. The Chevrolet was displaced to the left, departed the roadway, and came to rest facing west in the grass median.
