DOT HS 813 685

**Special Crash Investigations:  
On-Site Rollover Crash  
Investigation;  
Vehicle: 2018 Jeep Grand  
Cherokee;  
Location: Illinois;  
Crash Date: March 2022**

**Special Crash Investigations**  
**On-Site Rollover Crash Investigation**  
**Case Number: CR22009**  
**Vehicle: 2018 Jeep Grand Cherokee**  
**Location: Illinois**  
**Crash Date: March 2022**

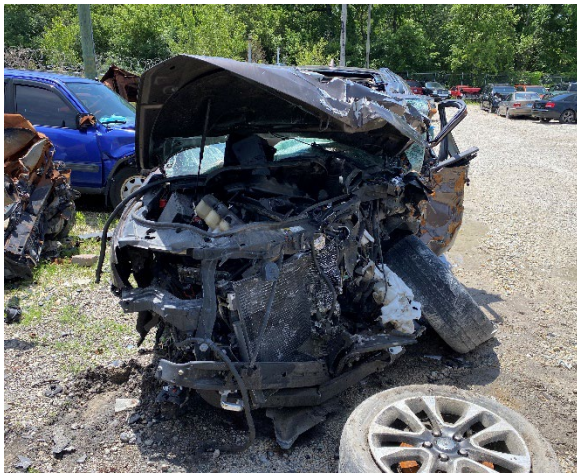
*Figure 1. Front view of the 2018 Jeep Grand Cherokee*

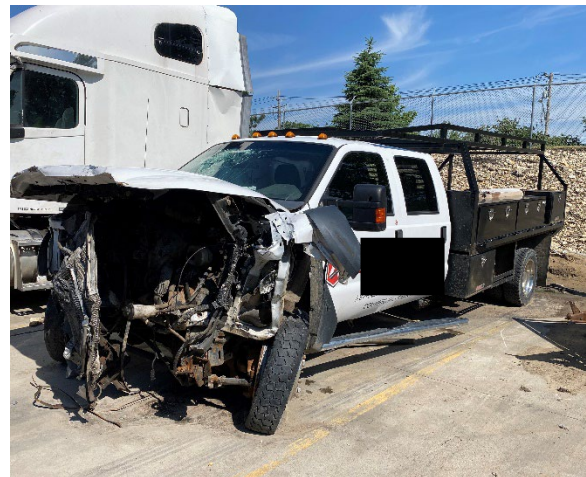
*Figure 2. Left-front oblique view of the 2013 Ford F-450*

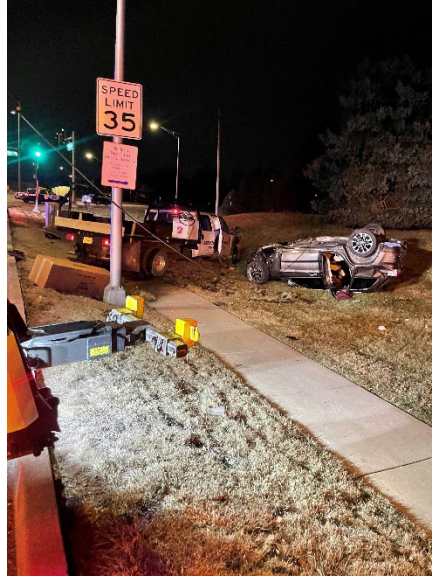
*Figure 4. Southeast view of the Jeep and Ford at final rest. Image provided by local law enforcement*

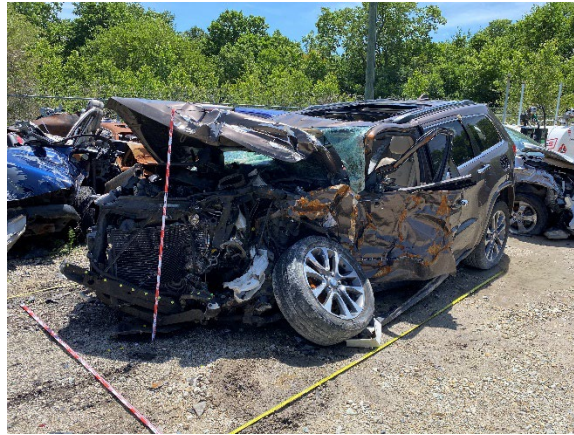
Figure 5. Left-front oblique view of the 2018 Jeep Grand Cherokee

The front plane of the Ford struck the front of the Jeep in an offset configuration (Event 2). The direct contact damage was located 2 cm (0.8 in) left of the front center point extending 72 cm (28.3 in) left. The residual crush at the front bumper reinforcement bar was: C1 = 33 cm (13.0 in), C2 = 36 cm (14.2 in), C3 = 30 cm (11.8 in), C4 = 21 cm (8.3 in), C5 = 0 cm, C6 = 0 cm. Maximum crush was observed to be 56 cm (22.0 in) and was located 24 cm (9.4 in) left of the front-center point. The WinSMASH program provided a Barrier Equivalent Speed (BES) of 34 km/h (21 mph). The reconstruction was borderline, and the results were considered low. The collision deformation classification<sup>1</sup> (CDC) for this damage profile was 12FYEW3.

The curb impact (Event 3) resulted in fracture of the right-front suspension and separation of the right-front wheel assembly. The CDC for this damage profile was 03RFWN1.

Damage from the rollover (Event 4) was noted on the right and top planes, consistent with two-quarter turns. The damage consisted of abrasions on the right and top planes of the vehicle. Overlapping damage was noted to the roof and left A-pillar due to the frontal impact (Event 2). Vertical and lateral crush from the rollover is unknown. The CDC for this damage profile was 00TDDO2.

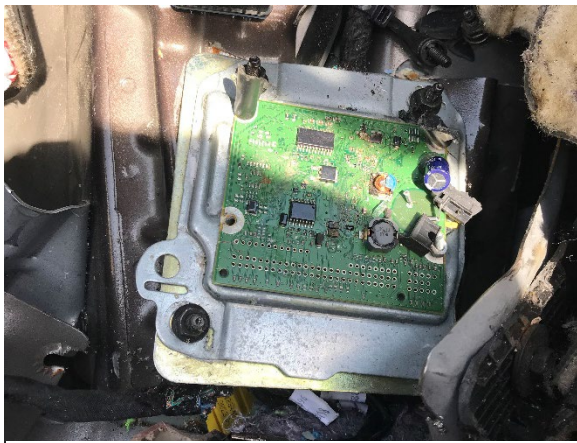
The Jeep had an occupant restraint controller (ORC) that performed the diagnostic, sensing, and deployment command functions for the vehicle's supplemental restraint system. The module had EDR capabilities and was located under the center console rear of the gear shift. The EDR was not able to be imaged due to damage sustained by the module (Figure 6) and the connector during the crash sequence (Figure 7). The module was removed and taken into evidence by local law enforcement prior to the SCI inspection. The investigating officer advised the SCI investigator that they attempted to download the data from the module but were unsuccessful. The investigating officer also stated that they contacted the manufacturer to see if there were any other options to obtain the data from the module and were advised that the damage was too severe to obtain any data.

*Figure 6. View of damage to the Jeep's EDR module. Image provided by local law enforcement*

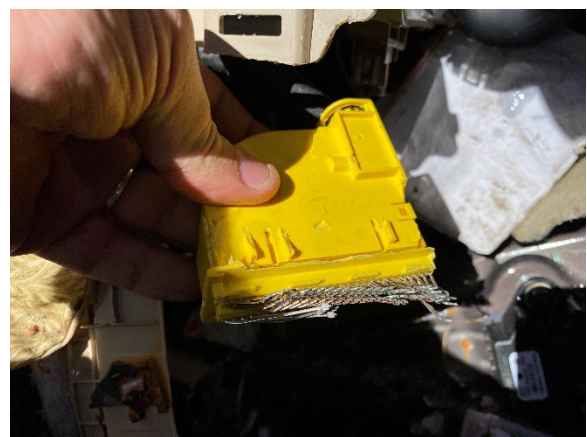
*Figure 7. View of damage to the Jeep's EDR connector cable*

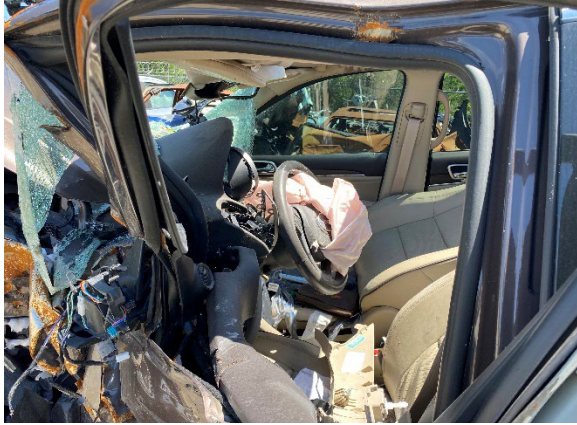
Local law enforcement restricted access to the interior due to pending litigation; therefore, a complete interior inspection could not be obtained. The investigating officer requested the interior components not be manipulated or disturbed. However, images were obtained to assist with the investigation. The Jeep's interior sustained damage (Figures 8 and 9) and intrusion attributed to the frontal impact. The left A-pillar, steering wheel, and left instrument panel all intruded longitudinally an estimated 30 cm (12 in) due to the impact with the Ford. The lower instrument panel/knee bolster intruded to the forward edge of the driver seat cushion. The left A-pillar laterally intruded a visually estimated 25 cm (10 in). Two areas of dried blood were noted at the right sun visor and the right grab handle.

*Figure 8. Lateral view of the Jeep's left A-pillar deformation*

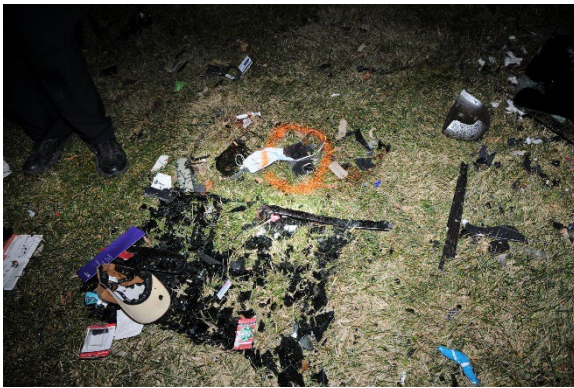
The police on-scene documentation (Figures 10 and 11) showed broken glass where the Jeep came to rest attributed to the sunroof. A contact was noted to a fractured metal support bar from the sunroof. Blood and hair were seen on the sunroof support bar attributed to the driver's head.

*Figure 10. Image of the fractured sunroof glass at the Jeep's final rest location. Image provided by local law enforcement.*

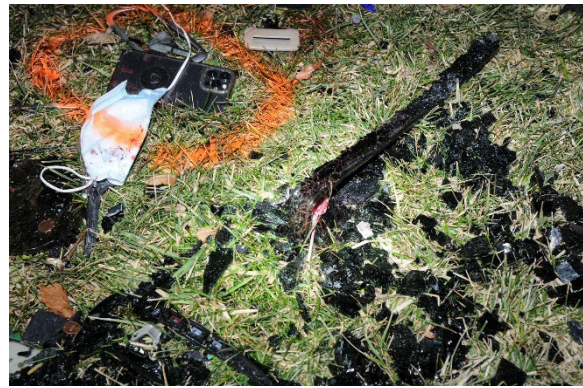
*Figure 11. Close-up view of the Jeep's sunroof metal support bar indicating driver head contact. Image provided by local law enforcement.*

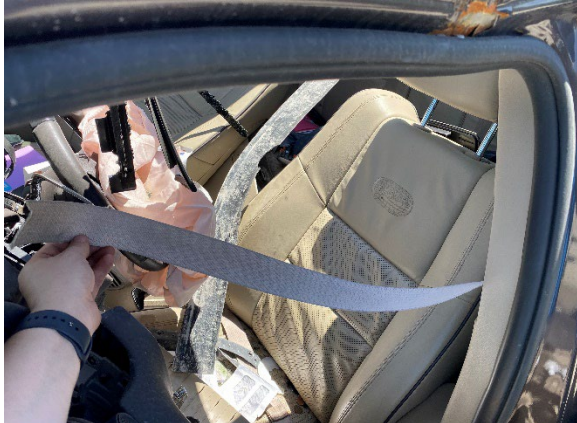
The driver's seat belt (Figures 12 and 13) was cut during extrication. The front passenger's seat belt was extended from the B-pillar but was looped under the seat. Due to the restrictions of not being able to move the seat, a detailed inspection of the front passenger's seat belt was not obtained. It should be noted that during the inspection the belt did not appear to have been cut.

*Figure 12. Overall view of the Jeep driver's seat belt*

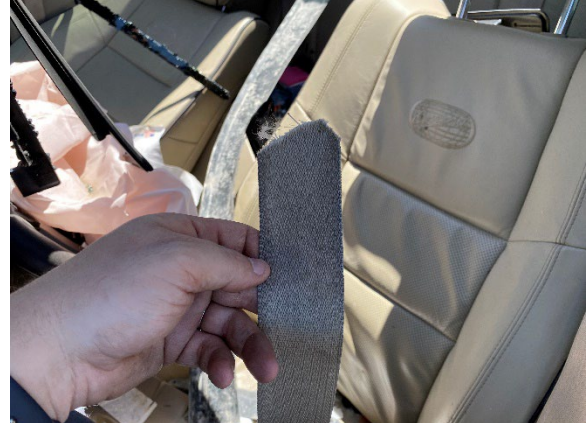
*Figure 13. Close-up view of the extrication cuts of the driver's seat belt in the Jeep*

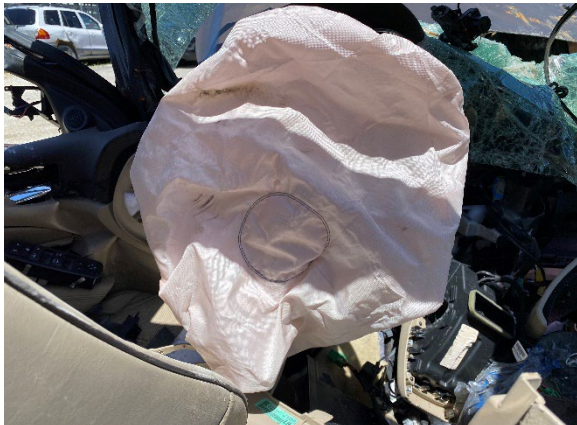
*Figure 14. View of the driver's frontal steering wheel hub-mounted air bag*

The driver's frontal air bag (Figure 14) deployed from the steering wheel hub-mounted module through the cover flaps without damage. It had no contact evidence. The driver knee air bag deployed and did not appear to be damaged. The passenger's frontal air bag (Figure 15) deployed through the cover flaps with no damage. A reddish stain in the center of the air bag was attributed to exposure to the environment.

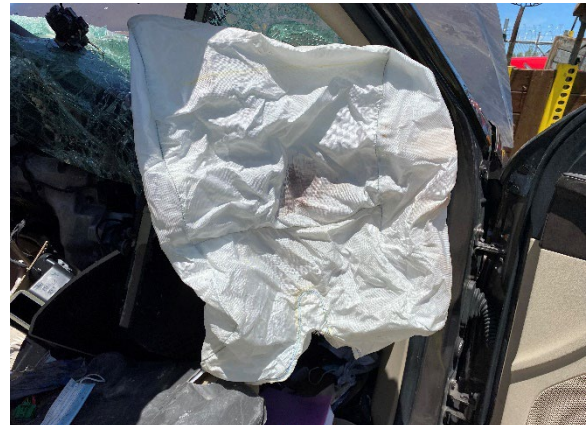
*Figure 15. View of the deployed passenger's frontal air bag*

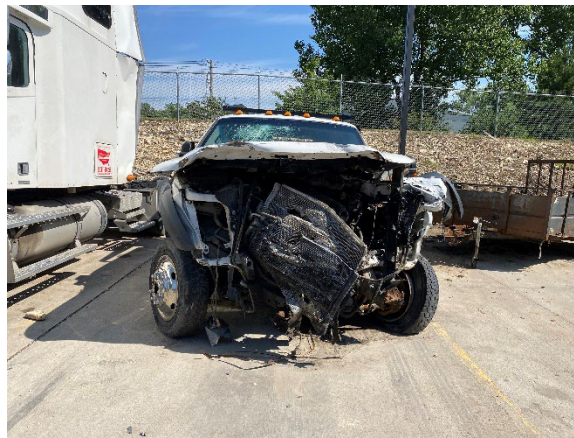
Figure 16. Front view of the 2013 Ford F-450

The sideswipe impact with the Volkswagen resulted in damage overlapped by the impact with the Jeep. This sideswipe damage resulted in the support step rail on the left side of the Ford to come loose. The damage resulted in an estimated TDC of 12FLEE1.

The frontal impact with the Jeep (Event 2) caused the aftermarket bumper guard to separate from the support frame mounts. The direct damage began 70 cm (27.6 in) right of the front center point and extended 60 cm (23.6 in) left. The residual crush at the front bumper reinforcement bar was: C1 = 8 cm (3.1 in), C2 = 4 cm (1.6 in), C3 = 1 cm (0.4 in), C4 = 0 cm, C5 = 0 cm, and C6 = 0 cm. Maximum crush was observed to be 8 cm (3.1 in) at the right-front bumper corner. The damage resulted in an estimated TDC of 01FZEW1.

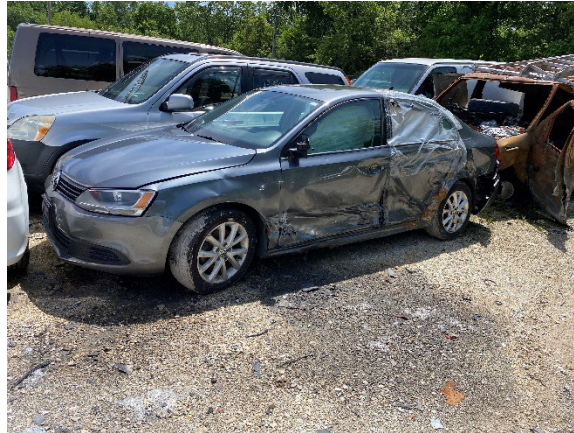
*Figure 17. Front-left oblique view of the 2011 Volkswagen Jetta*

No physical measurements were taken due to time constraints by the local law enforcement agency, but images were obtained. The sideswipe impact with the Ford resulted in damage extending from the left-front fender to the left-rear quarter panel. The damage resulted in an estimated CDC of 12LDES1.
