DOT HS 813 696

# **Special Crash Investigations: On-Site Rollover Crash Investigation; Vehicle: 2008 Cadillac Escalade; Location: California; Crash Date: August 2022**

**Special Crash Investigations  
On-Site Rollover Crash Investigation  
Case Number: DS22020  
Vehicle: 2008 Cadillac Escalade  
Location: California  
Crash Date: August 2022**

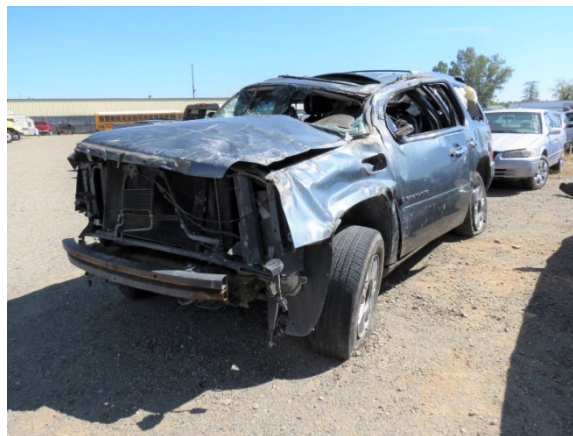
*Figure 1. The 2008 Cadillac Escalade*

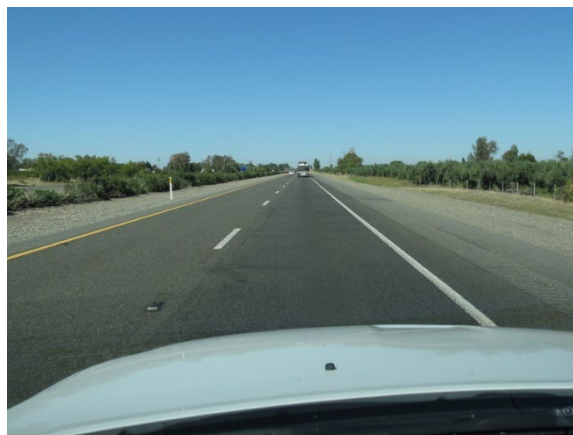
The crash site was the northbound lanes of a two-lane divided Interstate highway in California (Figure 2). The roadway was straight and level. It had two lanes each measuring 3.7 m (12.0 ft) wide separated by a dashed white painted lane line and bordered by a solid white painted edge line on the right and a solid yellow painted edge line on the left. The pavement and painted lines were in good condition. The left roadway edge was bordered by an asphalt shoulder measuring 1.5 m (4.9 ft) wide with a milled-in rumble strip. The paved shoulder was bordered on the left by a gravel center median. The right roadway edge was bordered by an asphalt shoulder measuring 3.7 m (12.1 ft) wide with a milled-in rumble strip. The asphalt shoulder was bordered by a gravel roadside measuring 6.4 m (21.0 ft) wide that had a descending slope of -2.2 percent. It was bordered by an unpaved strip of ground measuring 6.2 m (20.3 ft) wide and a barbed wire fence. The posted speed limit was 113 km/h (70 mph). Conditions at the time of the crash were daylight, clear, and dry. A crash diagram is included at the end of this report.

*Figure 2. The crash site looking north*

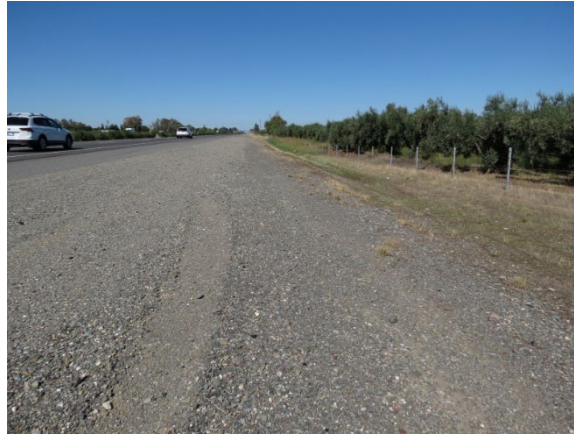
The Cadillac was traveling northbound in the left lane at an EDR-ROS reported speed of 124 km/h (77 mph) at event enable.<sup>2</sup> The focus of the driver's attention prior to the crash was not known. The front passenger later told police the driver may have fallen asleep. The vehicle's left tires traveled onto the center median in a partial departure and deposited tire furrows on the ground as it passed under an overpass. In response to the departure, the driver overcorrected to the right, returning the vehicle to the roadway where its tires deposited yaw marks in the left and right lanes. It continued traveling right and departed the roadway on the right edge. The driver likely steered left in response to this departure and the vehicle initiated a counterclockwise yaw depositing furrows in the gravel shoulder. At the time of the scene inspection, the furrows (Figure 3) measured 13.2 m (43.3 ft) long for the right front tire and 19.5 m (64.0 ft) long for the right rear tire.

*Figure 3. Furrows in gravel leading to trip rollover, looking north on the roadside*

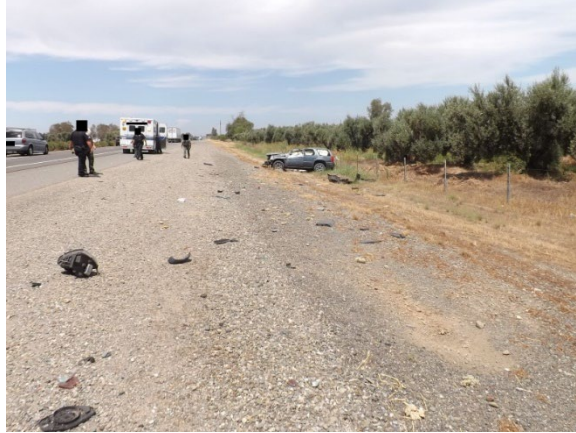
The rollover was the only crash event. The Cadillac rotated in a counterclockwise yaw until its right-side tires dug into the ground with sufficient opposing lateral force to cause a right-side-leading trip rollover (Event 1). It rolled about its longitudinal axis for eight quarter turns and came to rest facing west and upright (Figure 4). Disintegrated glass from the roof, side windows, and backlight were deposited in a debris field measuring 24 m (79 ft) long in the rollover path. The estimated roll distance was 44 m (144 ft). The left and right IC air bags deployed during the rollover event. According to EDR-ROS data, time from algorithm enable to deployment command criteria met was 637.5 ms and time from rollover event enable to deployment was 4,360 ms. Added together, time from algorithm enable to deployment was 4,997.5 ms. Based on the time sequence, vehicle speed, and distance traveled, it appears algorithm enable occurred at the left-side road departure, and deployment occurred when the vehicle tripped right-side leading. The unbelted driver was fully ejected during the rollover, most likely through the closed left side glass of the front row. Based on police photos, the driver came to rest on the ground approximately 2 m (6 ft) north of the Cadillac's at-rest location.

*Figure 4. Debris field and rollover path to final rest looking north, the 2008 Cadillac Escalade (police photo)*

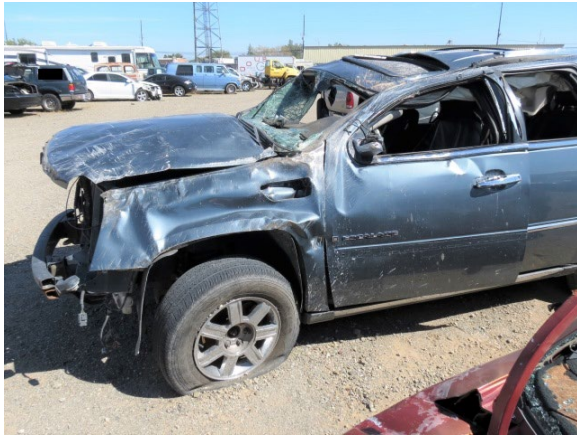
During the rollover, the vehicle's right rear tire and wheel struck the ground causing the wheel to fracture. All four tires were de-beaded, and all glazing was fractured or disintegrated. The greenhouse was crushed laterally and vertically. The left side view mirror was broken off entirely and the right one was fractured and hanging by wires. The rollover caused direct and induced damage to the right, left, and top planes (Figures 5 and 6). The front grille and bumper fascia were displaced as a single component. Direct damage to the roof extended laterally from roof side rail to roof side rail and measured 140 cm (55.1 in); it extended longitudinally beginning at the windshield header and ending near the left D-pillar. The OEM roof rack was fractured, bent, and some trim was missing. The moon roof glass was disintegrated. The hood was crushed and scraped. Direct damage to the left plane of the greenhouse began at the left A-pillar and extended rearward to the left C-pillar. Maximum vertical crush was located on the left roof at 110 cm (43.3 in) aft of the left front axle and measured 24 cm (9.4 in). Maximum lateral crush was located on the left roof side rail at 127 cm (50.0 in) aft of the left front axle and measured 15 cm (5.9 in). The collision deformation classification for the Cadillac in Event 1 was 00TDDO3.

*Figure 5. Rollover damage, left and top planes, the 2008 Cadillac Escalade*

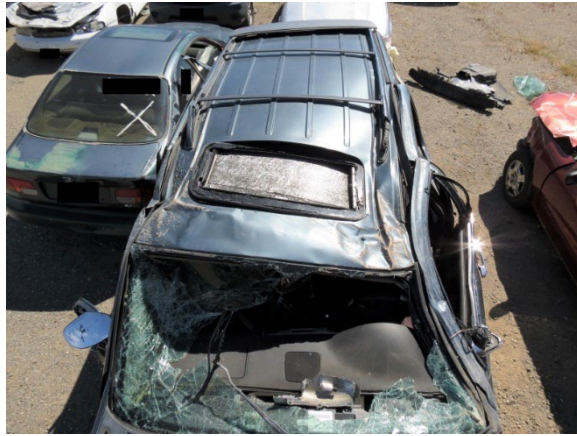
*Figure 6. Rollover damage, top plane, the 2008 Cadillac Escalade*

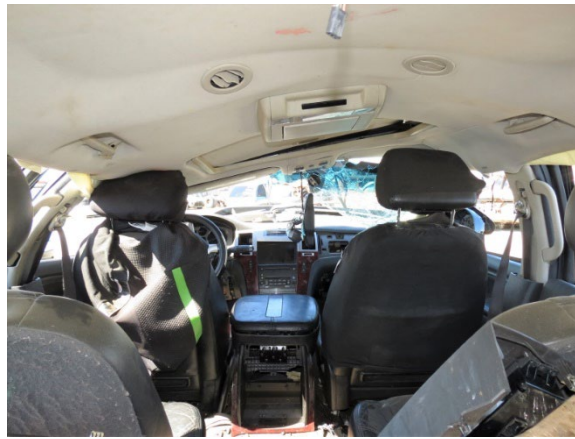
The Cadillac had interior damage caused by impact forces, air bag deployments, and post-crash activities. The windshield was fractured and holed, and all other glazing was disintegrated. The right-side doors were jammed shut. Trim was missing from the lower left instrument panel and the front-row D-rings. The rear-view mirror was hanging by electrical wires and trim pieces from the roof header were missing. The left and right IC air bags were deployed. The front row had vertical intrusion at the left windshield header (17 cm [6.7 in]); middle windshield header (7 cm [2.8 in]); left roof (22 cm [8.7 in]); middle roof (10 cm [3.9 in]); left roof side rail (22 cm [8.7 in]); and right roof side rail (7 cm [2.8 in]) (Figure 7). The second row had vertical intrusion at the left roof (13 cm [5.1 in]), and middle roof (3 cm [1.2 in]). The driver's head restraint was

bent downward and forward by roof intrusion. Possible driver contacts were identified on the left roof above the driver's seat, the left sun visor, and the left IC air bag.

*Figure 7. Vertical intrusion, the 2008 Cadillac Escalade*

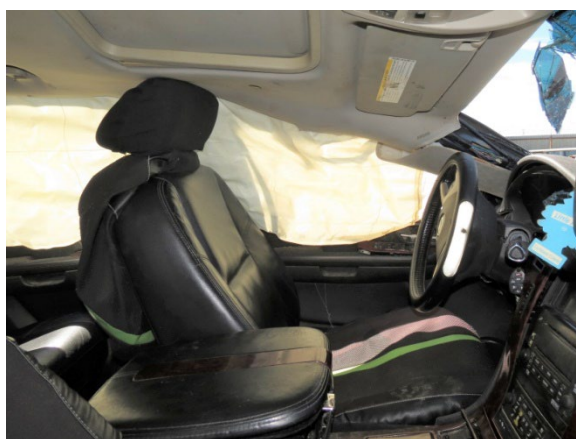
The left and right IC air bags deployed during the rollover event. According to EDR-ROS data, time from algorithm enable to deployment command criteria met was 637.5 ms and time from rollover event enable to deployment was 4,360 ms. Added together, time from algorithm enable to deployment was 4,997.5 ms. Based on the time sequence, vehicle speed, and distance traveled, it appears algorithm enable occurred at the left-side road departure and deployment occurred when the vehicle tripped right-side leading. The IC air bags deployed from the roof side rails above the front and second rows (Figure 8). Another set of IC air bags deployed from roof side rails above the third row. The left IC air bag was likely contacted by the driver during the rollover. It had what appeared to be a blood deposit at the bottom edge of the sail. According to the vehicle owner's manual, in a rollover event, IC air bag deployment is determined by the direction of the roll.

*Figure 8. Deployed left IC air bag, the 2008 Cadillac Escalade*
