DOT HS 813 698

# **Special Crash Investigations: On-Site Rollover Crash Investigation; Vehicle: 2019 Lexus NX300; Location: North Carolina; Date: May 2022**

**Special Crash Investigations**  
**On-Site Rollover Crash Investigation**  
**Case Number: CR22013**  
**Vehicle: 2019 Lexus NX300**  
**Location: North Carolina**  
**Crash Date: May 2022**

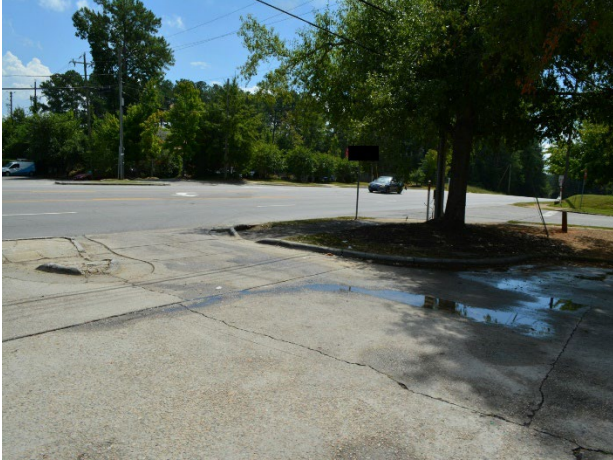
*Figure 4. Facing southeast toward the south curb in Event 4*

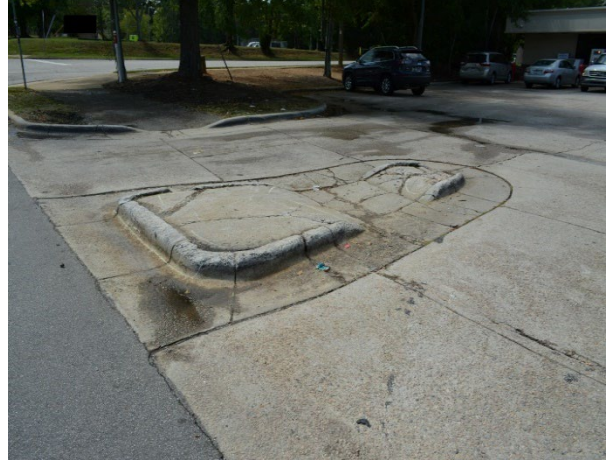
The Hyundai was displaced laterally to its left by the Event 1 impact. Its left side tires contacted the curbed gore area of the service station driveway (Figure 5) and tripped the vehicle into a left-side-leading rollover (Event 2). The Hyundai rolled across the gore and into the south aspect of the driveway where it came to rest on its roof approximately 10 m (33 ft) southwest of the initial impact.

*Figure 5. Facing southwest towards the tripping point of the Hyundai Event 2*

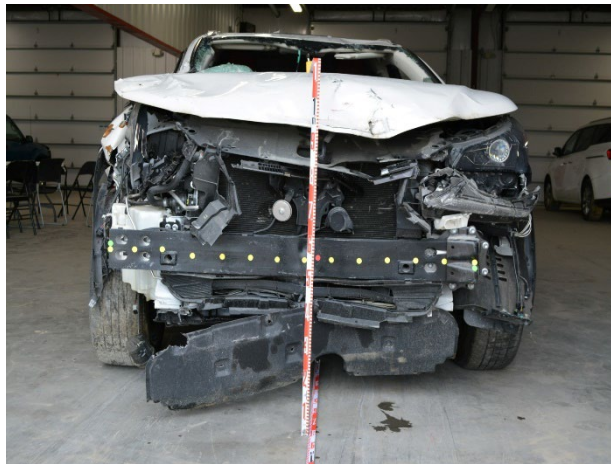
The Lexus sustained damage to the front (Event 1), left, right, and top planes from the interrupted subsequent rollover (Events 3 and 4). The frontal damage was distributed across the front plane with a direct contact length of 127 cm (50.0 in) that extended from corner-to-corner. The bumper fascia was fractured and partially separated. The outer aspects were removed to access the bumper reinforcement bar for accurate documentation of the residual crush (Figure 7). The Field L, measured along the bumper reinforcement bar, was 126 cm (49.6 in). The residual crush was measured with a total station and the resultant profile was: C1 = 6 cm (2.4 in), C2 = 18 cm (7.1 in), C3 = 29 cm (11.4 in), C4 = 27 cm (10.6 in), C5 = 22 cm (8.7 in), C6 = 19 cm (7.5 in). The maximum crush of 29 cm (11.4 in) was at the C3 position.

*Figure 7. Damage to the front of the Lexus from SCI Event 1*

For comparative purposes, the severity of the impact was calculated by the missing vehicle algorithm of the WinSMASH program. The total change in velocity (delta V) was 42 km/h (26.1 mph). The longitudinal and lateral components were -41 km/h (-25.5 mph) and 7 km/h (4.3 mph). The calculated result was considered borderline reconstruction due to missing damage information for the Hyundai. The collision deformation classification<sup>1</sup> (CDC) assigned to this damage pattern for Event 1 was 12FDEW2.

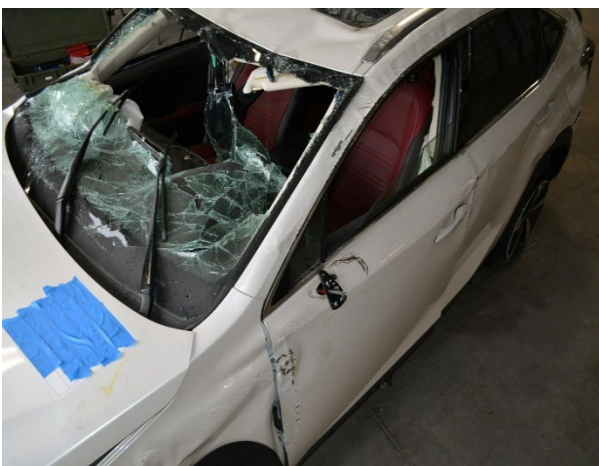
The rollover events (Events 3 and 4) produced damage to the left, top, and right planes. The left plane damage had abrasions and isolated dents and deformation along the full-length of the vehicle that extended onto the left roof side rail (Figure 8). The top plane damage was limited to the leading edge of the hood and the roof between the header and the sunroof. Minimal intrusion occurred at the level of the windshield header. This Event 3 was assigned a CDC of 00TDDO2.

*Figure 8. Damage to the left and top plane during Event 3*

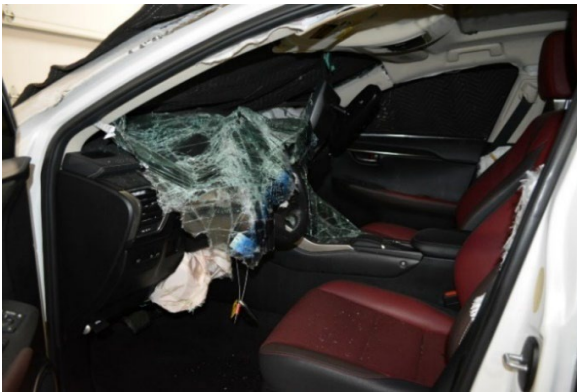
The interior of the Lexus sustained minor severity damage associated with deployment of several air bag systems, occupant contact, seat belt loading, passenger compartment intrusion, and post-crash windshield collapse (Figures 10 and 11). The maximum intrusion was located at the front passenger's A-pillar with 4 cm (1.5 in) vertically and 3 cm (1.1 in) laterally (Figure 12). The windshield header was also intruded 1 cm (0.3 in) vertically at a location 23 cm (9.1 in) right of the left A-pillar/header junction. There was a contact to the windshield located left of the rearview mirror. The driver reported that the small dog that was riding in the rear of the vehicle struck the windshield during the crash events.

*Figure 10. Viewing the first interior row damage*

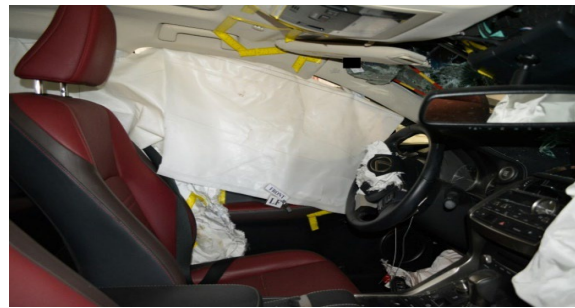
*Figure 11. Contacts/damage to driver seat area*

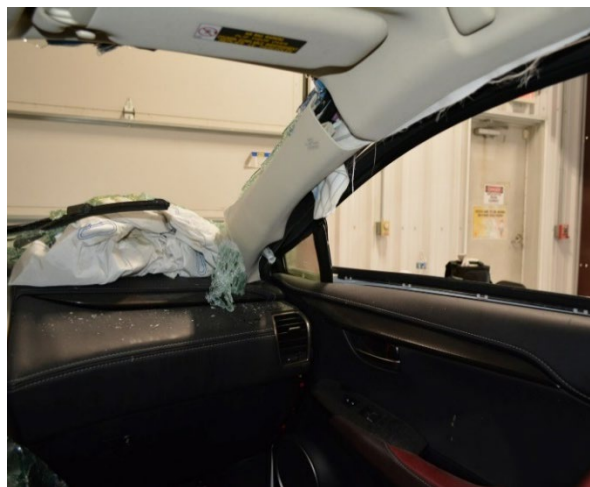
*Figure 12. The intruded right A pillar*

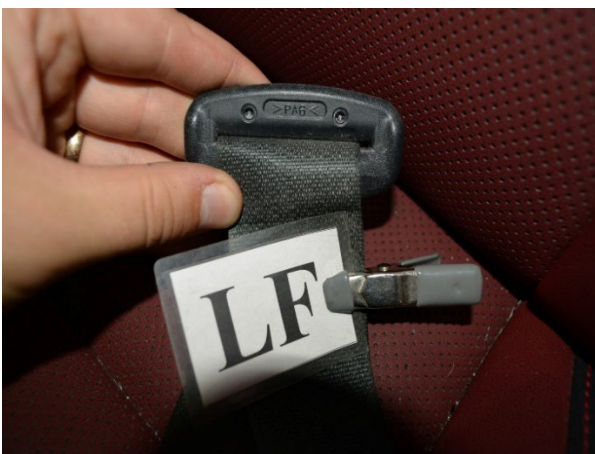
At inspection, the driver's seat belt was locked in the extended/worn position. The driver was wearing the seat belt system evidenced by frictional abrasions on the polymer surface of the latch plate (Figure 13). There was no significant loading evidence of the belt webbing.

*Figure 13. Driver's latch plate with friction burns evidence*

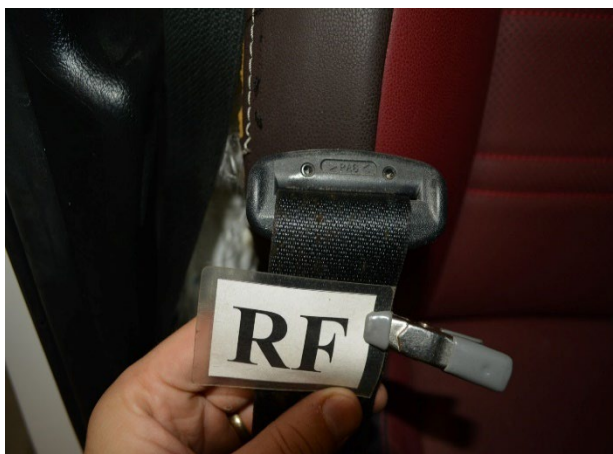
The front passenger was also belted, evidenced by the locked and extended position of the belt webbing due to actuation of the pretensioner (Figure 14). The loading evidence had frictional abrasions on the polymer surface of the latch plate and waffling of the belt webbing.

*Figure 14. Front passenger's latch plate with friction burn evidence*

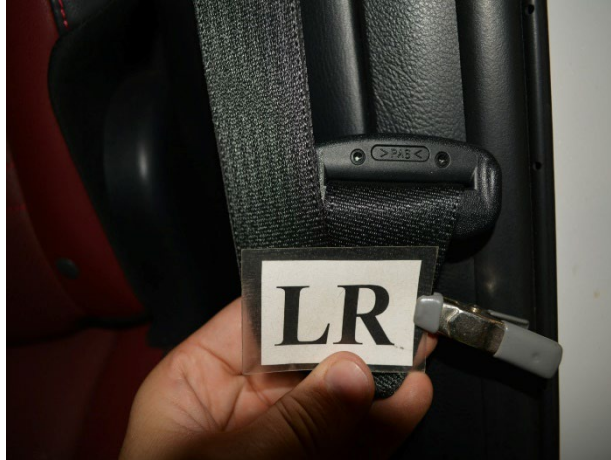
The second-row-left passenger was presumed to have been belted by the three-point seat belt. At inspection, there was no evidence of loading to the belt system (Figure 15). No occupant contacts in her occupant space were present to support an unbelted occupant; however, hair fibers were present along the ceiling and showed that the child possibly contacted the headliner when freed from her restraints. Her mass may have been insufficient to cause residual evidence of seat belt use.

*Figure 15. Left rear passenger's latch plate void of friction evidence*

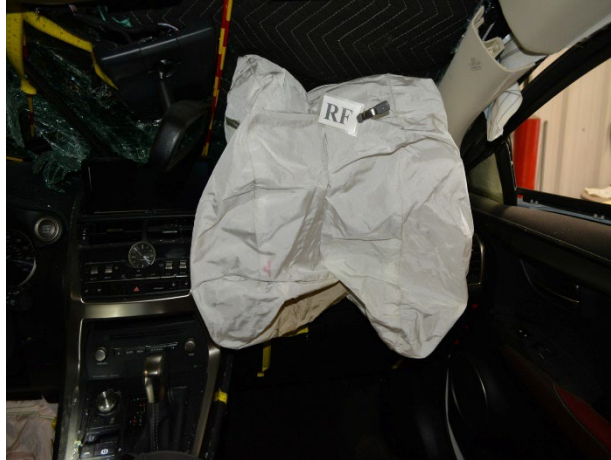
At impact with the Hyundai (Event 1), the front passenger initiated a forward trajectory and loaded the seat belt system and the deployed frontal air bag (Figure 16). During the rollover event (Event 3), he probably contacted the center console, the deployed right IC air bag, and the outboard seat-mounted side-impact air bag. He was transported by ambulance to a level 1 trauma center where he was treated for a driver-reported hip injury and hospitalized for an unknown number of days.

*Figure 16. Passenger's frontal air bag*
