DOT HS 813 718

**Special Crash Investigations:  
On-Site Ambulance Crash  
Investigation;  
Vehicle: 2014 Ford E-350 Type II  
Ambulance;  
Location: Arkansas;  
Crash Date: January 2023**

**Special Crash Investigations**  
**On-Site Ambulance Crash Investigation**  
**SCI Case No: CR23002**  
**Vehicle: 2014 Ford E-350 Type II Ambulance**  
**Location: Arkansas**  
**Crash Date: January 2023**

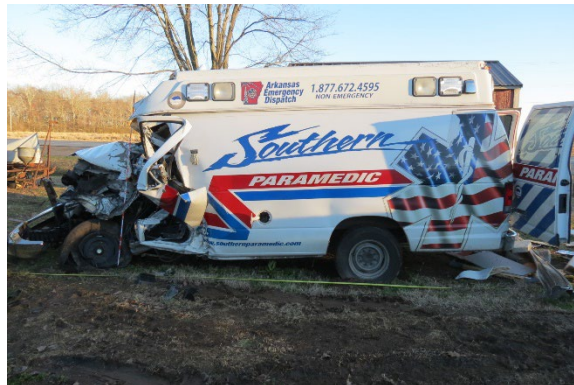
*Figure 1. 2014 Ford E-350 Type II ambulance*

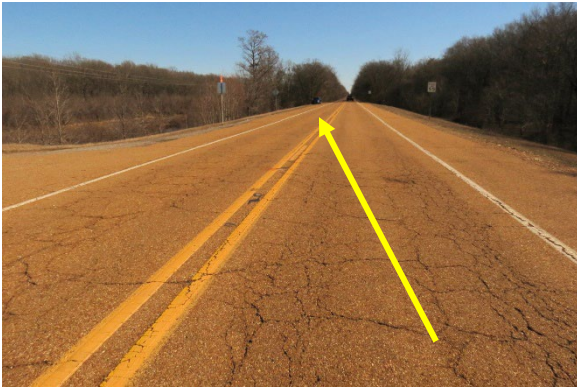
The ambulance was traveling east in its through lane at EDR-reported speeds of 97 km/h (60.3 mph) to 98 km/h (60.9 mph) in the 5 seconds prior to algorithm enable (AE). Forward-looking video provided by the ambulance service showed that the ambulance drifted into the left lane and steered back into the right lane. Six seconds after returning to the right lane, the ambulance drifted into the left lane again (Figure 2) and then continued off the left road edge (Figure 3).

*Figure 2. East view of the travel path off the north road's edge*

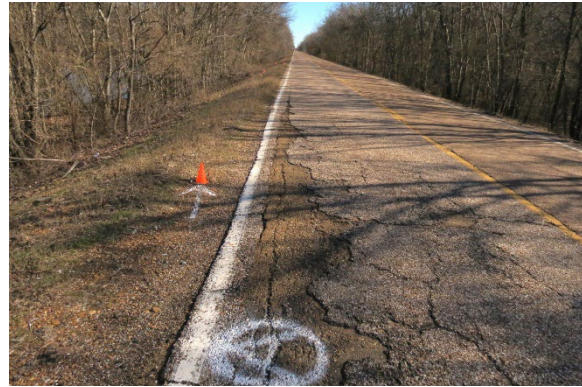
*Figure 3. East view, ambulance's roadway departure*

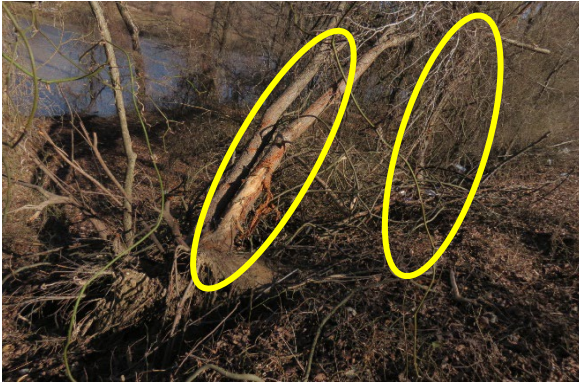
tree (Event 2, Figure 4) that had twin trunks measuring 22 and 24 cm (8.7 and 9.4 in) in diameter. The impact uprooted and displaced the tree forward and caused the ambulance to rotate counterclockwise and roll over, right-side leading, one quarter turn (Event 3). As it rolled over, the windshield header and front roof bulkhead struck a second tree (Event 4, Figure 5), 26 cm (10.2 in) in diameter. The ambulance came to final rest on its right side, facing northeast.

*Figure 4. East view, initial and secondary points of impact*

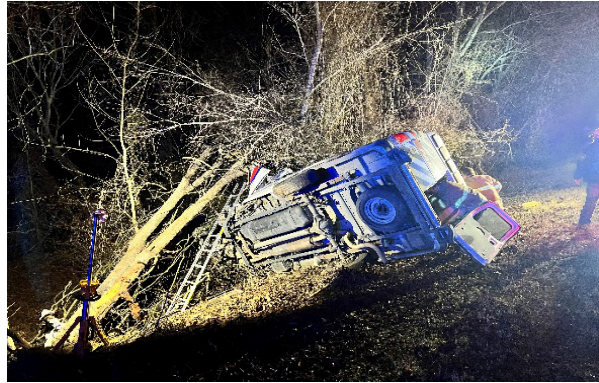
*Figure 5. Northeast view, ambulance at final rest (image provided by ambulance service, used with permission)*

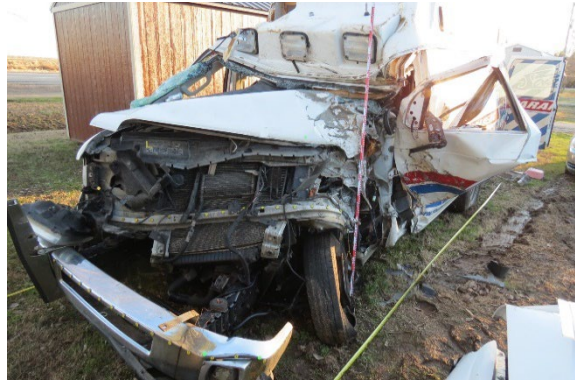
The tree impact (Event 2) involved the ambulance's front and left planes (Figure 6). Direct damage began at the left-front bumper corner, 94 cm (37.0 in) left of the centerline and extended 24 cm (9.4 in) to the right. The Field L was 188 cm (74.0 in). The crush measurements were taken at the bumper level and on the lower radiator support and averaged where necessary, per NHTSA field crash investigation vehicle measurement protocols. The maximum residual crush on the structure above the bumper was 109 cm (42.9 in), located 94 cm (37.0 in) left of the center line. The crush values were: C1 = 73 cm (28.7 in), C2 = 46 cm (18.1 in), C3 = 37 cm (14.6 in), C4 = 27 cm (10.6 in), C5 = 15 cm (5.9 in), C6 = 12 cm (4.7 in). The WinSMASH program could not be used to calculate velocity change since yielding objects are out of scope for the program. The calculated barrier equivalent speed was 43 km/h (26.7 mph). The CDC for this damage pattern was 11FLEE7 (340°).

*Figure 6. Front plane damage on ambulance*

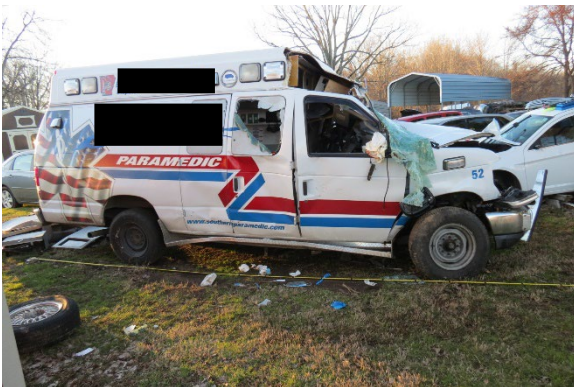
The ambulance rotated counterclockwise and rolled onto its right side (Event 3). There was no significant lateral or vertical crush from the rollover (Figure 7). The WinSMASH program could not calculate the velocity change for this event because non-horizontal impacts are out of scope for the program. The CDC for this damage pattern is 00RDAO2.

*Figure 7. Minimal rollover damage on the ambulance's right side*

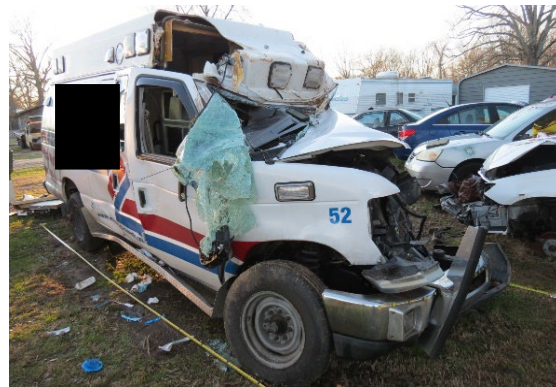
As the ambulance rolled onto its right side, the windshield header and front roof bulkhead (Figure 8) struck the second tree (Event 4). The WinSMASH program could not calculate velocity change for this event because non-horizontal impacts are out of scope for the program. The CDC for this damage pattern was 00FDGW99.

*Figure 8. Damage to ambulance front roof bulkhead*

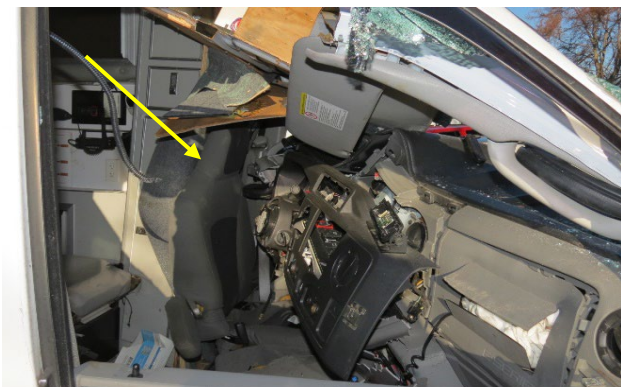
The ambulance’s interior sustained severe intrusion damage during the crash (Figure 9). The left A-pillar intruded longitudinally 88 cm (34.6 in) while the left instrument panel and steering column both intruded longitudinally 74 cm (29.1 in). The front of the ambulance’s cab was catastrophically damaged, and the steering assembly was cut from the vehicle during occupant extrication. The steering wheel and its deployed air bag were found at the crash scene and when examined, blood stains were seen on the air bag’s face as well as cuts to the rim made by rescue personnel. It is probable that the driver contacted the steering wheel rim, despite the post-crash damage. Blood stains were also noted on the intruding A-pillar (Figure 10) indicating contact by the driver. No other discernable occupant contacts were noted. The seatbacks from the right-front passenger’s seat and the rear captain’s chair were cut and removed from the vehicle to ease occupant removal.

*Figure 9. Longitudinal intrusion into the ambulance's front row (image taken through the right-front window; driver's seatback highlighted)*

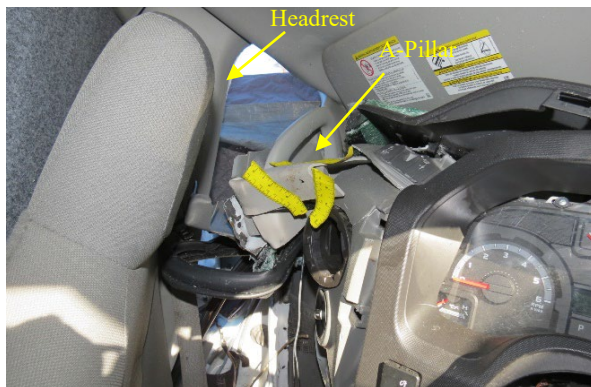
*Figure 10. Longitudinal intrusion and contacted left A-pillar*

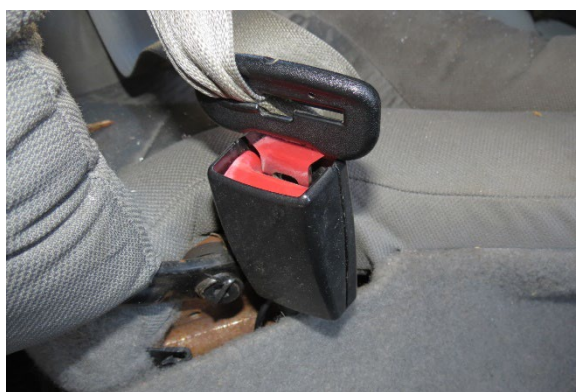
The driver's position had a lap and shoulder seat belt with a sliding latch plate, emergency locking retractor, retractor-mounted pretensioner, and adjustable D-ring that was adjusted to the full-down position. The EDR reported the driver seat belt status as "Buckled" yet there was no evidence of usage. The police crash report (PCR) said no seat belt usage, as did personnel from the ambulance service who said that the driver routinely buckled the latch plate and would drive the vehicle with the seat belt buckled behind her. This was seen by ambulance service personnel in video from earlier on the day of the crash. The latch plate was found buckled at the time of the SCI inspection. The pretensioner actuated and retracted the belt webbing such that it became jammed in the latch plate belt guide (Figure 11).

*Figure 11. Jammed seat belt webbing in driver's latch plate (found buckled at time of the SCI inspection)*

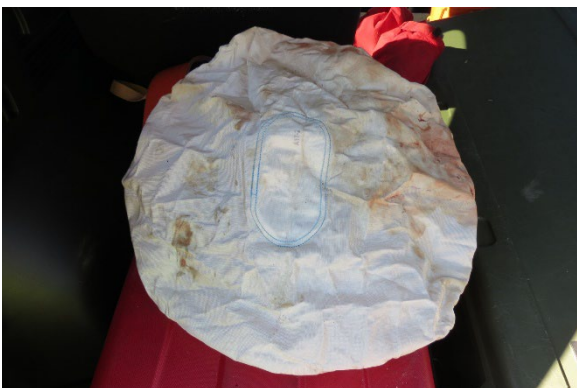
The ambulance had dual stage driver's and passenger's frontal air bags. Both air bags deployed during the crash. The driver's frontal air bag (Figure 12) was in the steering wheel hub, which had been cut off by rescue personnel and discarded at the crash scene. The wheel rim was also cut (Figure 13). The steering assembly and air bag were later found during the SCI scene inspection and the deflated air bag measured 48 cm (18.9 in) in diameter. Large blood stains were seen on the front and back surfaces. The module cover was a three-flap configuration constructed of pliable vinyl with horizontal and vertical tear seams. Each bottom flap measured 8 cm (3.1 in) wide and 10 cm (3.9 in) high. The top flap was 16 cm (6.3 in) wide and 5 cm (2.0 in) high. There was no damage to the air bag or flaps.

*Figure 12. Deployed driver's frontal air bag*

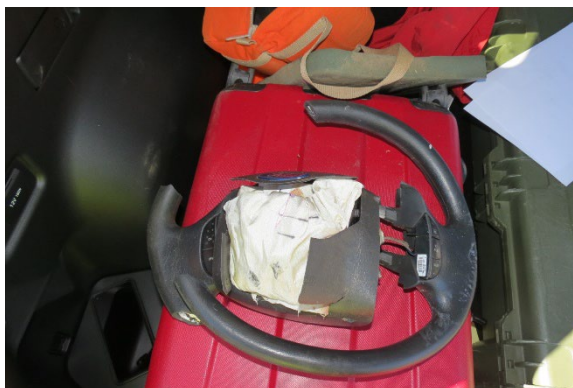
*Figure 13. Cut steering wheel rim and air bag module, found at crash scene*
