DOT HS 813 725

**Special Crash Investigations:  
Remote Frontover Incident  
Investigation;  
Vehicle: 2022 Honda Civic;  
Location: California;  
Incident Date: March 2023**

**Special Crash Investigations**  
**Remote Frontover Incident Investigation**  
**Case Number: DS23009**  
**Vehicle: 2022 Honda Civic**  
**Location: California**  
**Incident Date: March 2023**

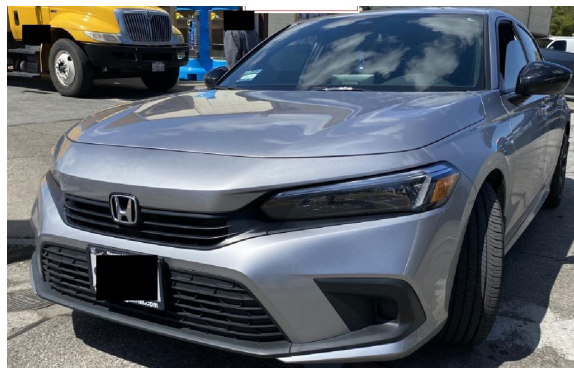
*Figure 1. The 2022 Honda Civic, front plane  
(police photo)*

The male nonmotorist did not sustain any injuries. The female nonmotorist sustained "C" (complaint of pain) injuries to her head, left shoulder, left hand, and right leg. She was transported to a local hospital where she was treated and released. The Honda was not damaged

(Figure 1). The Honda driver was unlicensed. The vehicle owner was contacted. She took possession of the vehicle and drove it from the scene.

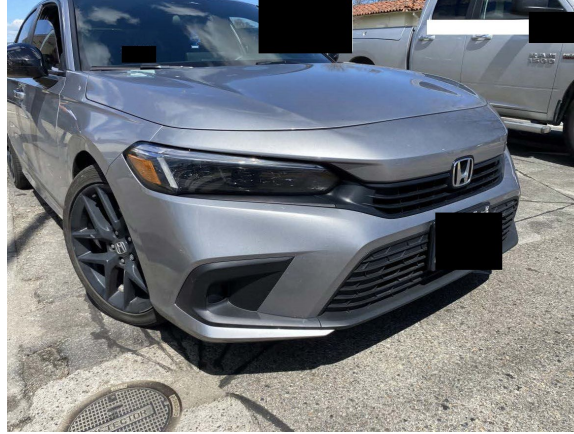
Figure 2. The 2022 Honda Civic, front plane  
(police photo)

The Honda did not sustain any residual damage (Figure 2). The collision deformation classifications for the no residual damage contacts were 12F9EU1 and 12F9EU1.

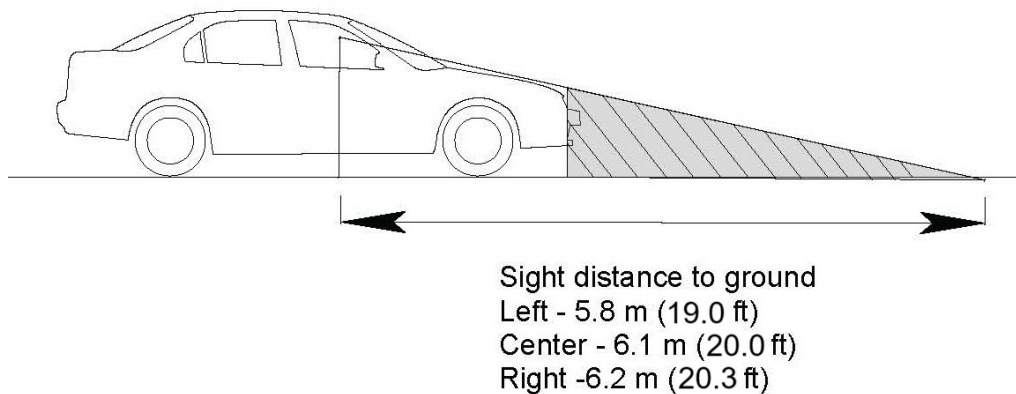
*Figure 3. Sight visibility diagram*

Based on available data, the sight distances to the ground for the driver looking forward over the hood's left side, center, and right side were 5.8 m (19.0 ft), 6.1 m (20.0 ft), and 6.2 m (20.3 ft), respectively (Figure 3).

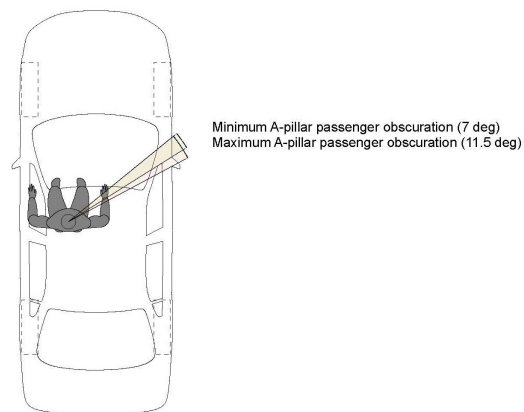
*Figure 4. Passenger A-pillar obscuration*

The right A-pillar was a potential blind spot as the nonmotorist came from the right to the left. The wider the A-pillar the wider the blind spot. For the Honda, the width dimensions for the A-pillar were 24 cm (9.4 in), 8 cm (3.1 in), and 9 cm (3.5 in) for the bottom, middle, and top. One third-party study focused on A-pillar driver obscuration/location and A-pillar passenger obscuration, which determines the interaction between a driver and the vehicle's pillar, which

affects the driver's ability to see external objects, including pedestrians.<sup>3</sup> In the study vehicle pillars are measured in the all-around view from the driver's monocular eye point 63.5 cm (25 in) above the seating reference point taking into account all obstructive elements. Research was done on approximately 75 vehicles. The minimum A-pillar obscuration was reported as 7° and the maximum 11.5° (Figure 4). The authors noted that there are other interior dimensions that affect obscuration/location, including seating reference point to ground front, seat height, and torso angle. There were two nonmotorists involved in this incident. Their position relative to one another is unknown and the A-pillar would not have obscured both if they were not exactly side by side.

In the interview the driver said he never saw the two nonmotorists prior to the incident but could

not say if the A-pillar was a factor or not. It is unclear if he looked to the right before proceeding.
