DOT HS 813 735

**Special Crash Investigations:
On-Site Heavy-Truck Underride
Crash Investigation;
Vehicle: 2017 International ProStar
LF687 Truck Tractor;
Location: California;
Crash Date: December 2022**

Special Crash Investigations
On-Site Heavy Truck Underride Crash Investigation
Case No. DS23003
Vehicle: 2017 International ProStar LF687 Truck Tractor
2010 Hyundai Trailer
Location: California
Crash Date: December 2022

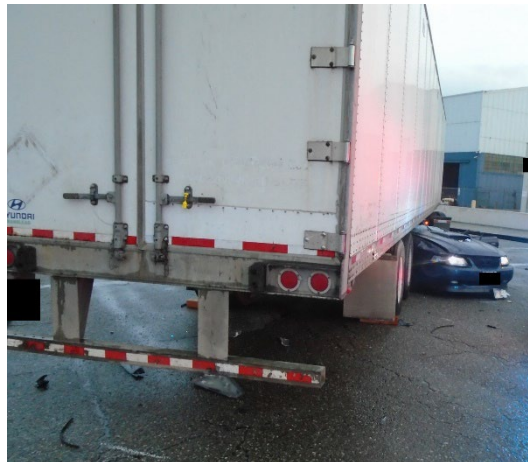
*Figure 1. 2002 Ford Mustang's final rest,
looking southwest (police image)*

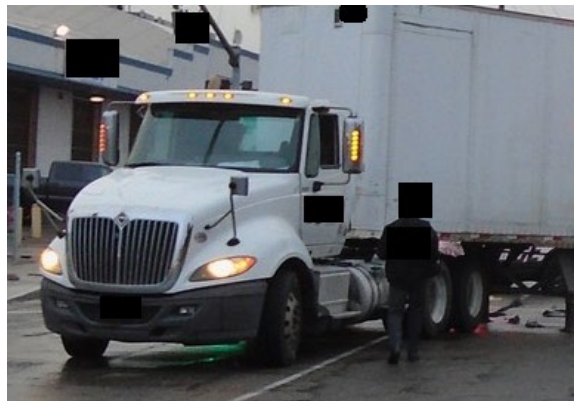
The International truck tractor was not damaged (Figure 4).

Figure 4. 2017 International ProStar truck tractor (police image)

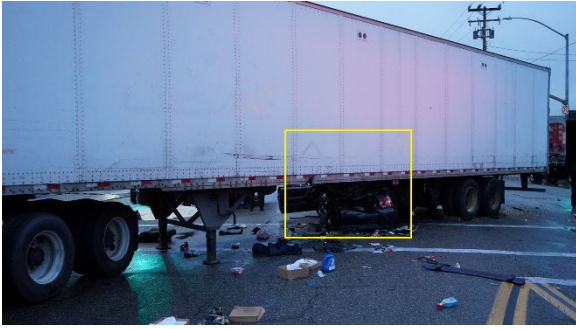
Figure 5. 2010 Hyundai Translead trailer damage, on-scene image looking west (police image)

The Hyundai trailer sustained moderate left plane and undercarriage damage from the impact with the Ford (Figures 5 and 6). The damage was between the axles and the landing gear at the frame level. The damage extended along the undercarriage to the right plane. The estimated truck deformation classification was 10LTFWA. The trailer sustained damage to the plastic side skirts (Figures 7 and 8).

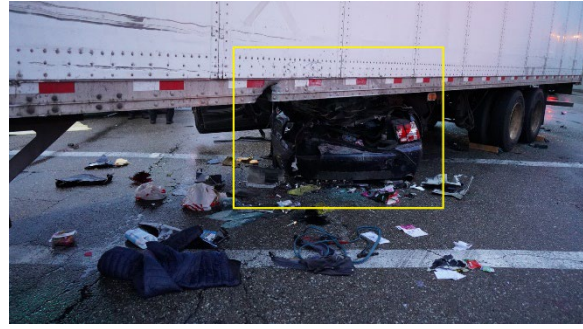
Figure 6. 2010 Hyundai Translead trailer damage, on-scene image looking west (police image)

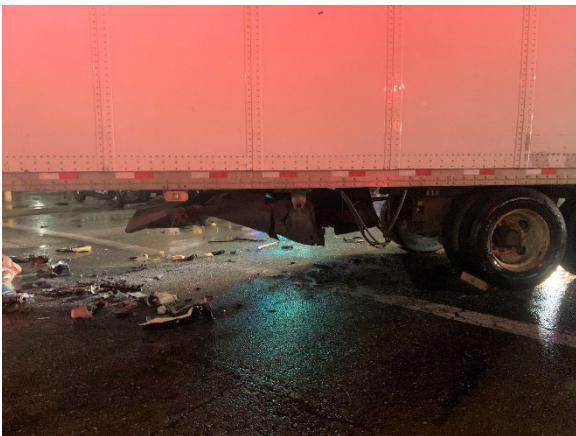
Figure 7. 2010 Hyundai Translead trailer side skirt damage, left side of trailer (police image)

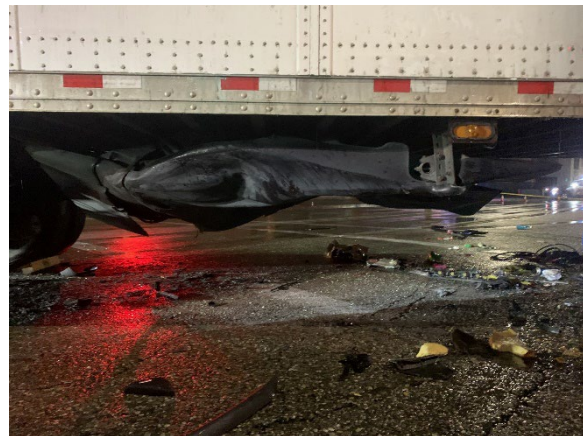
Figure 8. 2010 Hyundai Translead trailer side skirt damage, right side of trailer (police image)

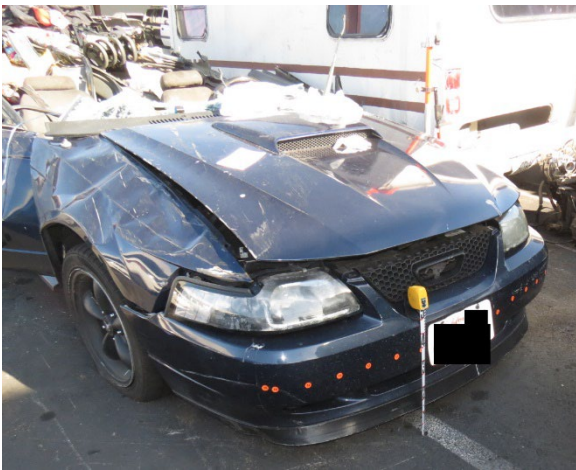
The Ford sustained major damage through the front plane (Figures 9 and 10) from the underride impact with the Hyundai trailer. The direct damage began 70 cm (27.5 in) left of the vehicle centerline and measured 146 cm (57.4 in). The Field L extended from bumper corner to bumper corner and measured 138 cm (54.3 in). Sixteen measurements were taken at the bumper level using the Nikon total station mapping system and the AutoCrush tool calculated six crush measurements as follows: C1=0 cm, C2=0 cm, C3=0 cm, C4=0 cm, C5=0 cm, C6=3 cm (1.1 in). The maximum crush to the bumper was located 70 cm (27.5 in) right of the front centerline and measured 3 cm (1.1 in). There was 119 cm (46.8 in) of direct contact to the right part of the hood and 356 cm (140.1 in) scraping damage along the right plane from the trailer side skirt. There was direct contact to the left and right A-pillars. Both A-pillars were cut during extrication. The A-pillars/roof/windshield header structure was displaced rearward to a position above the rear bumper, partially due to damage and partially due to extrication efforts. The estimated collision deformation classification was 12FDAW9.

Figure 9. 2002 Ford Mustang, front right

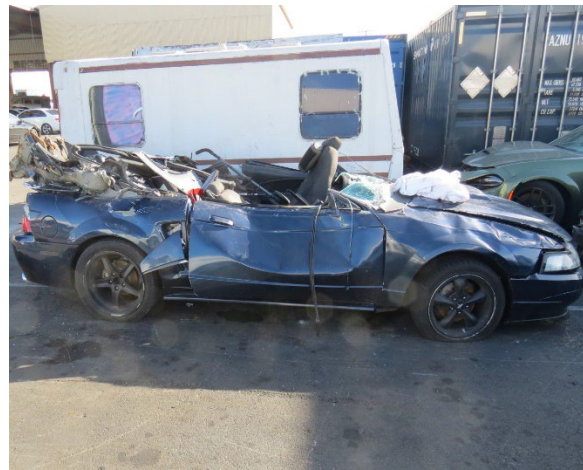
Figure 10. 2002 Ford Mustang, right plane
