U.S. Department
of Transportation
**National Highway
Traffic Safety
Administration**

DOT HS 813 767

**Special Crash Investigations:
On-Site Ambulance Crash
Investigation;
Vehicle: 2018 Chevrolet Silverado
3500 Type I Ambulance;
Location: Kentucky;
Crash Date: April 2024**

Special Crash Investigations
On-Site Ambulance Crash Investigation
Case Number: CR24010
Vehicle: 2018 Chevrolet Silverado 3500 Type I Ambulance
Location: Kentucky
Crash Date: April 2024

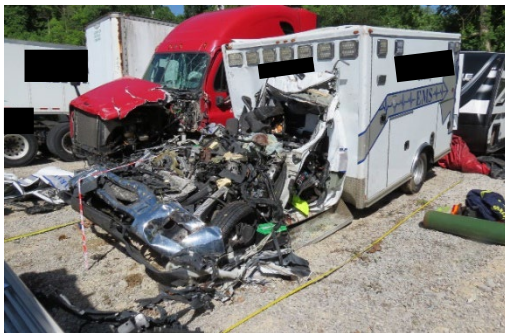
Figure 1. The 2018 Chevrolet Silverado 3500 Type I ambulance

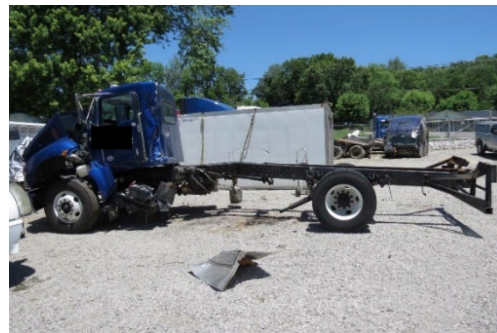
Figure 2. The 2021 Kenworth T3 (detached box immediately behind)

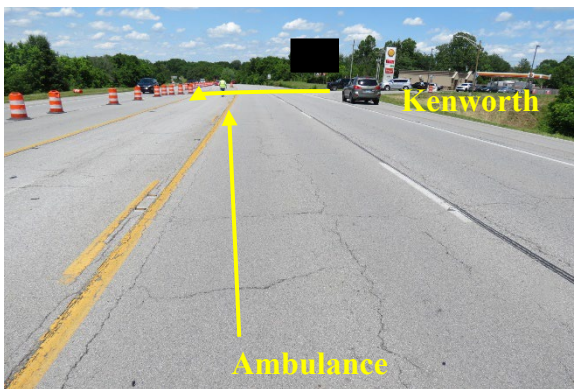
Figure 3. Northeast view, ambulance's pre-crash travel path to impact area (note: construction barrels were not present at time of crash)

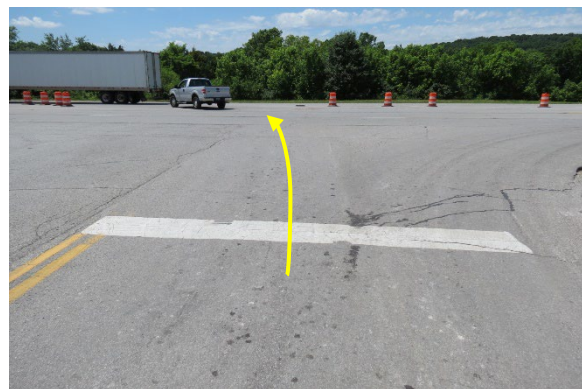
Figure 4. Northwest view, Kenworth's pre-crash travel path to impact area (note: construction barrels were not present at time of crash)

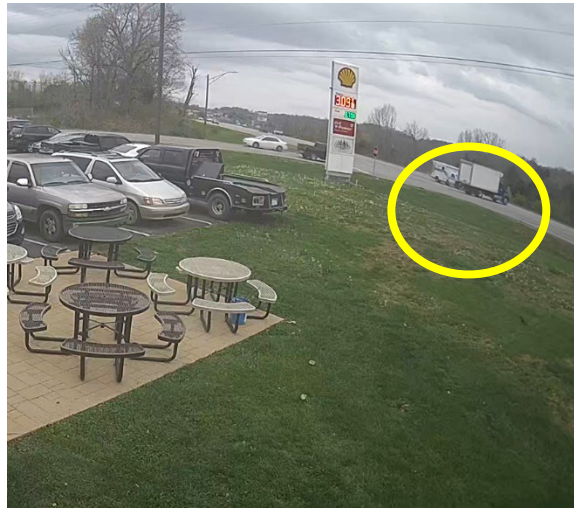
The front of the ambulance struck the left side of the Kenworth at the back and behind of the left corner of its cab (Event 1). During the impact, the ambulance's front plane underrode the refrigerated cargo box and truck frame (Figure 5). The impact separated the cargo box from the truck's frame (Figure 6). Both vehicles were redirected to the left, across both southbound lanes and onto the west roadside. The ambulance came to final rest facing north and the Kenworth was facing west.

Figure 5. West view, video surveillance of impact. Image used with permission.

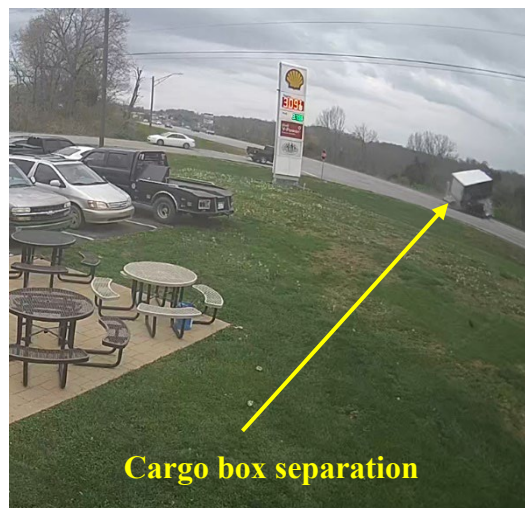
Figure 6. Video surveillance of impact, truck/ cargo box separation from truck frame (ambulance is under truck). Image used with permission.

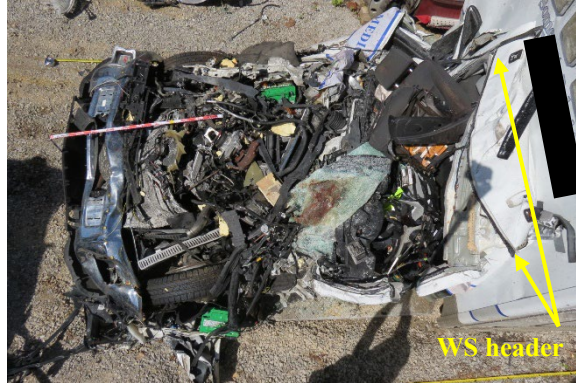
The front plane of the ambulance struck the left side of the Kenworth at a speed estimated at 108 km/h (67 mph) and underrode the refrigerated cargo box and frame. The entire front plane sustained direct damage that extended rearward to the right front portion of the patient compartment (Figure 7). The Field L was 182 cm (71.7 in). Crush measurements were taken on the front bumper beam. Above-bumper crush measurements were not taken as there were no remaining measurable structures. The maximum residual bumper crush was 56 cm (22.0 in) and occurred 58 cm (22.8 in) left of the center line. The residual crush profile of the bumper was C1 = 52 cm (20.5), C2 = 56 cm (22.0 in), C3 = 55 cm (21.7 in), C4 = 50 cm (19.7 in), C5 = 50 cm (19.7 in), C6 = 42 cm (16.5 in). The WinSMASH program could not be used for this impact since medium-heavy vehicles are out of scope for the program. The Truck Deformation Classification² for frontal impact damage was 12FDAW9.

Figure 7. Overhead view of front end/cab damage (WS header noted for reference)

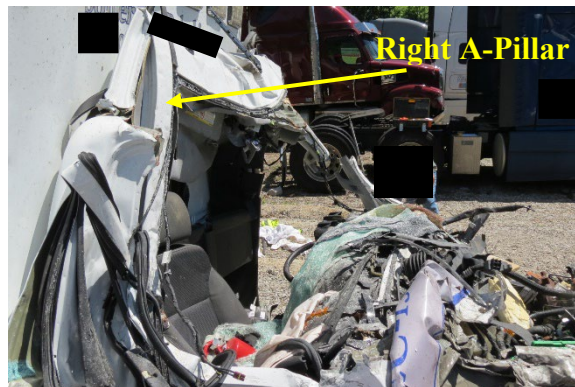
The ambulance cab sustained significant damage and intrusion from the impact with the Kenworth. The right A-pillar, right, and center instrument panels intruded longitudinally 67 cm (26.4 in), 58 cm (22.8 in), and 44 cm (17.3 in) (Figure 8). The contact to the Kenworth frame rail bent the steering wheel rim 14 cm (5.5 in), to a 90° angle rearward (Figure 9). The driver seat was deformed and came loose from the floor/seat track due to passenger compartment intrusion. There were blood stains on the driver’s air bag and windshield, but there were other no discernable occupant contacts in the vehicle interior.

Figure 8. Right A-pillar/IP intrusion

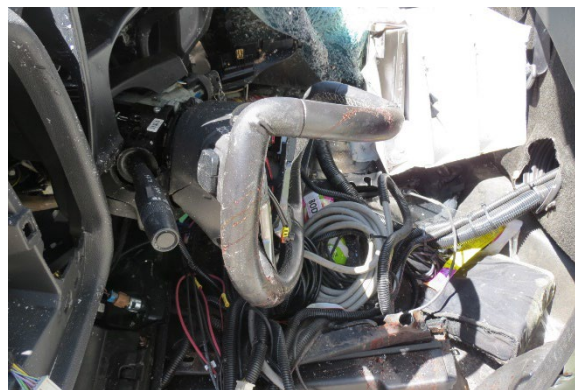
Figure 9. 90° steering wheel deformation during Kenworth frame underride

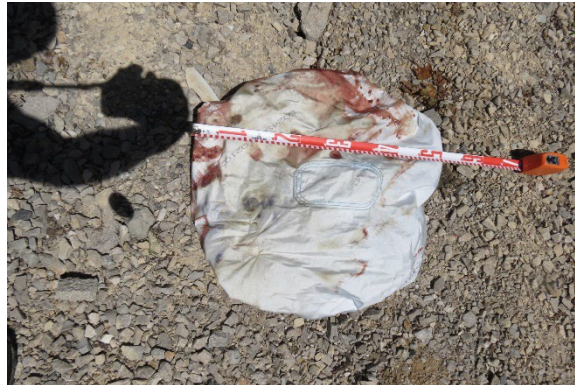
The ambulance had driver and front passenger dual stage frontal air bags, both of which deployed during the crash. The driver air bag was removed from the steering assembly by other unknown investigators prior to SCI inspection. Significant blood was found on the front (Figure 10) and back of the air bag fabric and there was a small tear on the back side lateral to the vent port.

Figure 10. Blood transfers on air bag

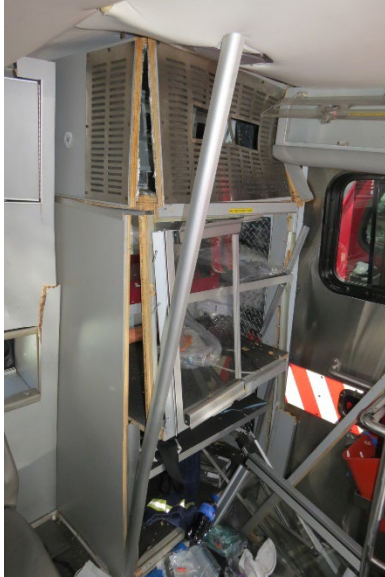
There were no intrusions to the patient compartment but there was moderate impact damage to the right-side cabinets (Figure 11) and the front bulkhead (Figure 12).

Figure 11. Damaged right front cabinets

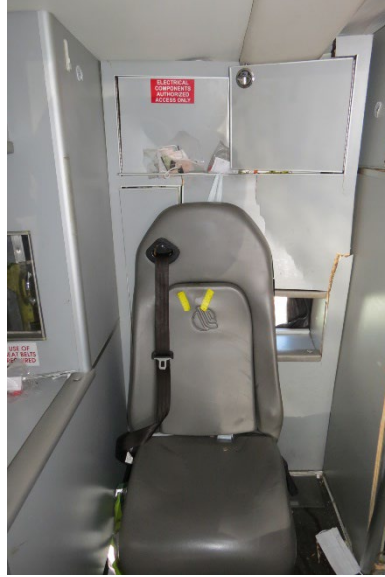
Figure 12. Damaged bulkhead

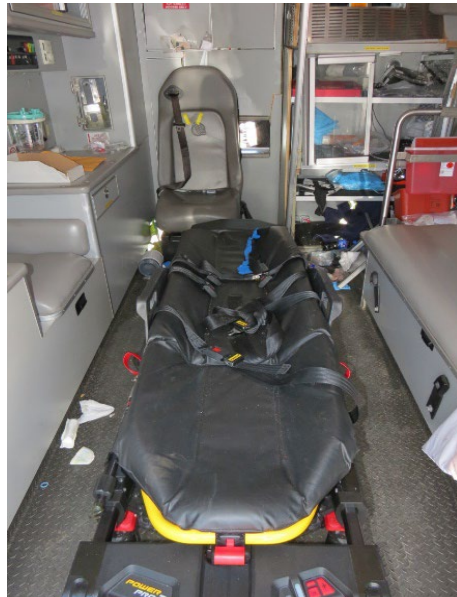
The Stryker Power-Pro 2 patient cot³ (S/N: 230600xxxx) was held in place by the electronic floor-mounted on/off loading system. The cot (Figure 13) was removed from the ambulance after the crash and later replaced back onto the floor mount. At the time of SCI inspection, the cot was fastened onto the mount. There was no power supply for the ambulance and the cot could not be removed.

Figure 13. Stryker Power Pro 2 patient cot

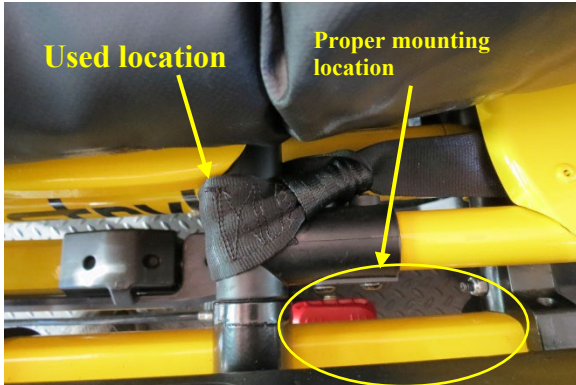
Cot restraints were present at the lower leg, thigh, and shoulder levels. All restraint webbings were anchored in the proper positions except for the shoulder restraints. The left restraint was anchored to the horizontal hinge (Figure 14) which allowed the back support to be raised and lowered; the proper anchoring point was on the cot frame (Figure 15). The right restraint was anchored to the back support frame; the proper anchoring point for both shoulder restraints was on the cot frame (Figure 16). There was no damage to the cot frame or any of the shoulder restraints; however, the impact force displaced the right shoulder webbing anchor forward and mildly deformed the back support (see Figure 16). The only other damage noted was a broken oxygen cylinder mount under the head of the cot.

Figure 14. Left shoulder strap anchor location (hinge for back support)

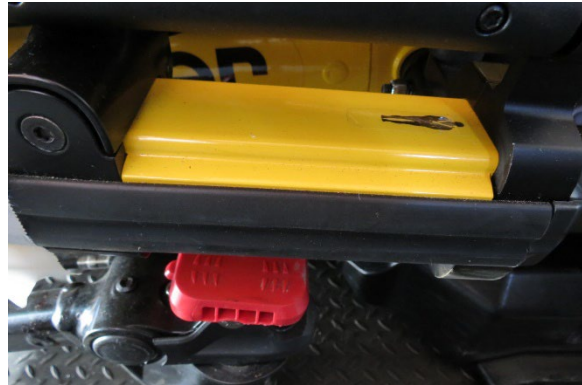
Figure 15. Proper mounting location for left shoulder restraint webbing

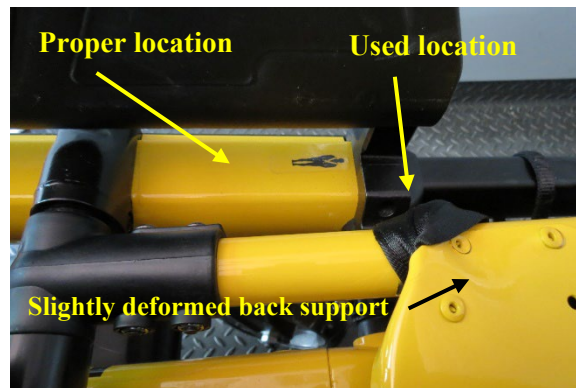
Figure 16. Right shoulder strap anchor location

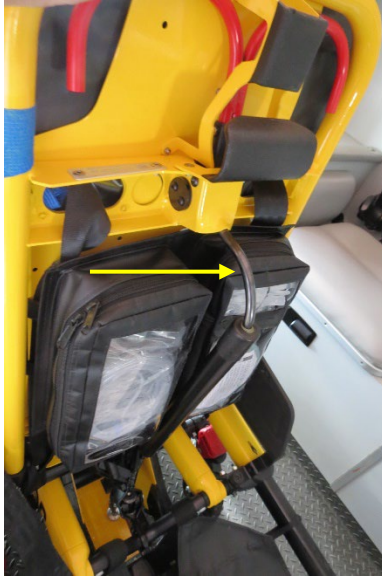
The pneumatic piston that raised and lowered the cot's back support was deformed (Figure 17) as a result of the crash. This indicated that the back support was raised during transport and that the patient's loading during the crash forced it downward to a horizontal position. There was no evidence to indicate that the patient cot separated from the floor mount during crash sequence. A representative of the ambulance service confirmed this.

Figure 17. Bent pneumatic piston for back support adjustment denoted by the yellow arrow

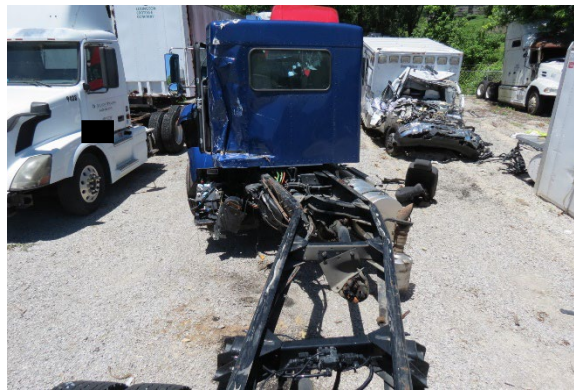
The Kenworth's left plane was damaged during the impact with the ambulance. Direct damage began 142 cm (55.9 in) rear of the left front wheel, near the back of the cab, and extended 201 cm (79.1 in) rearward along the frame (Figure 18) and refrigerated cargo box. The cargo box separated from the frame during the impact (Figure 19). At inspection the cargo box was inverted, lying on its top surface. As the ambulance underrode the Kenworth, the diesel exhaust fluid tank ruptured and the diesel fuel tank was indirectly damaged. The WinSMASH program could not be used on this impact since medium-heavy vehicles are out of scope for the program. The TDC for this impact was 09LZAWB.

Figure 18. Kenworth damaged left plane

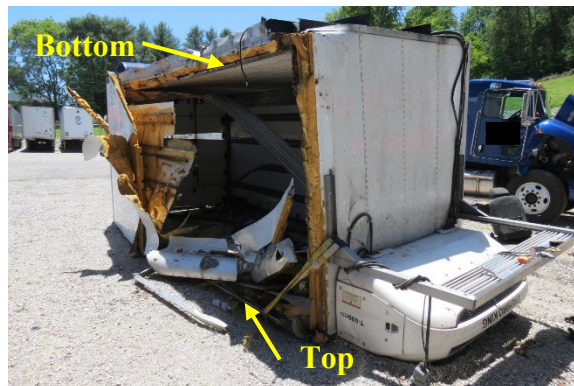
Figure 19. Refrigerated box, separated from the Kenworth frame
