U.S. Department
of Transportation
**National Highway
Traffic Safety
Administration**

DOT HS 812 613

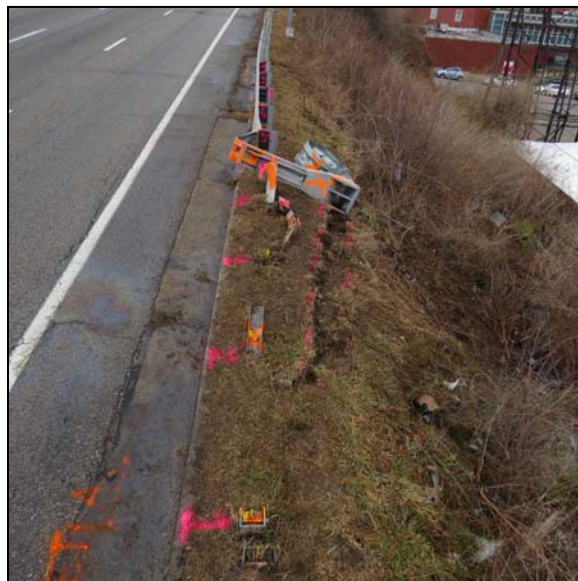
Figure 1: SKT end treatment and guardrail

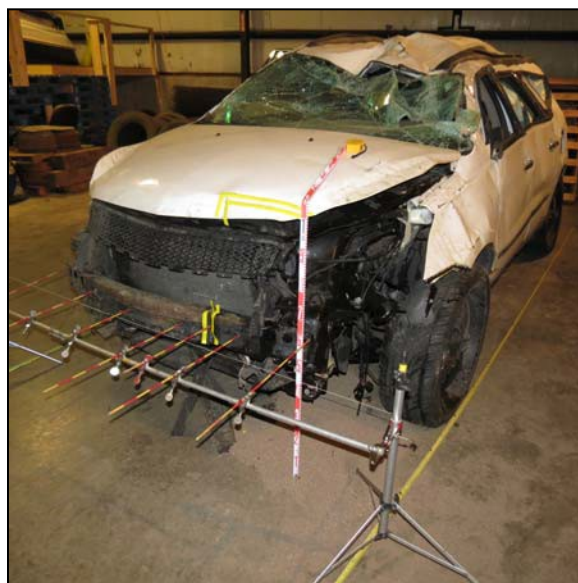
Figure 2: 2010 Chevrolet Traverse

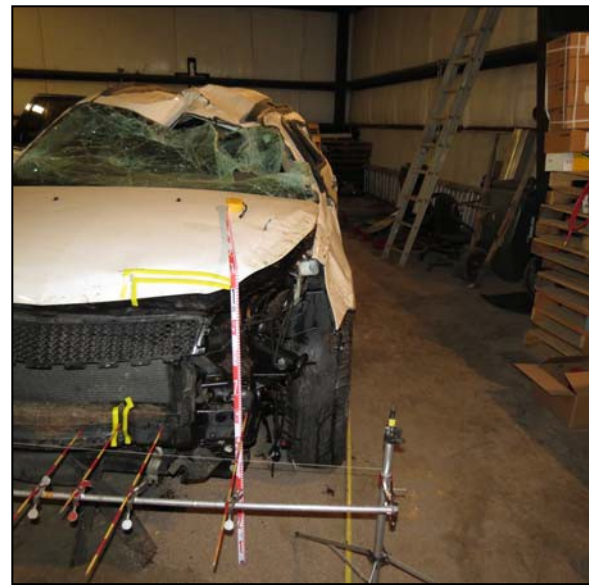
Figure 5: Chevrolet's front end damage

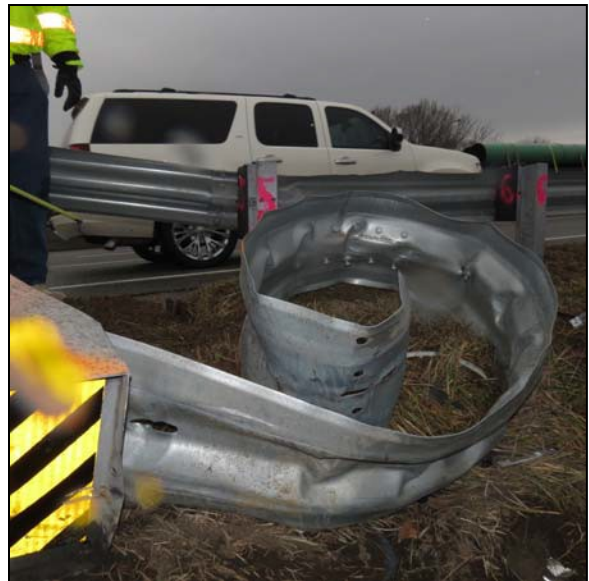
Figure 7: Extruded guardrail from SKT head

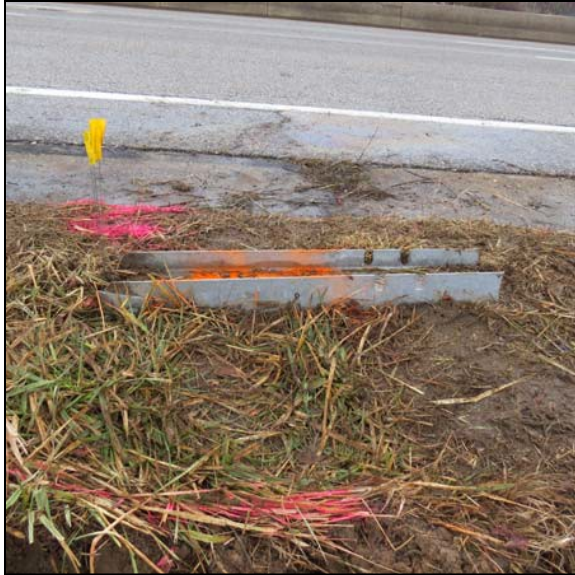
Figure 8: Post 2 damage

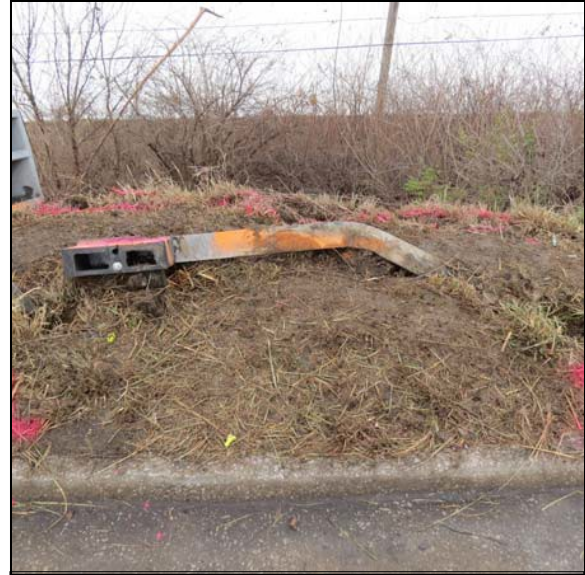
Figure 9: Post 3 damage

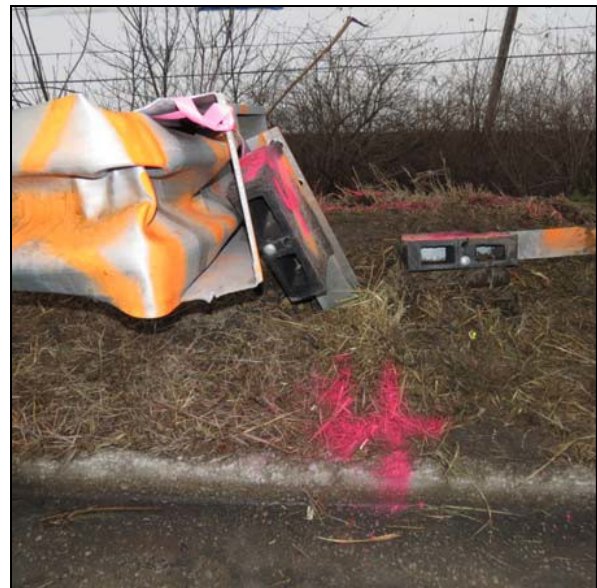
Figure 10: Post 4 damage

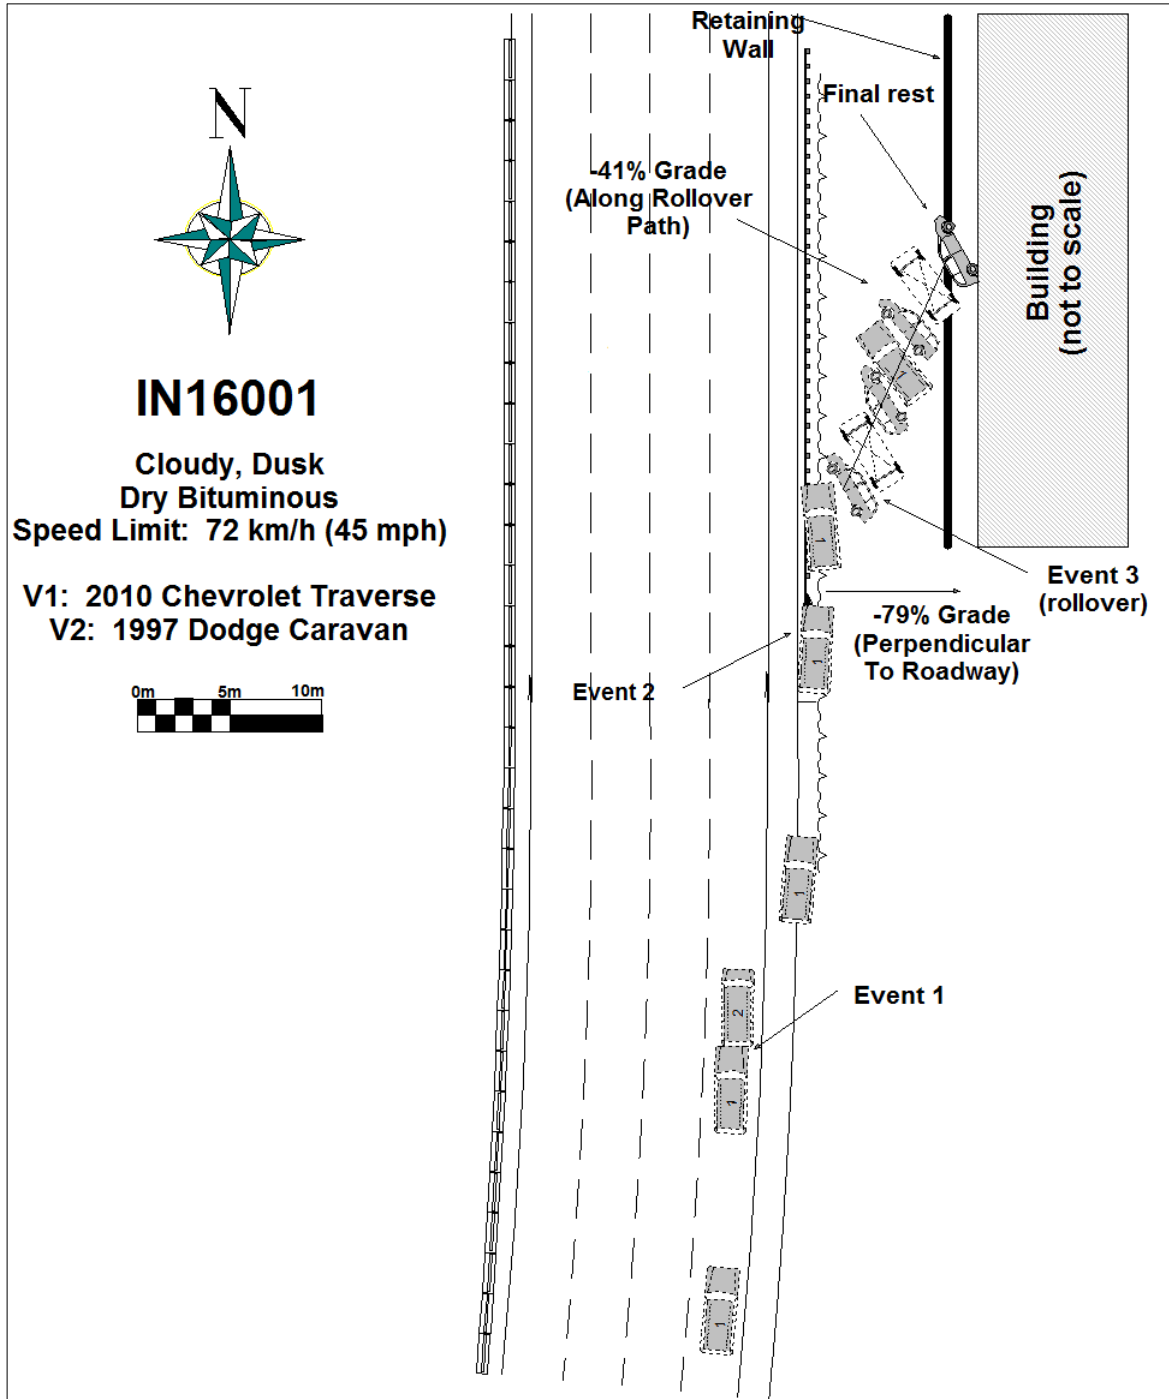
Appendix A:
In-Service End Treatment Evaluation Data Collection Form
