DOT HS 812 817

Special Crash Investigations Remote Air Bag Non-Deployment Crash Investigation Vehicle: 2016 Ram 1500 Location: Washington Crash Date: March 2017

Special Crash Investigations Remote Air Bag Non-Deployment Crash Investigation Office of Defects Investigation (ODI) Case No. DS17012 Vehicle: 2016 RAM 1500 Location: Washington Crash Date: March 2017

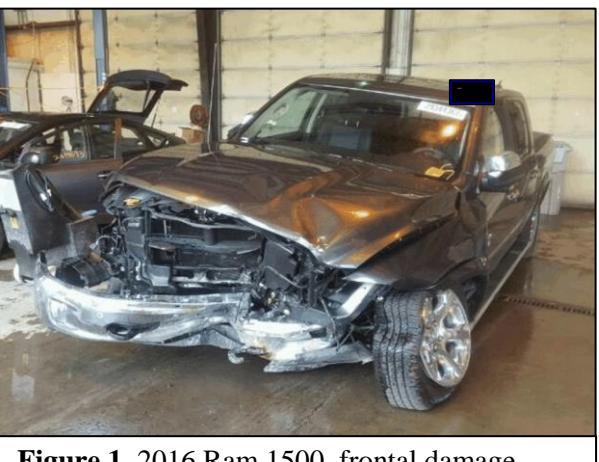
This report documents the remote investigation of the non-deployment of air bags and the injuries sustained by the driver of a 2016 Ram 1500 involved in a head-on crash with a 2016 Toyota Camry (**Figure 1**). This investigation was initiated by the Office of Defects Investigation (ODI) in response to a driver notification. The Special Crash Investigations (SCI) group of the National Highway Traffic Safety Administration assigned the case to Dynamic Science, Inc. in July 2017. The vehicle had been declared a total loss by the insurance company shortly after the crash. The vehicle was then sold to a second party and transported to Missouri. SCI contacted the

Figure 1. 2016 Ram 1500, frontal damage (salvage facility photo).

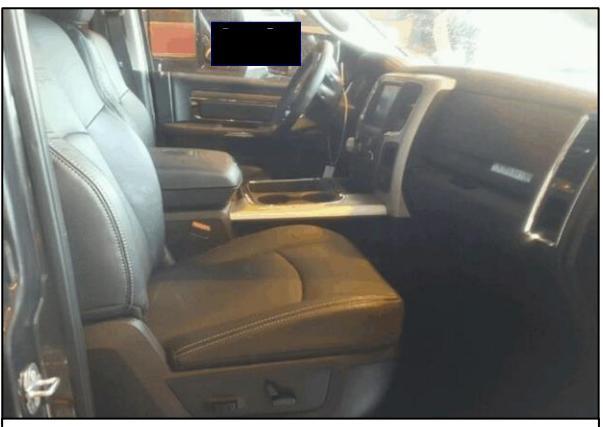
Figure 2. 2016 Ram 1500, interior (salvage facility photo).

Based on a limited number of interior images there does not appear to be any significant interior damage.

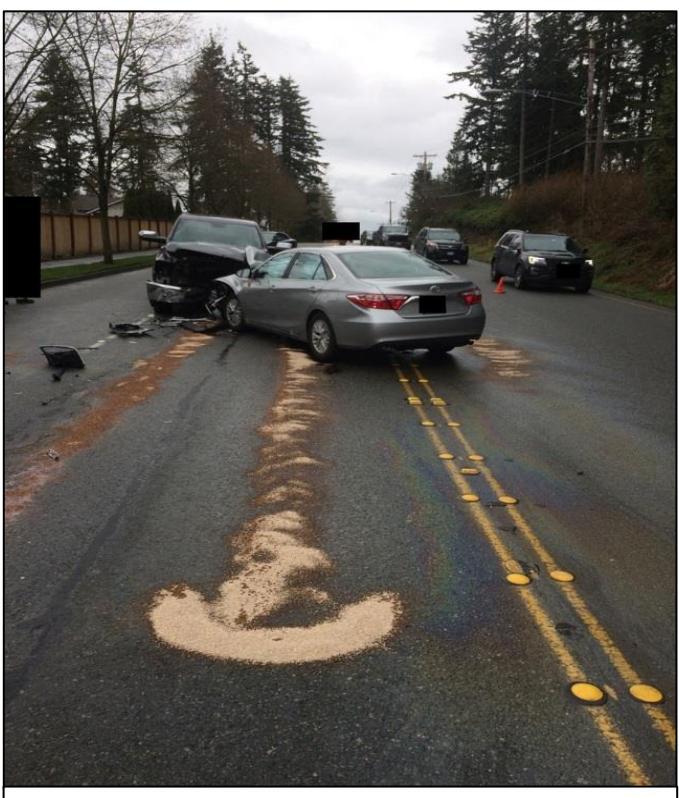
Figure 4. Final rest, looking east (police photo).

results were low and borderline. There were no air bag deployments. The program calculated a total delta-V of 29 km/h (18 mph) for the Toyota. The longitudinal and lateral components were -29 km/h (-18 mph) and 5 km/h (3 mph), respectively. The Ram rotated slightly clockwise and came to rest in its original travel lane. The Toyota rotated slightly counterclockwise and came to rest partially in the westbound travel lane (**Figure 4**).

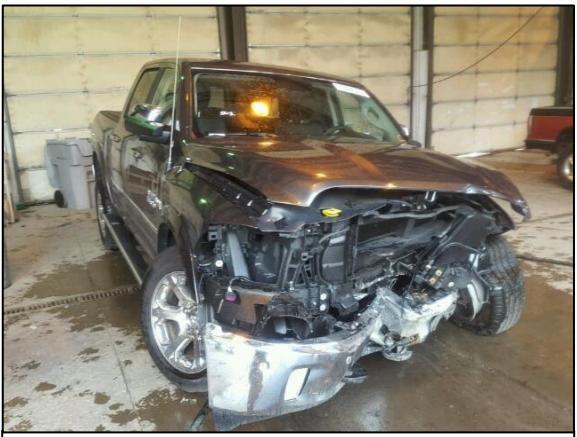
Figure 5. 2016 Ram 1500 pickup, frontal damage (salvage facility photo).

The Ram sustained moderate frontal plane damage from the impact with the Toyota (**Figure 5**). The direct damage began at the left bumper corner and extended approximately half-way across the front bumper to the left. The Field L extended from bumper corner to bumper corner. The left front tire was debeaded and restricted. The maximum crush was located at the left bumper corner and estimated to be 50 cm (19.6 in). The CDC was 11FYEW2.

The front air bag system has multistage driver and front passenger air bags. This system provides output appropriate to the severity and type of collision as determined by the ORC. The system is not designed to deploy in all frontal collisions, including impacts with pole, truck overrides, etc. In this crash, however, the impact severity was of sufficient magnitude, impact configuration was typical, and it would be expected that the driver's frontal air bag would deploy.

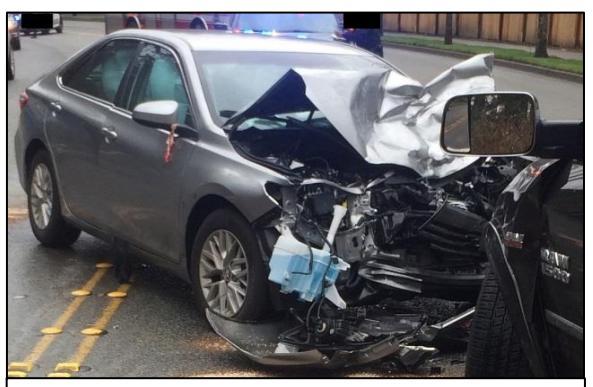
The Toyota sustained moderate front plane damage from the impact with the front of the Ram (**Figure 6**). Both frontal air bags deployed. The vehicle was not inspected and the EDR was not available for imaging. The vehicle sustained moderate longitudinal crash along the entire front plane. The hood was displaced rearward and the left front tire was restricted. The estimate CDC was 12FDEW1. The Toyota was towed from the scene due to damage.

Figure 6. 2016 Toyota Camry, front damage (police photo).
