U.S. Department
of Transportation

**National Highway
Traffic Safety
Administration**

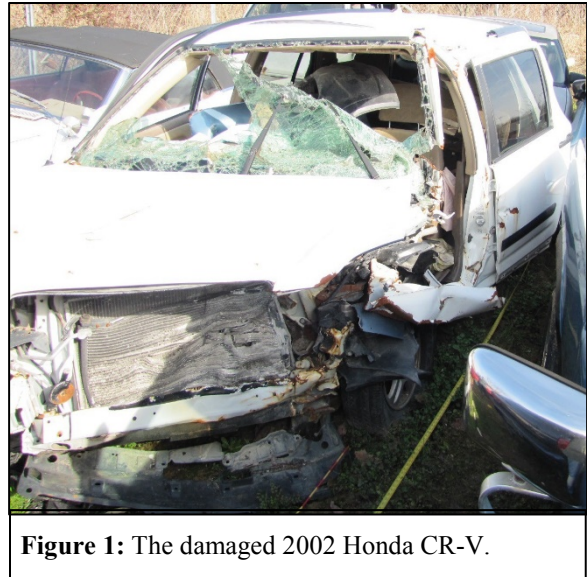
This report documents the on-site investigation of an alleged rupture of the driver's frontal air bag inflator of a 2002 Honda CR-V (**Figure 1**) that resulted in fatal injuries to the driver. This investigation was initiated by the National Highway Traffic Safety Administration in March 2017 and assigned to the Special Crash Investigation (SCI) team at the Indiana University Transportation Research Center. This crash involved the Honda, a 2007 Ford Taurus, and a 2013 Lexus ES 350. The crash occurred during the morning in January 2016 and was investigated by a local police agency. The Honda was inspected in May 2017. The crash scene was inspected in July 2017.

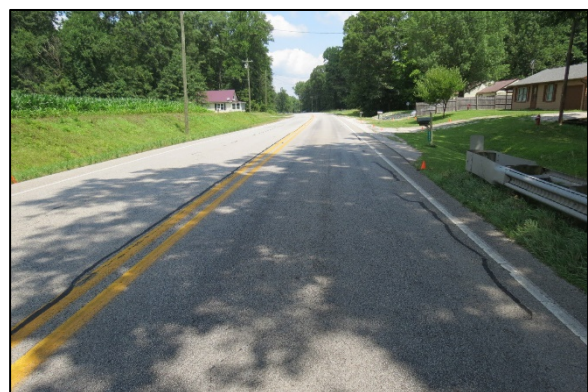
Figure 3: Northbound approach of the Ford.

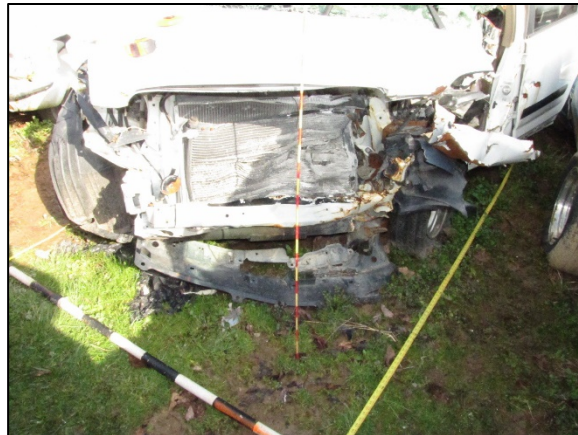
Figure 4: Damage to the front plane of the Honda from the impact with the Ford.

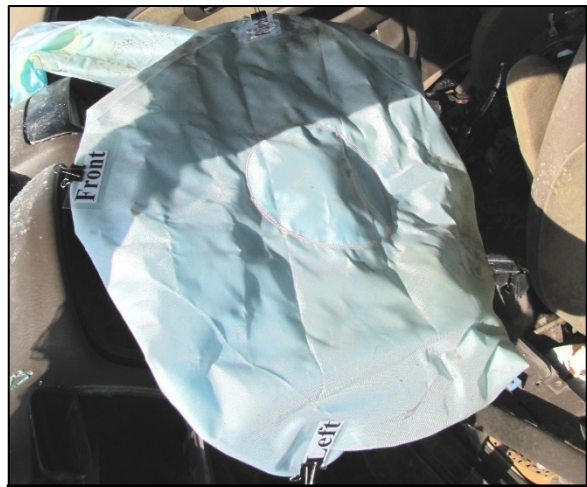
Figure 5: Honda's driver's frontal air bag.

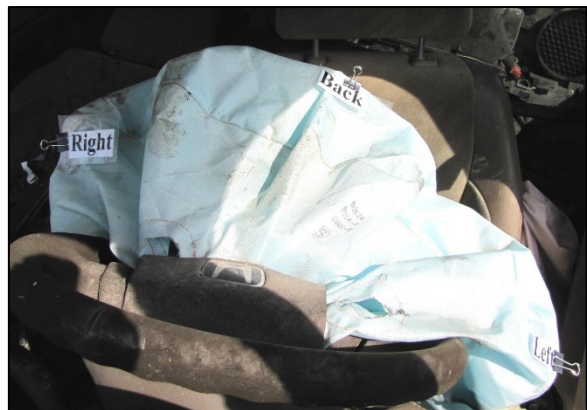
Figure 6: Driver's frontal air bag, top back portion.
