U.S. Department  
of Transportation  
**National Highway  
Traffic Safety  
Administration**

DOT HS 813 005

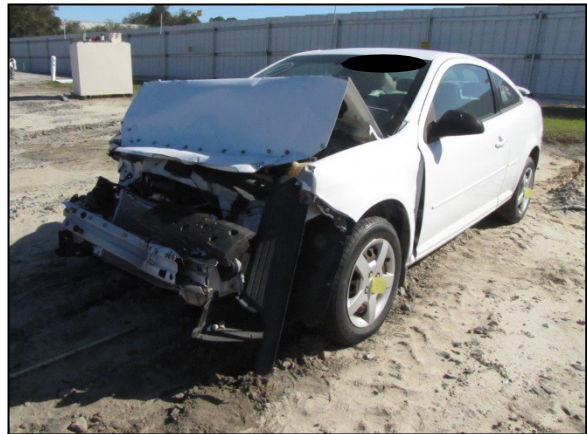
**Figure 1.** Front right oblique view of the 2006 Chevrolet Cobalt.

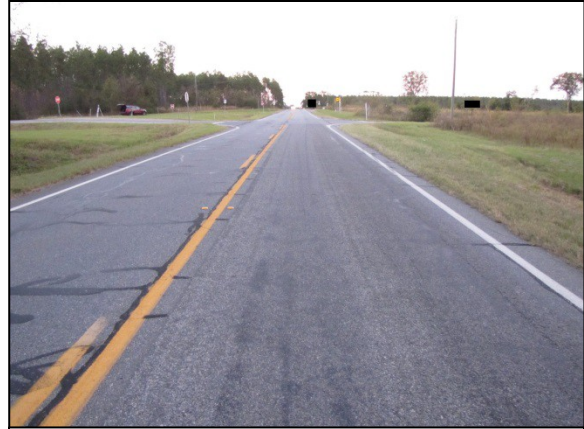
**Figure 2.** North-facing trajectory view of the Chevrolet on the approach to the intersection.

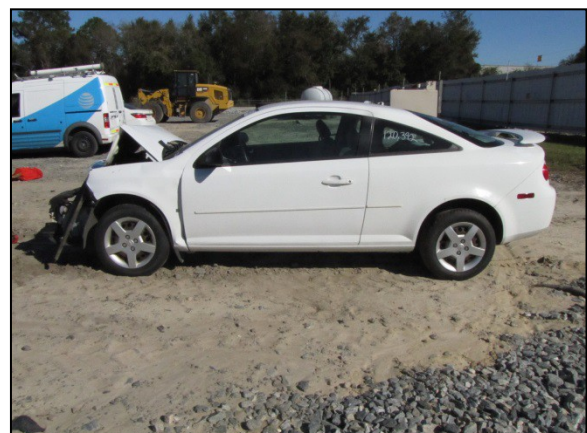
**Figure 4.** Left side view of the Chevrolet.

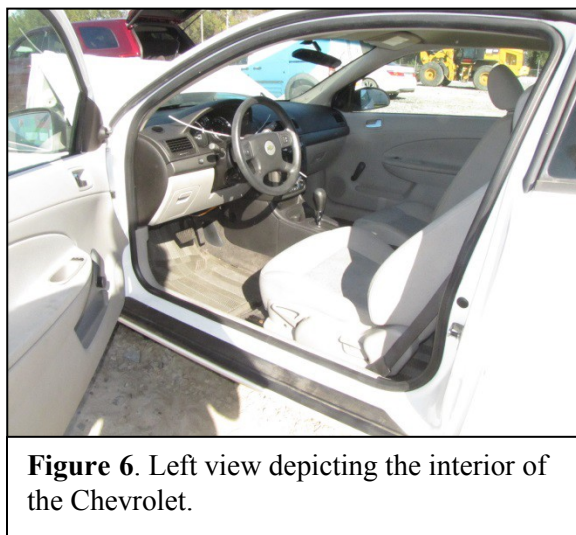
### ***Manual Restraint Systems***
