U.S. Department  
of Transportation  
**National Highway  
Traffic Safety  
Administration**

DOT HS 813 153

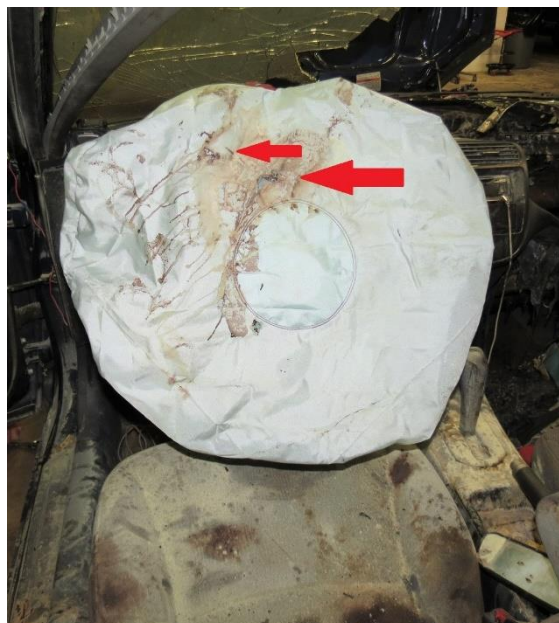
*Figure 1. The driver's frontal air bag, the 2002 Honda Civic*

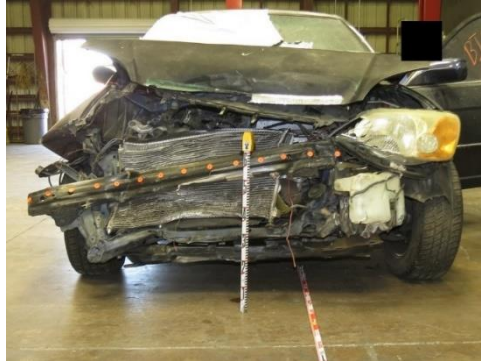
*Figure 5. Front plane damage, the 2002 Honda Civic*

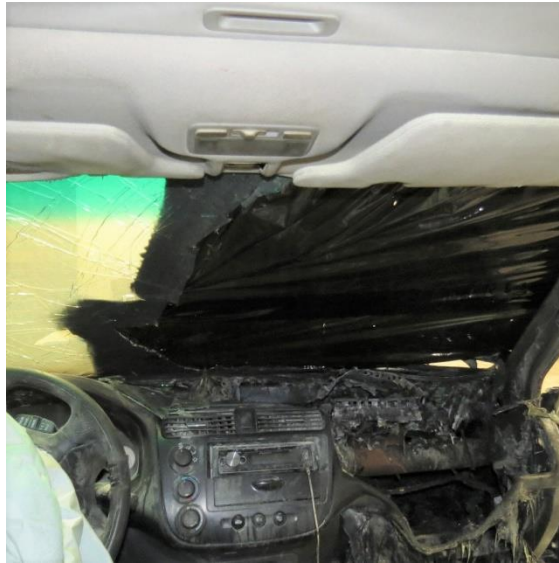
*Figure 6. Right instrument panel, the 2002 Honda Civic*

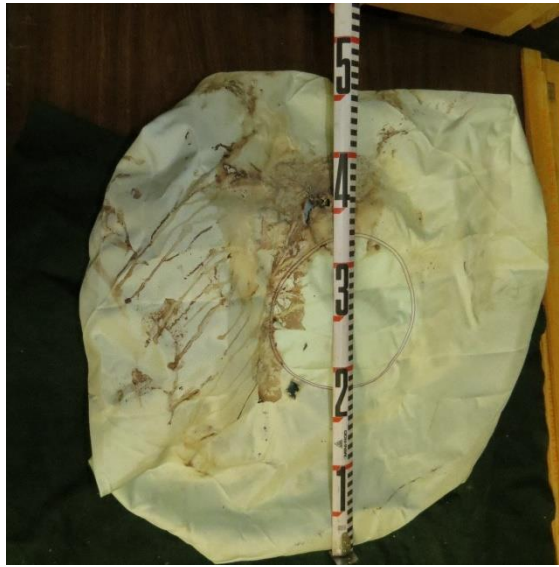
*Figure 7. The driver's air bag, the 2002 Honda Civic*

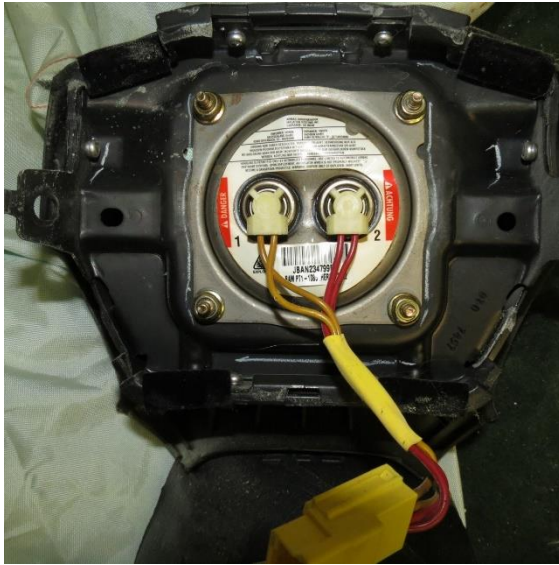
Figure 8. The driver's frontal air bag, back of the module, the 2002 Honda Civic

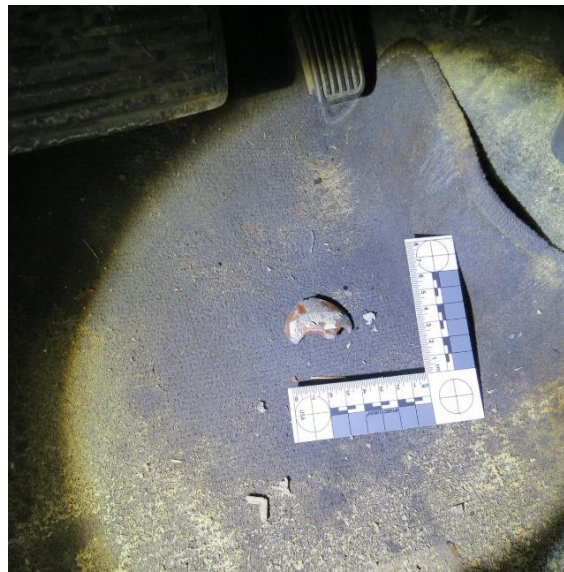
Figure 11. Outer casing fragment, the 2002 Honda Civic

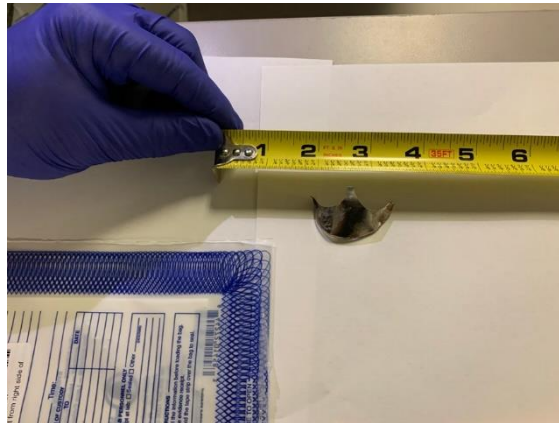
*Figure 12. Embedded fragment, the 2002 Honda Civic (police image)*

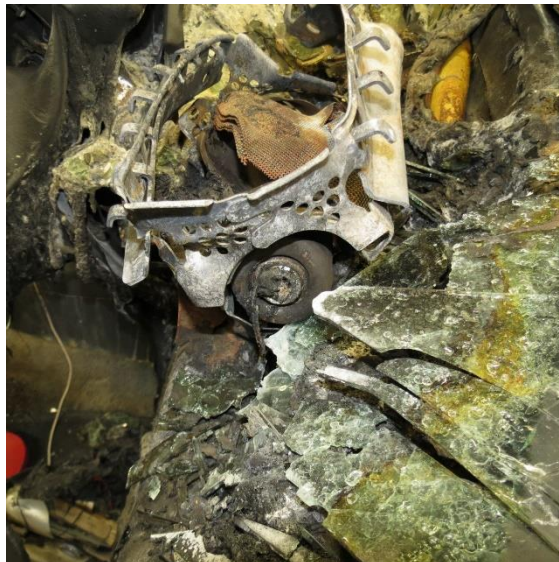
*Figure 13. The passenger's frontal air bag inflator, the 2002 Honda Civic*

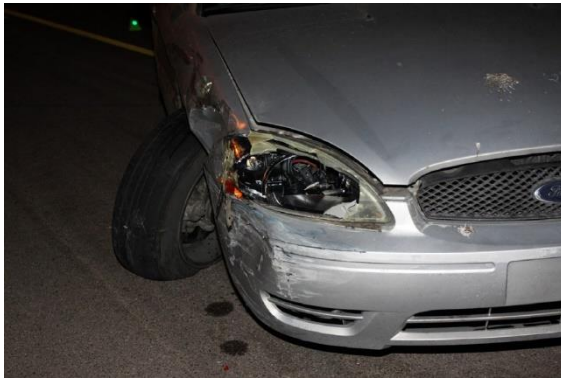
*Figure 14. Front plane damage, the 2004 Ford Taurus (police image)*

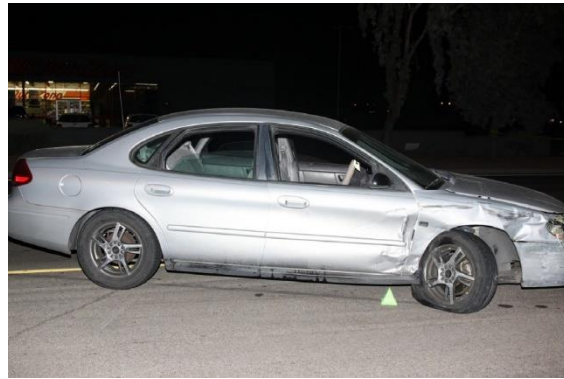
*Figure 15. Right plane damage, the 2004 Ford Taurus (police image)*
