U.S. Department  
of Transportation  
**National Highway  
Traffic Safety  
Administration**

DOT HS 813 154

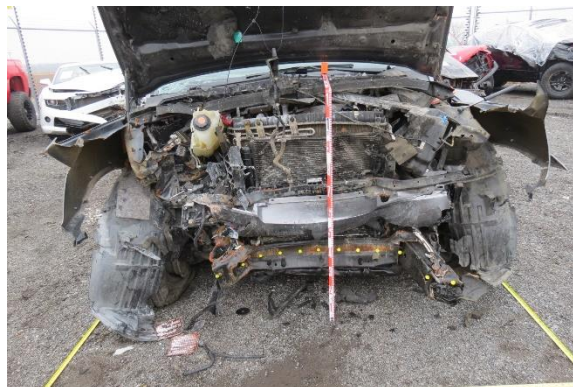
Figure 5. Front plane damage to the Nissan

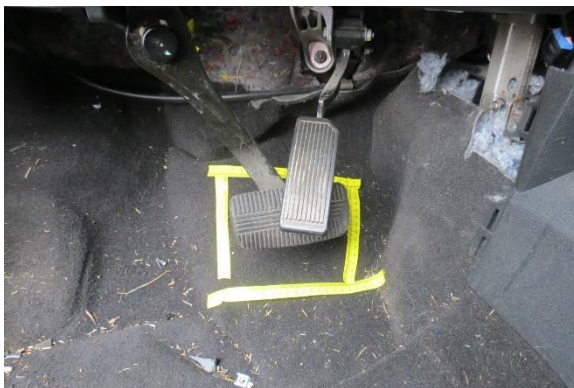
Figure 6. The Nissan's displaced foot pedals

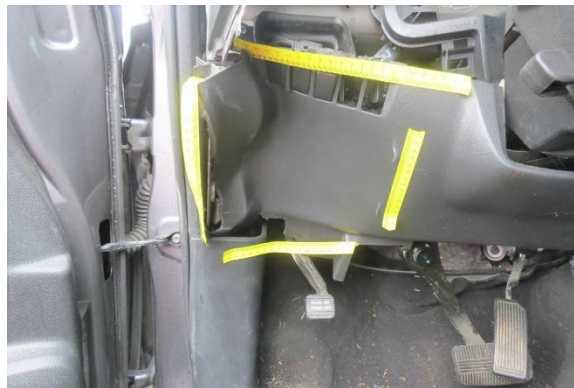
*Figure 8. Left instrument panel deformed by the Nissan driver's left knee*

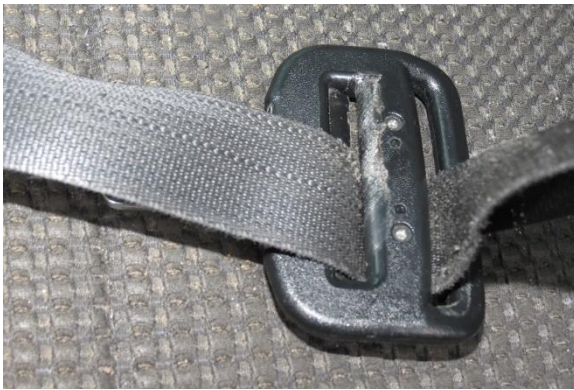
*Figure 10. Load marks on the Nissan driver's latch plate belt guide*

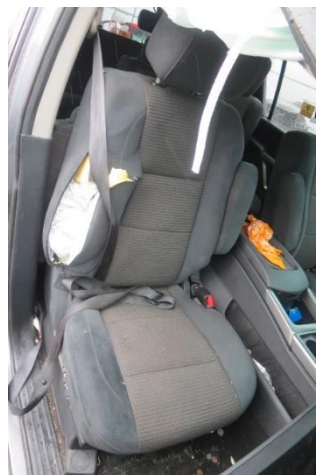
*Figure 12. The Nissan's right- front seat. Note the length of the webbing to accommodate large occupant.*

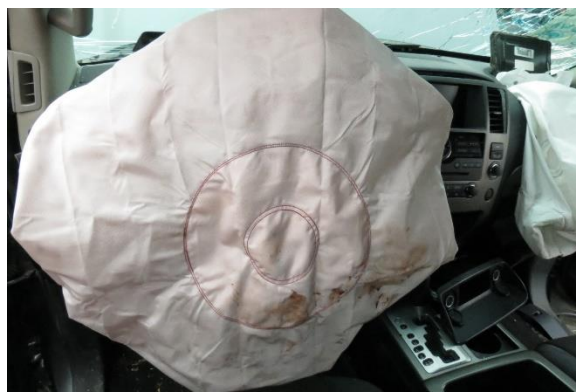
*Figure 13. The Nissan's deployed driver's air bag*

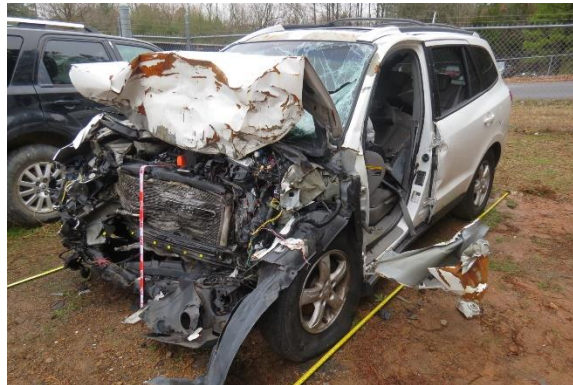
*Figure 14. The 2007 Hyundai Santa Fe's front plane damage*
