U.S. Department  
of Transportation  
**National Highway  
Traffic Safety  
Administration**

DOT HS 813 261

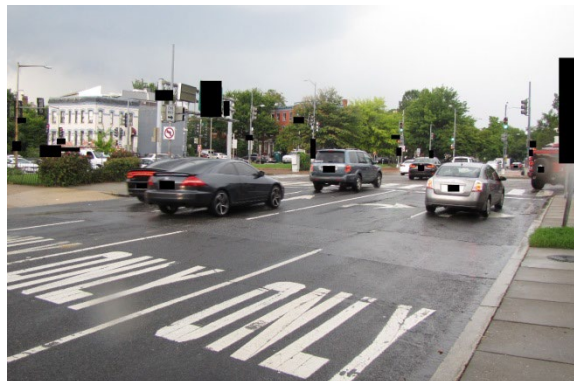
*Figure 2. Northerly view of the Audi's approach to the intersection*

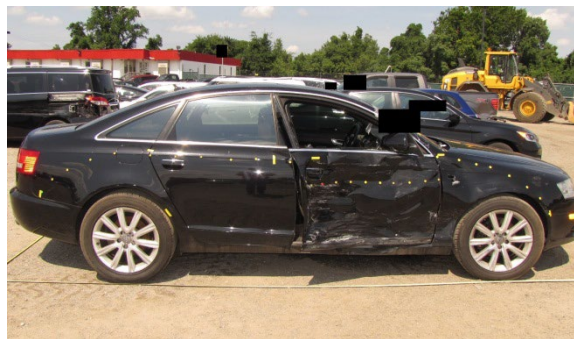
*Figure 4. Damage to the right plane of the Audi A6*

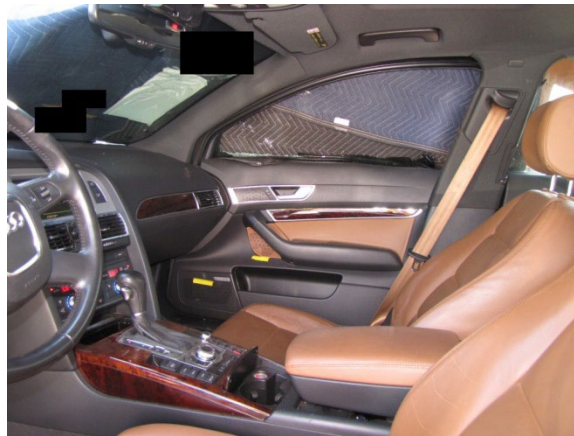
*Figure 5. Lateral view across the interior of the Audi, documenting the lack of intrusion and the non-deployed status of the right side impact air bags*

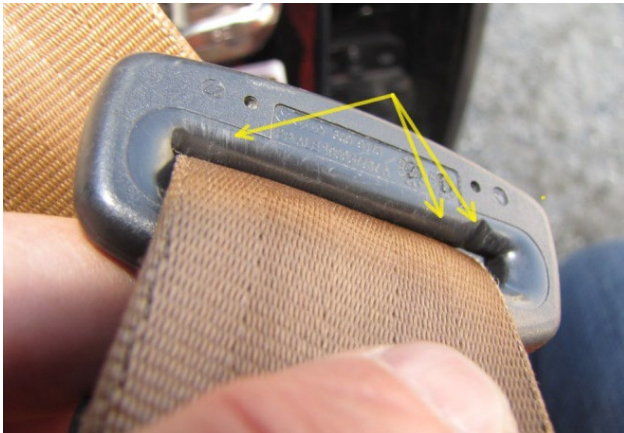
*Figure 6. Frictional abrasions to the driver's latch plate and the V-groove from historical usage*

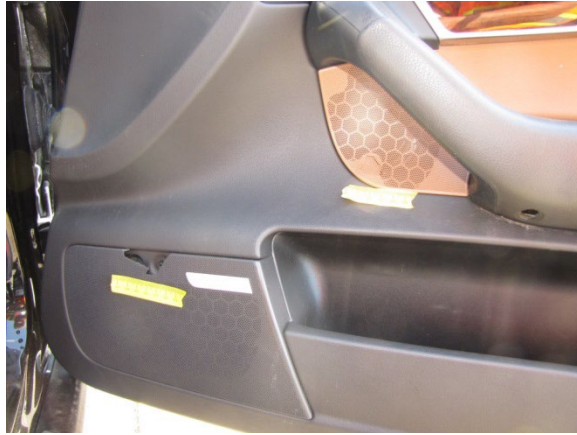
*Figure 8. Front row right occupant lower extremity contact damage to the right front door panel*

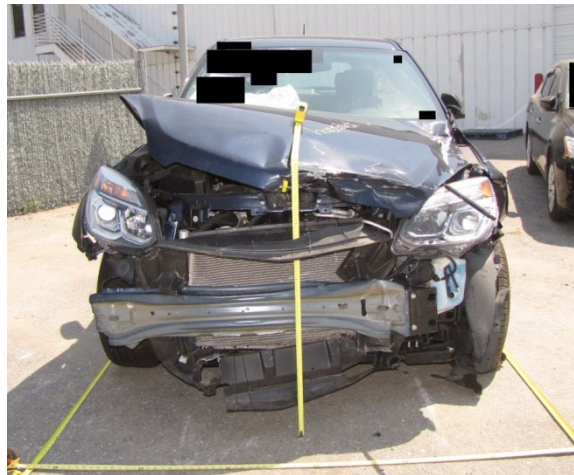
*Figure 10. Front plane damage to the 2016 Chevrolet*
