U.S. Department  
of Transportation  
**National Highway  
Traffic Safety  
Administration**

DOT HS 813 331

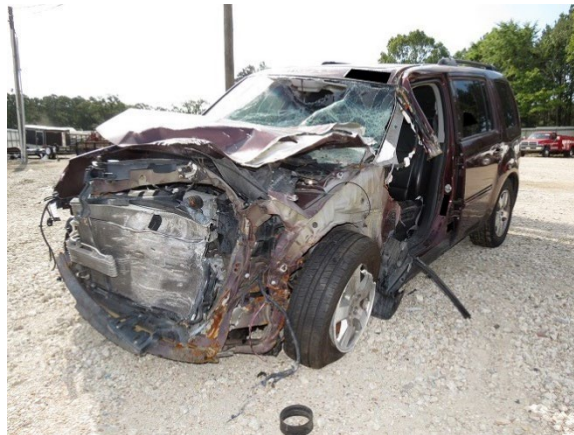
*Figure 1. The 2011 Honda Pilot*

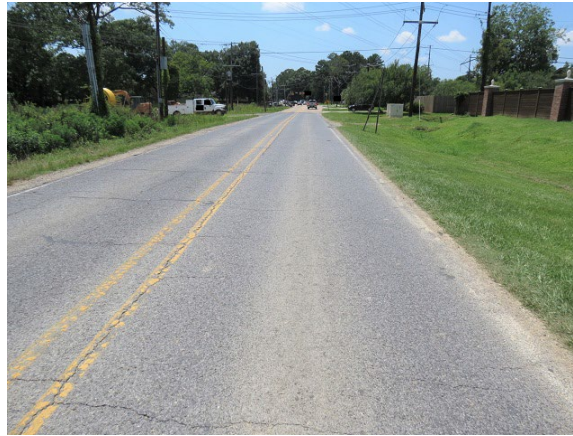
*Figure 2. Crash site looking west*

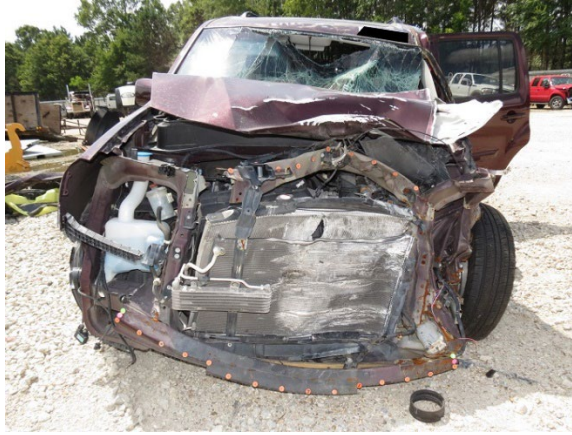
*Figure 3. Front-plane damage, the 2011 Honda Pilot*

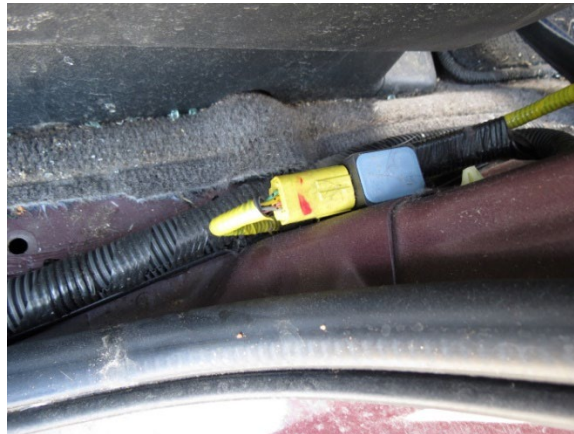
*Figure 4. Left-side air bag sensor, the 2011 Honda Pilot*
