DOT HS 813 372

Special Crash Investigations: Reported Air Bag Non-Deployment Crash Investigation; Vehicle: 2018 Ford F-150; Location: West Virginia; Crash Date: September 2019

Special Crash Investigations Reported Air Bag Non-Deployment Crash Investigation Office of Defects Investigation Case Number: CR19033 Vehicle: 2018 Ford F-150 Location: West Virginia Crash Date: September 2019

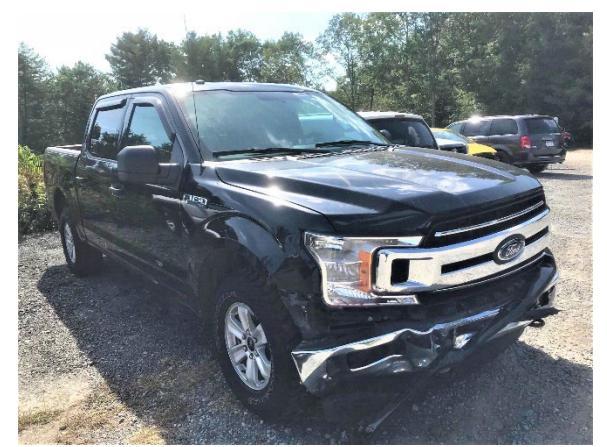
This report documents the reported non-deployment of the air bag systems in a 2018 Ford F-150 (Figure 1) involved in a reported offset frontal crash with a 1991 Chevrolet Prism. The vehicle owner notified the National Highway Traffic Safety Administration of the crash. She reported that while traveling approximately 72-80 km/h (45-50 mph), the Ford was struck by an oncoming vehicle. During her interview, she later reported a vehicle pulled out in front of her and the impact configuration was front-to-rear. The driver further reported that none of the Ford air bag systems deployed in the crash, and stated that the seat belt systems did not restrain the front occupants and did not lock. At the time of the crash the Ford was driven by a 51-year-old female with an 18-year-old female front-right passenger. The owner stated that both occupants were belted at the time of the crash. The driver further stated that she sustained neck injuries, a lumbar strain, and a cervical strain; however, she was not medically evaluated at the scene or transported, and she did not seek medical care after the crash. The front-right passenger was not injured. Police documentation of the crash was not provided with the crash notification. The police report, crash site, and Chevrolet could not be located with the limited information provided by the owner.

Figure 1. Right-front oblique view of the damaged 2018 Ford F-150 (owner provided image)

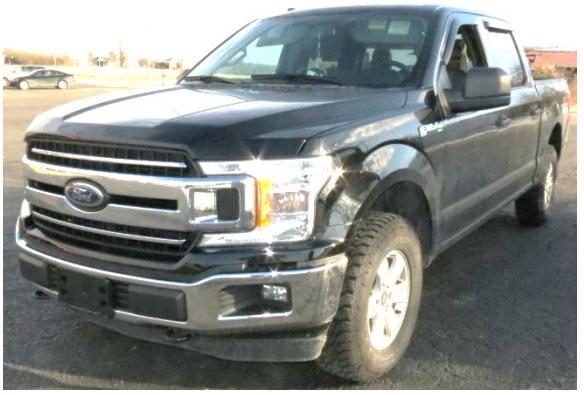
Figure 2. Left-front oblique view of the 2018 Ford F-150 after its repair

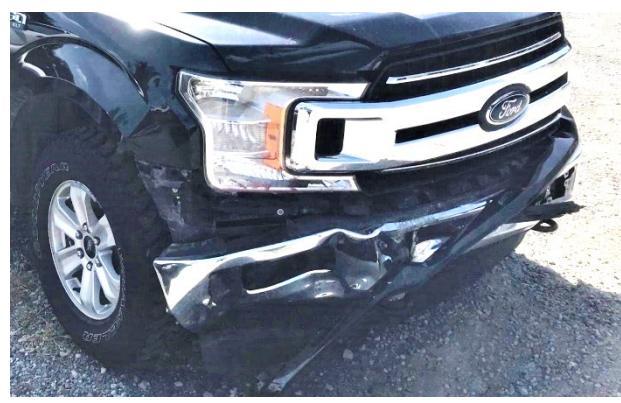
The Ford was completely repaired prior to SCI case assignment. However, 26 images of the damaged vehicle were provided to the SCI team by the repair facility, which documented the minor severity damage to the Ford and its post-crash condition prior to its repair. A front image (Figure 3) showed minor front end direct damage that appeared to begin near the vehicle's centerline and extended to the right-front bumper corner. There was minor crush and deflection of the bumper beam, and based on a visual review of the images appeared to be less than 10 cm (4 in) in magnitude.

The trim was displaced from the top of the bumper beam, and the right headlight assembly was cracked. The grille appeared to be depressed less than 2 cm (1 in). A small outward deflection of the right-front fender was visible immediately below the headlight. Red paint transfer was visible on the lower aspect of the headlight (Figure 4) and on the polymer bumper trim. Based on the images of the Ford, the SCI investigator assigned a collision deformation classification to the Ford of 01FZEW1. A complete WinSMASH calculation could not be computed due to the lack of damage measurements and unknown crash configuration. The WinSMASH barrier equivalent speed based on the estimated damage was 14 km/h (9 mph).

Figure 3. View of the Ford's front-plane damage pattern (repair facility provided image)

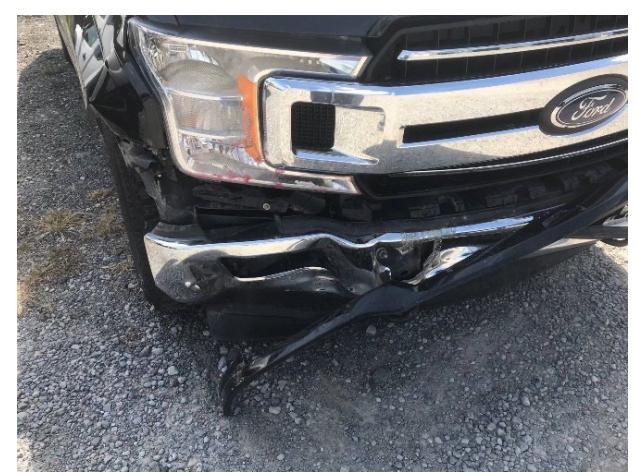
Figure 4. Close-up view of the Ford's front-plane damage pattern (repair facility provided image)

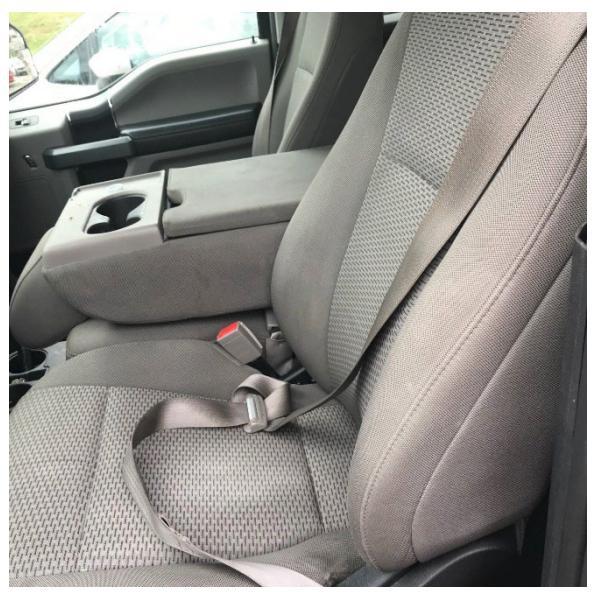
The repair order indicated that both the driver and front passenger belt systems, including the webbing, latch plate, and retractor, were replaced following the crash. The belt buckles were *not* replaced. It appeared to the SCI investigator that both front retractor pretensioners had actuated

as a result of the crash. In the images below, the webbing is extended from the retractor in the worn (used) position, which is the typical evidence of an actuated pretensioner.

Figure 5. View of the driver seat belt system (repair facility image)

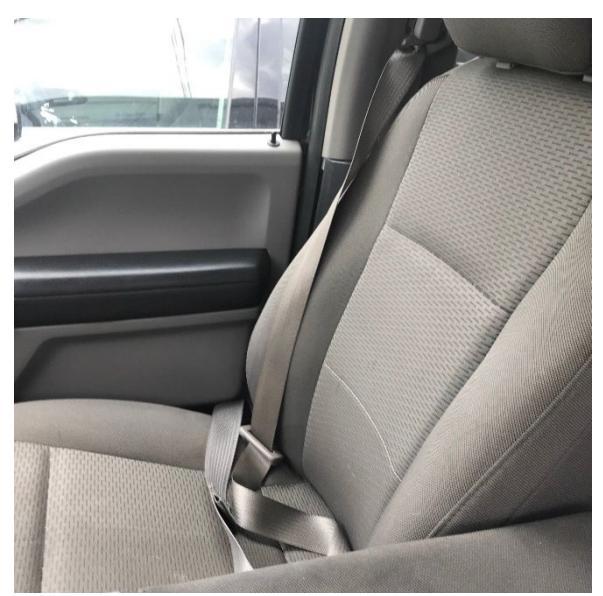
Figure 6. Passenger seat belt system (repair facility image
