U.S. Department  
of Transportation

**National Highway  
Traffic Safety  
Administration**

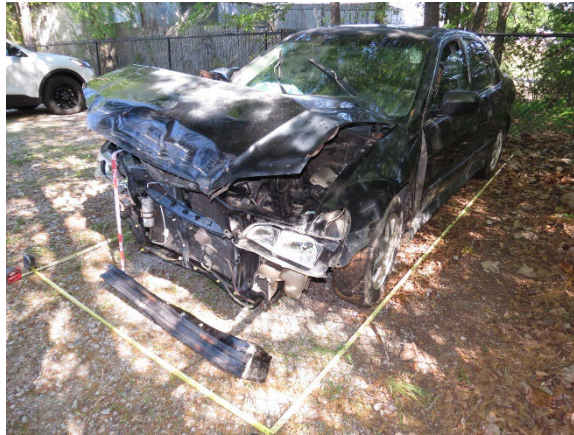
*Figure 1. Left front oblique view of the Honda*

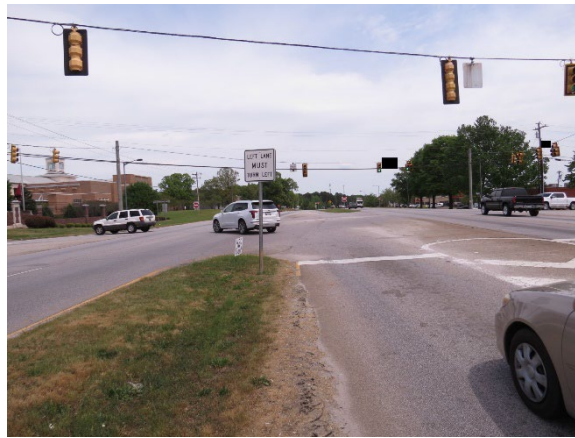
*Figure 2. East-looking trajectory view for the Honda at the intersection*

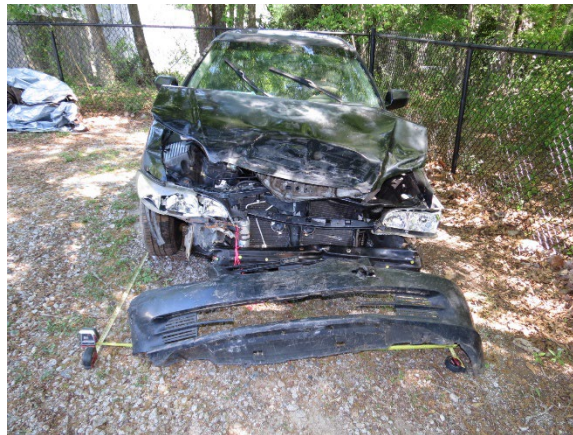
*Figure 4. Front view of the damaged Honda*

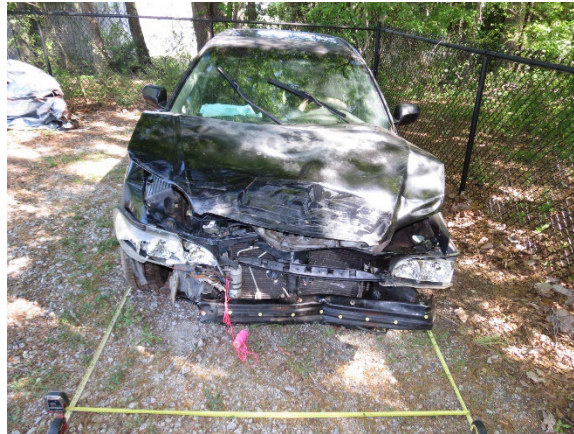
*Figure 5. Frontal crush of the Honda*

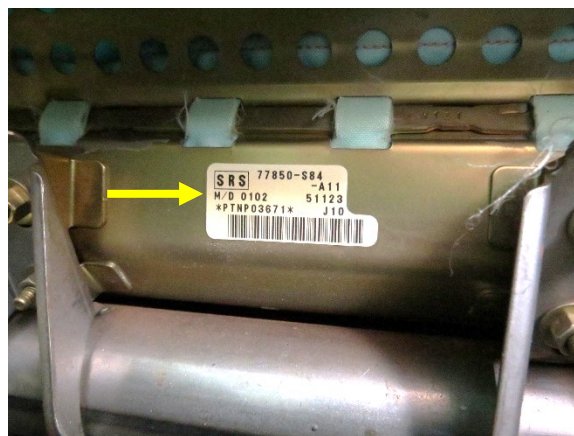
*Figure 9. Manufacturer's label for the passenger's frontal air bag in the Honda*

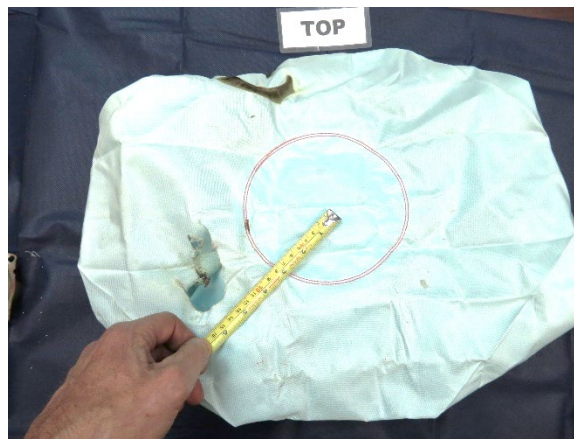
*Figure 10. Image depicting the holed driver's frontal air bag from the Honda*

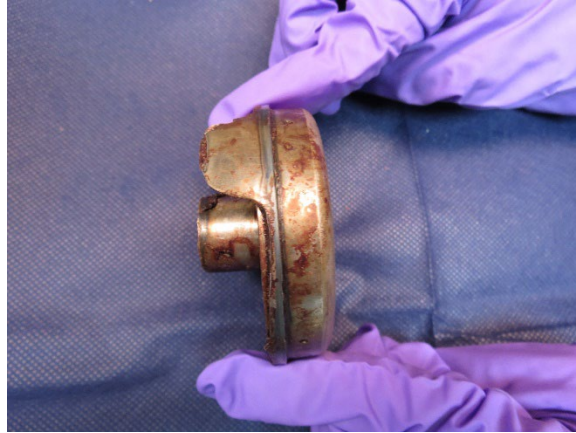
*Figure 11. Side view of the body of the Honda's ruptured inflator*

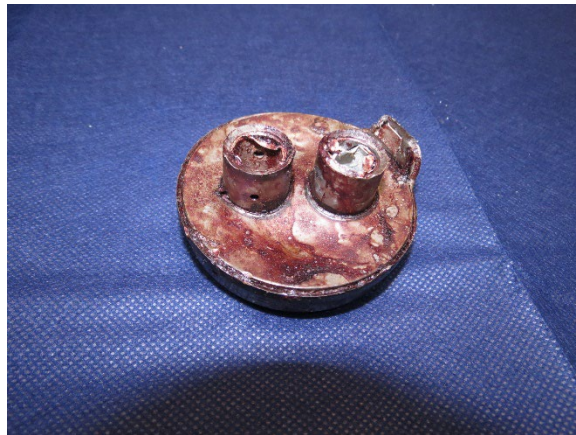
*Figure 12. Interior surface of the body of Honda's ruptured inflator*

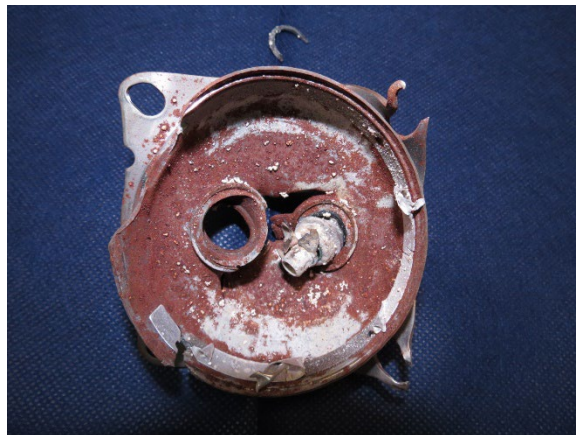
*Figure 13. Interior side of the bottom half to the Honda's ruptured inflator*

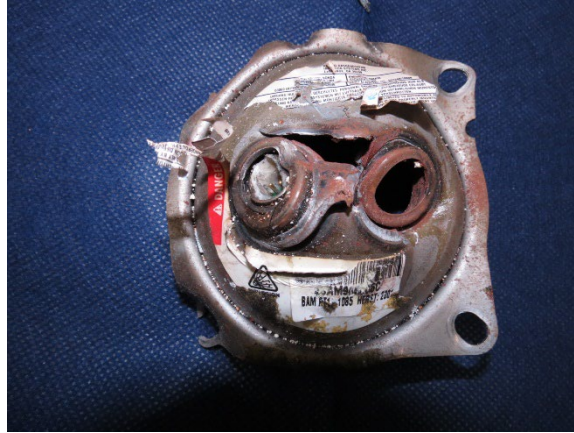
*Figure 14. Bottom half of the Honda's rupture inflator and the manufacture labels*
