U.S. Department
of Transportation

**National Highway
Traffic Safety
Administration**

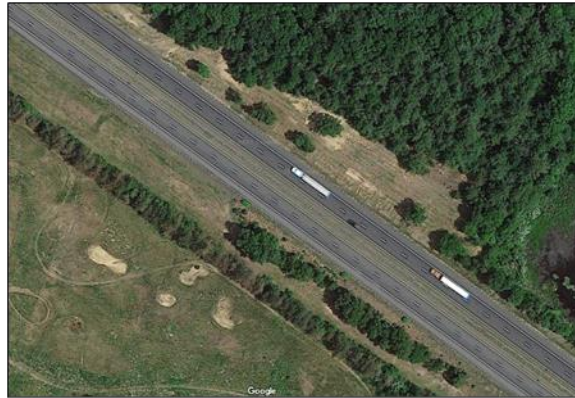
Figure 2. Aerial view of the trafficway from Google Maps © 2023 Maxar Technologies, MassGIS

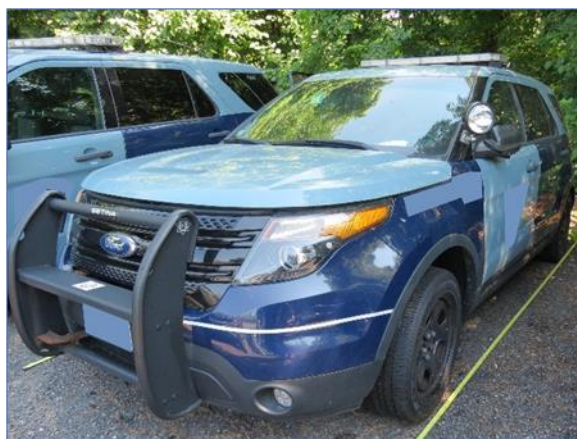
Figure 5. Left front oblique view of the 2014 Ford Explorer Police Interceptor at the time of the SCI vehicle inspection

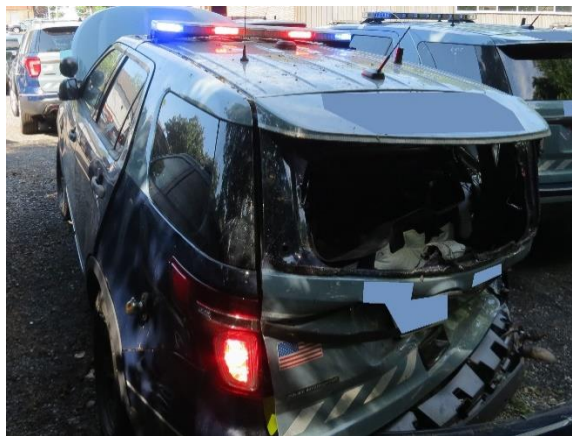
Figure 7. View of the Ford's partially illuminated emergency warning lights from the rear

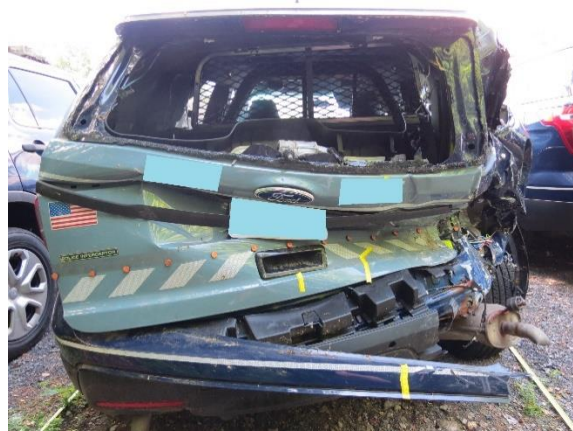
Figure 8. Back plane damage profile to the Ford from the impact by the Subaru

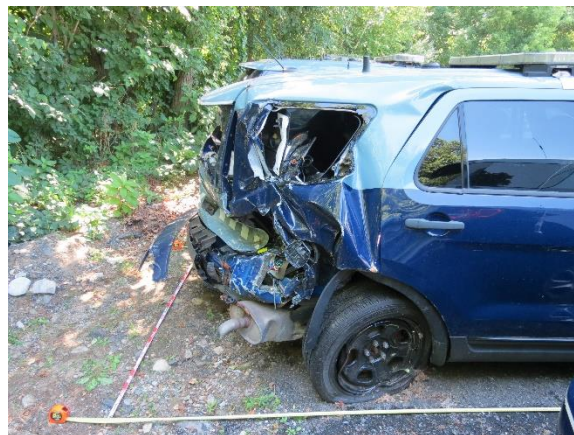
Figure 9. View of the back plane damage profile and depth of crush from the right plane perspective

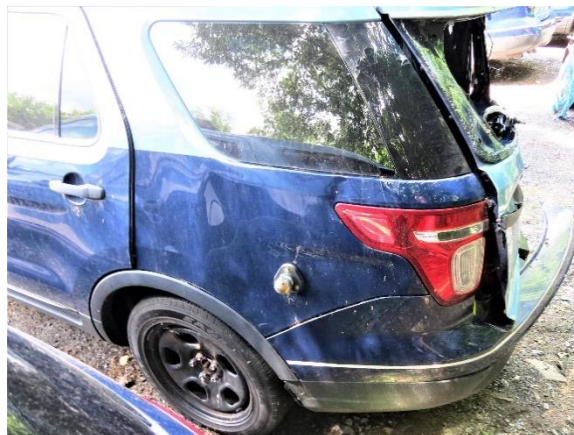
Figure 10. Left rear quarter panel damage from impact by the non-motorist

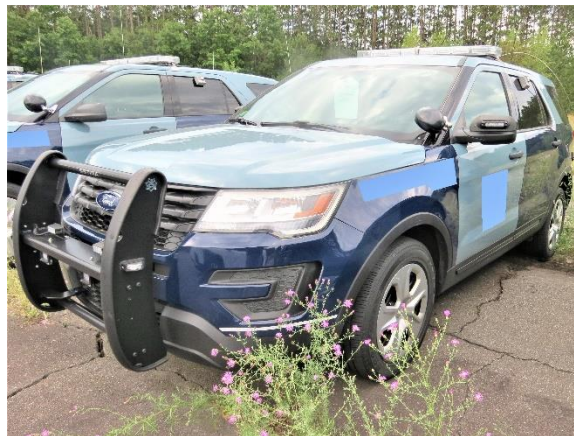
Figure 11. Left front oblique view of the 2017 Ford Explorer Police Interceptor at the time of the SCI vehicle inspection

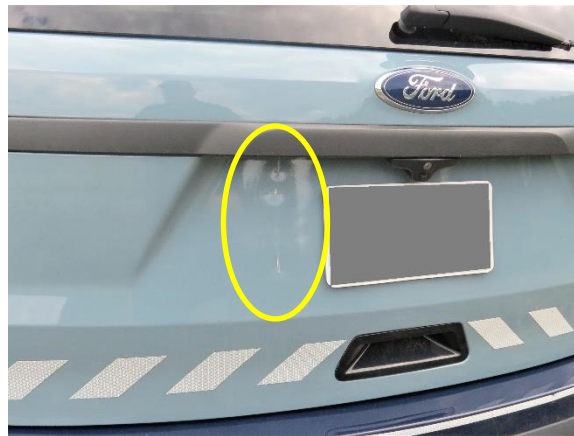
Figure 12. Back plane view of the minimal contact damage to the 2017 Ford (highlighted by yellow circle)

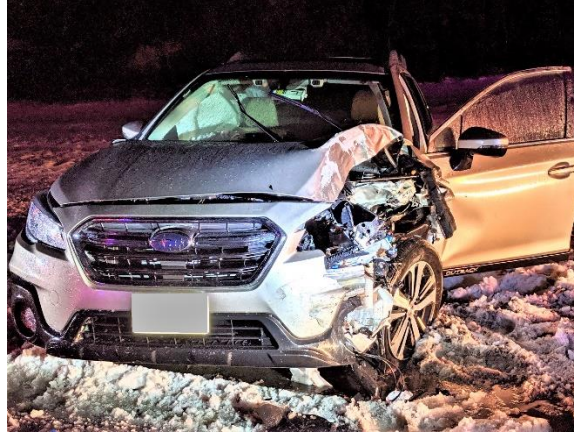
Figure 13. South-facing frontal view of the Subaru (on-scene law enforcement image)

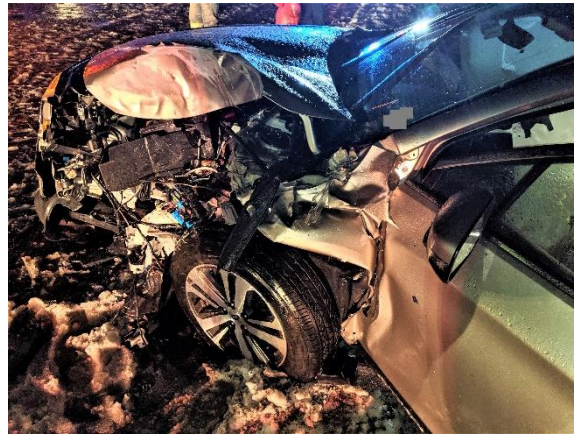
Figure 14. East-facing view of the left damage profile to the Subaru from the impact with the Ford (law enforcement image)
