National Highway Traffic Safety Administration

DOT HS 813 455

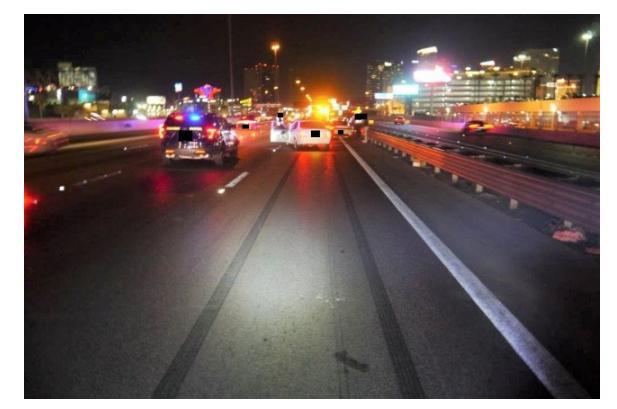
Figure 1. Crash site, approach to striking vehicle looking north (police photo)

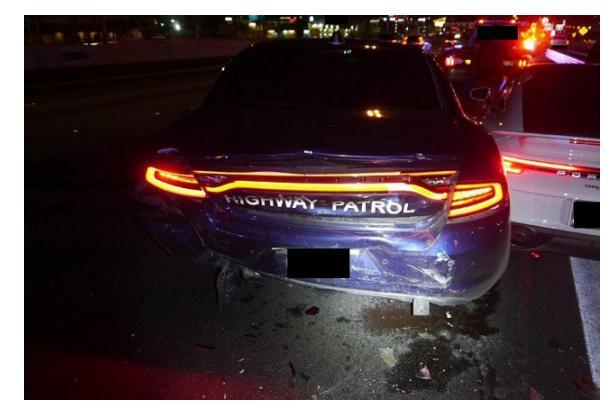
Figure 6. Rear emergency lights in flash mode looking north, 2016 Dodge Charger Pursuit and 2021 Porsche 911 Turbo (police photo)

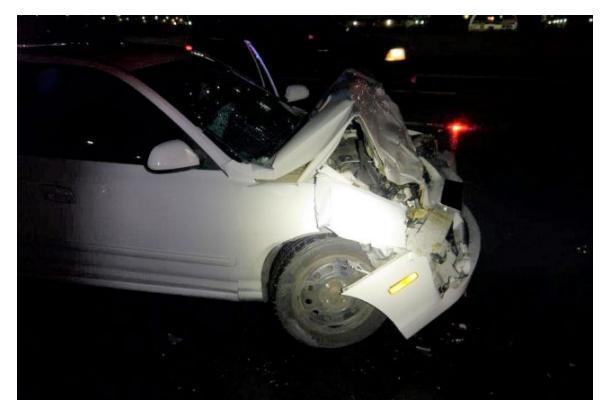
Figure 7. 2004 Hyundai Elantra at final rest looking west (police photo)

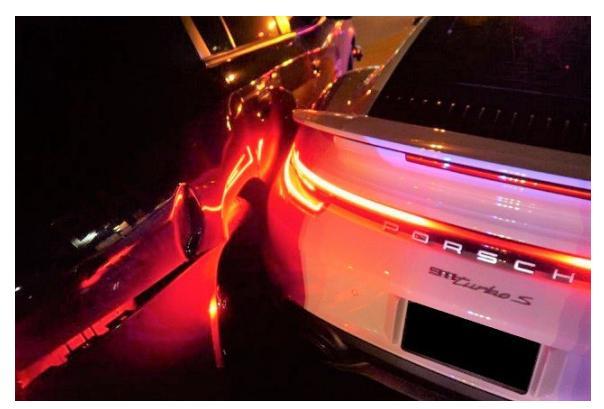
Figure 8. Porsche 911 Turbo S (right) and 2016 Dodge Charger Pursuit (left) at rest looking north (police photo)
