DOT HS 812 544

Special Crash Investigations On-Site Crash Avoidance Technology Investigation Vehicle: 2016 Mercedes-Benz C450 Location: California Crash Date: April 2016

On-Site Crash Avoidance Technology Investigation SCI Case Number DS16012 Vehicle: 2016 Mercedes-Benz C450 Location: California Crash Date: April 2016

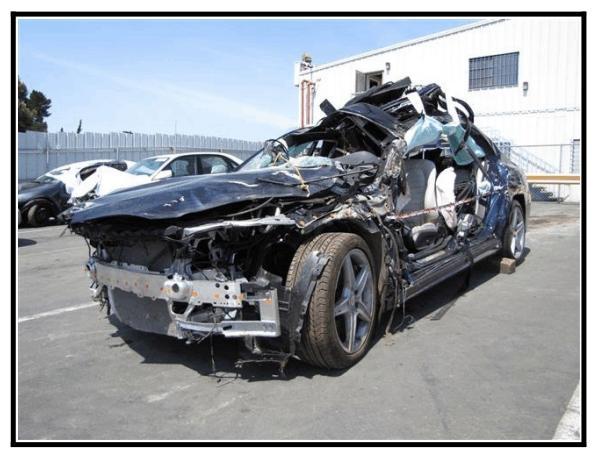
The interest in this single-vehicle crash was the crash avoidance (CA) technology in a 2016 Mercedes-Benz C450 (**Figure 1**). The Mercedes was equipped with a forward collision warning system that included active lane keeping assist, active brake assist, and autonomous brake intervention. The on-site investigation was intended to determine what role the CA system may have played in the crash. This investigation was initiated by the Special Crash Investigations (SCI) group of the National Highway Traffic Safety Administration on April 21, 2016 following a notification from Dynamic Science, Inc. The

Figure 1. 2016 Mercedes-Benz C450

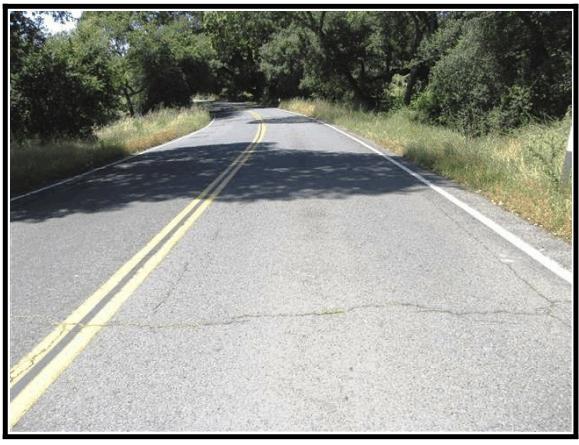
The crash site was a two-lane east/west countymaintained roadway situated in a rural area in California (**Figure 2**). The roadway configuration included one lane for each direction of travel. Each lane measured 3.3 m (10.8 ft) in width and the roadway measured 6.6 m (21.6 ft) in total width. The lanes were separated by a double yellow painted stripe, and were bordered on each side by solid white painted fog lines. The painted stripes appeared to be old, worn, chipped, and cracked in some areas, but were still clearly visible and continuous without interruption or gaps. According to the "Driving systems" section in

Figure 2. Crash site looking west

the operator's manual, the vehicle's lane keeping assist system can be impaired or may not function if lane markings are worn away or not clearly defined and sufficiently visible. The manual also states the system may be impaired or may not function if the lane or roadway is narrow and winding, but it does not define the parameters for such conditions.

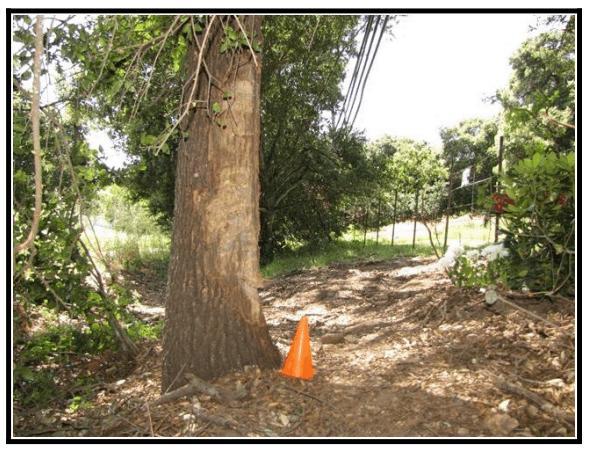
Event 2, another tree impact, immediately followed Event 1 and the front plane of the Mercedes impacted a tree trunk (**Figure 3**). This was a narrow left corner engagement which continued down the left plane of the vehicle.

Figure 3. Area of impact Event 2, damaged tree, looking northwest on roadside

Damage to the tree began 20.0 cm (7.8 in) above ground and extended upward ending at 140.0 cm (55.1 in) above ground. For the Mercedes in Event 2, the barrier algorithm of the WinSMASH program calculated a total delta-V of 13.0 km/h (8.0 mph), a longitudinal delta-V of -13.0 km/h (-8.0 mph), a lateral delta-V of 0 km/h, and a barrier equivalent speed (BES) of 13.0 km/h (8.0 mph). The WinSMASH results are considered borderline. The vehicle's EDR likely reported Event 1 and Event 2 as a single event (see EDR report, Record 2). The EDR record identified a frontal event type with deployments in which both frontal air bags deployed in two stages at 271 msec and 276 msec, respectively. Additionally, both pretensioners actuated at 278 msec, the driver's seat-mounted side air bag deployed at 315 msec and the passenger's frontal air bag third stage (vent) deployed at 349 msec. The Mercedes' EDR reported a maximum longitudinal delta-V of -18.0 km/h (-11.2 mph) and a maximum lateral delta-V of 7.0 km/h (4.3 mph). The EDR-reported vehicle speed at Time Stamp 0.0 seconds was 150 km/h (93 mph). EDR reported time from previous event (rollover) to current event (frontal) was 373 msec and the calculated distance traveled between events was 15.5 m (50.9 ft). Following Event 2, the Mercedes rotated counterclockwise and continued traveling at a relatively high speed.

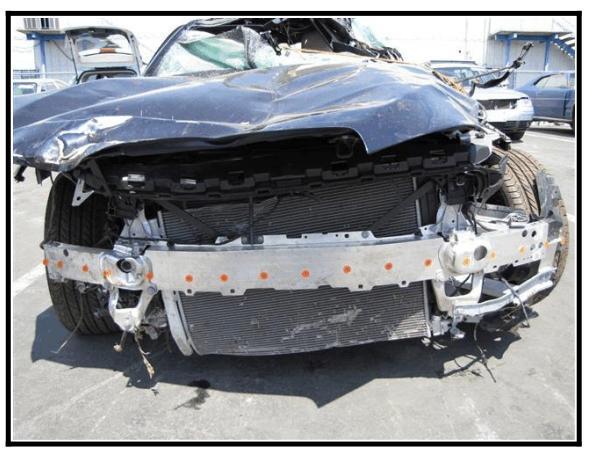
Figure 4. Front bumper crush measurements, 2016 Mercedes-Benz C450

structure, resulting in a moderate damage severity. The collision deformation classification (CDC) for the Mercedes in Event 1 was 12FRGN8.

Event 2 was another tree impact where the front plane of the Mercedes impacted a tree trunk. This impact was the most severe of the three events. The event was a narrow left corner engagement which continued down the left plane of the vehicle. The front bumper fascia, left front fender, left B-pillar, and both left side doors were missing from the vehicle at the time of the inspection precluding exact direct damage measurements. However, the front bumper backing bar was crushed, and the damage pattern on the left plane including the left roof side rail, left A-pillar, and left C-pillar suggested that direct damage to the left plane began at or near the front left bumper corner and extended rearward ending 17.0 cm (6.7 in) aft of the left rear axle. The Field L extended from a bumper corner to bumper corner and measured 145.0 cm (57.1 in). Seventeen measurements were taken at bumper level (**Figure 4**) by the Nikon Total Station, and the Faro Blitz program computed crush measurement in six increments as follows: $C_1 = 6.0$ cm (2.4 in), $C_2 = 0$ cm, $C_3 = 0$ cm, $C_4 = 2.0$ cm (0.8 in), $C_5 = 0$ cm, $C_6 = 2.0$ cm (0.8 in). Maximum crush was located at C_1 and the CDC for the Mercedes in Event 2 was 12FLAE9.

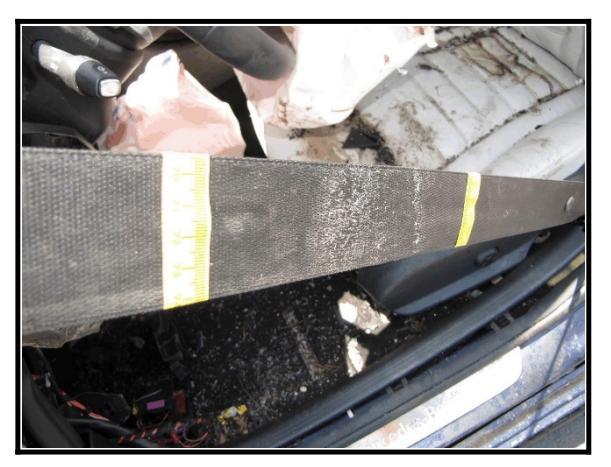
locking retractor (ELR). The EDR report stated the driver's belt was buckled, and occupant loading evidence was located at 24.0 cm (9.4 in) above the stop button (**Figure 5**). This belt was cut during post-crash activities, and the left Bpillar with the D-ring assembly was removed and missing.

Figure 6. Driver's seat belt, occupant loading evidence, 2016 Mercedes-Benz C450

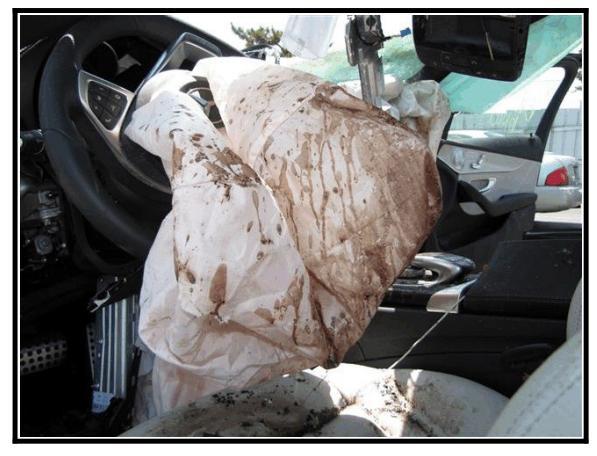
The driver's frontal air bag deployed from a module in the steering wheel hub. The air bag deployed normally without damage to either the air bag or cover flaps. It measured 45.0 cm (17.7 in) in diameter and was configured with two internal tethers and two vent ports located on the

Figure 5. Driver's deployed frontal air bag, 2016 Mercedes-Benz C450

back panel. This air bag was soaked with blood deposited by the driver, who sustained a head injury including massive trauma to his skull and brain (**Figure 6**).

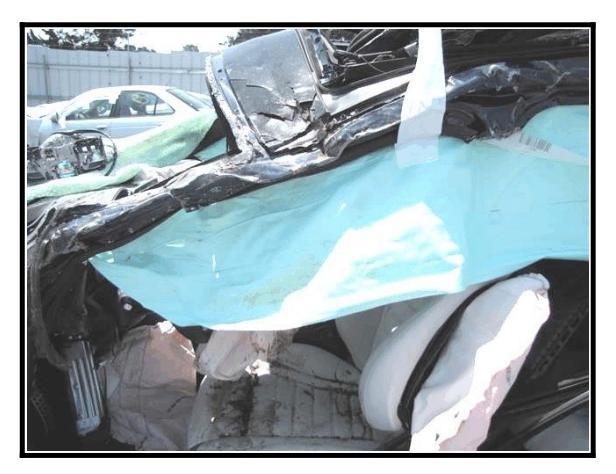
The Mercedes was configured with IC air bags that complied with Federal Motor Vehicle Safety Standard (FMVSS) 226 "Ejection Mitigation," a rule established to reduce the partial and complete ejection of vehicle occupants through side windows in crashes, particularly rollover crashes. Both IC air bags deployed during a non-collision situation when the SRS sensed an impending rollover. The left IC air bag deployed from the roof rail above the front and second rows. It measured 177.0 cm (69.7 in) in width and 37.0 cm (14.6 in) in length. The air bag provided full coverage over the side glass for both rows. In its deflated state, the bottom edge extended to a length 10.0 cm (3.9 in) below the bottom edge

Figure 7. Deployed left IC air bag, 2016 Mercedes-Benz CC450

of the side glass. This air bag was configured without sail panels or tethers. At the forward aspect, it was connected to the A-pillar beginning at 8.0 cm (3.1 in) above the side glass and continuing upward to the roof side rail (**Figure 7**). The air bag revealed abrasions on the outboard panel caused by contact with the fractured side glass and contact with the impacted tree. This damage appeared to be superficial and did not penetrate the panel. The inboard panel revealed slight blood deposits from the driver.
