U.S. Department of Transportation

National Highway Traffic Safety Administration

DOT HS 812 612

Special Crash Investigations On-Site Child Restraint System Crash Investigation Vehicle: 2015 Honda Odyssey Location: New Jersey Crash Date: March 2016

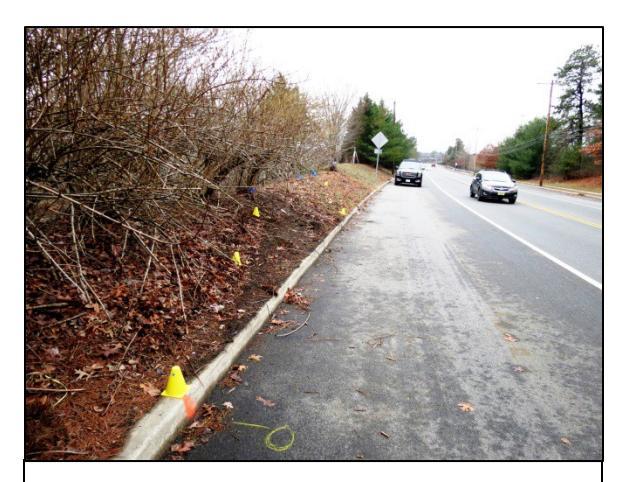
The first crash event occurred as the left front tire of the Honda struck and overrode the raised curb of the east roadway edge (Event 1). This impact was evidenced by a tire mark on the concrete surface of the curb. The Honda proceeded on its errant trajectory as it departed the roadway (Figure 4) and sideswiped shrubbery on its left aspect (Event 2). The Honda then began to ramp up the berm as it struck the curb with its right front tire (Event 3). SCI reconstruction of the crash and analysis of the imaged EDR data determined that the initial left front curbstrike was the source of AE. According to the vehicle's imaged EDR data, the combination of the initial ramp of the vehicle along the upslope of the berm and the subsequent right front curbstrike resulted in the respective de-

Figure 4: View of the southbound Honda's errant east roadside departure, with yellow cones highlighting the Honda's tire marks.

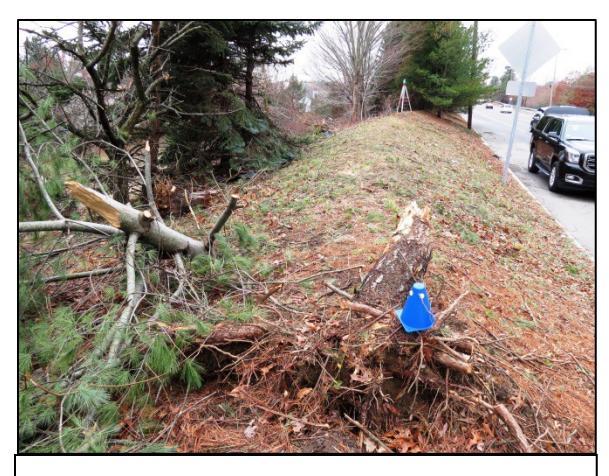
Figure 5: South-facing view of the berm and the Honda's crash trajectory, with sheared tree debris in the foreground and a visible path through the trees in the background.

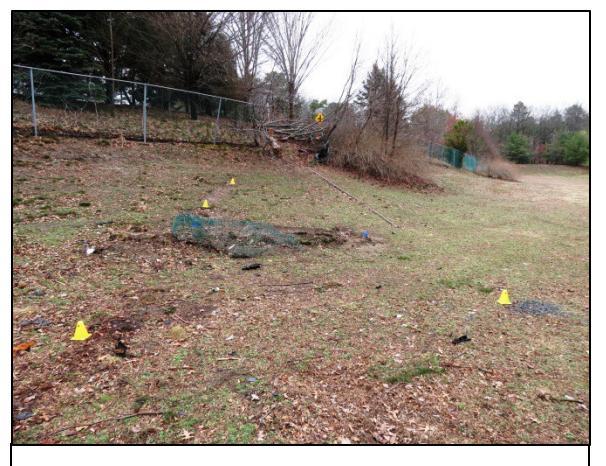
Figure 6: North-facing lookback view at the Honda's final rest location toward the elevated berm and its destructive path through the roadside.

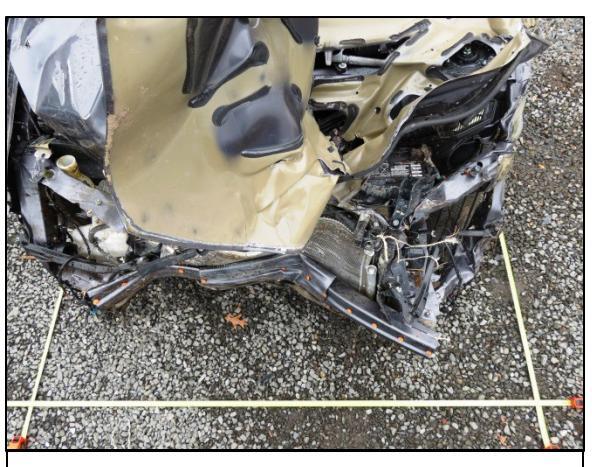
Front plane damage to the Honda consisted of the disintegration of both headlight assemblies and the separation of the bumper fascia, grille, and surrounding front plane trim. There was moderate longitudinal deformation to the bumper beam and underlying engine compartment components, and the vehicle's hood was partially separated and awkwardly deformed. Several distinct U-shaped patterns of deformation were visible to the front bumper beam, associative to multiple impacts with large and small diameter trees. **Figure 8** depicts the Honda and the SCI documentation of its damage. A residual crush profile was documented using a Nikon Nivo 5.M+ total station mapping system and a direct and induced damage (Field-L)

Figure 8: Overhead perspective view of the Honda's front plane deformation pattern.

width of 120 cm (47.2 in) across the entire width of the exposed front bumper beam. It is important to note that this profile represented the total damage sustained by the front bumper beam as a cumulative result of the numerous frontal events. The resultant measurements included: C1 = 9 cm (3.5 in), C2 = 22 cm (8.7 in), C3 = 39 cm (15.4 in), C4 = 35 cm (13.8 in), C5 = 37 cm (14.6 in), and C6 = 25 cm (9.8 in). Maximum crush was located at the C3 measurement location, immediately left of the vehicle's centerline.

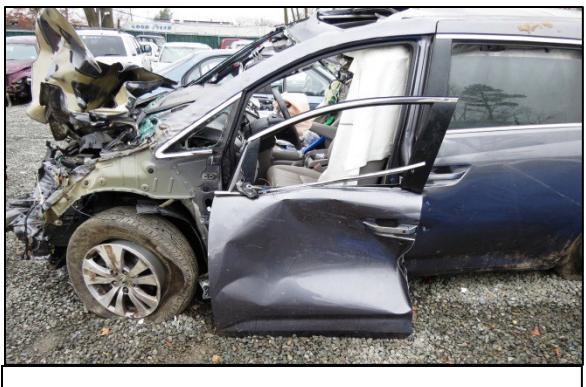
Figure 9: View of the damage to the Honda's left plane

Damage to the left plane was biased to the forward aspect of the Honda (**Figure 9**). Rearward displacement of the left front tire/wheel measured 6 cm (2.4 in). The left front fender and mirror were sheared from the vehicle, with deformation to the left lower A-pillar and left front door. This deformation had jammed the left front door closed, and it was removed post-crash by emergency response personnel using hydraulic rescue tools. Inoperability of the vehicle's electric system prevented operation of the left rear sliding door at the time of the SCI inspection. There were surface scratches, abrasions, and minor deformation

to the left roof side rail from ground contact during the rollover sequence. The remainder of the damage to the left plane consisted of minor longitudinal surface scratches and abrasions to the body panels and deflection of the rear bumper fascia from the numerous sideswipes with trees during the crash.

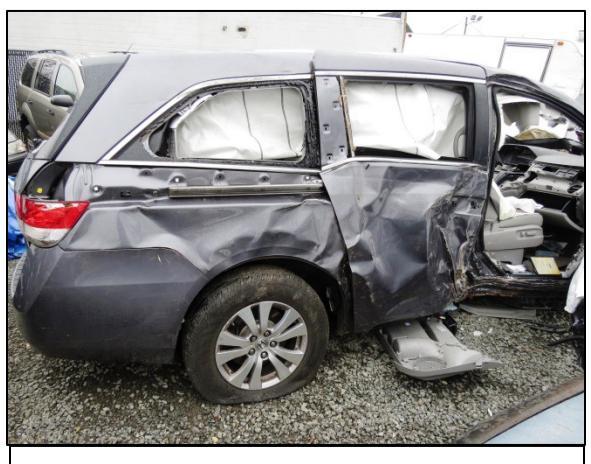
The right plane of the Honda (**Figure 10**) exhibited damage from the rollover and impacts with multiple trees/vegetation. The right front fender was deformed, and the right front tire/wheel was rotated CW and displaced rearward approximately 8 cm (3.1 in). At least one swiping tree impact produced deformation to the right front door, right B-pillar, and right rear sliding door, evidenced by brown-colored abrasions and bark/tree fiber captured in the body seams. As a result of this damage, both right doors were jammed shut. Post-crash, the right front door was forced open. During that process, the exterior door skin of the right front door was sheared

Figure 10: The Honda's damaged right plane.

completely off. Rollover deformation was visible to the right rear sliding door, right quarter panel, and right roof side rail, consisting primarily of minor lateral deformation with minor surface scratches and abrasions.

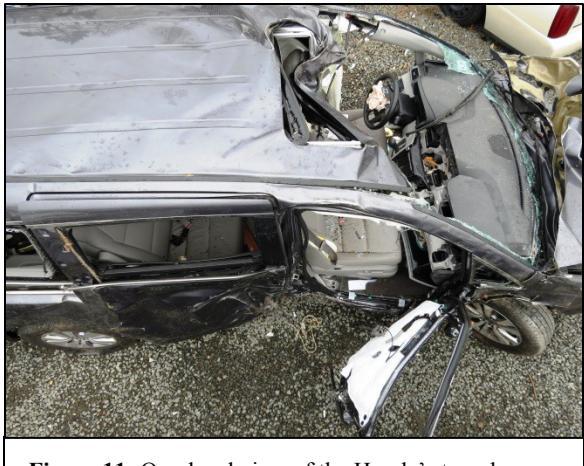
Significant damage was sustained by the forward aspect of the Honda's top plane as a result of the multiple event crash sequence. The most significant damage consisted of longitudinal deformation to the windshield header and roof structure above the front row of the Honda. Specifically, the windshield header was sheared from its juncture with the left upper A-pillar and left roof side rail. In conjunction with this separation, the header and roof structure between the windshield header and the opening of the sunroof were crushed longitudinally such that nearly the entire opening of the sunroof was collapsed.

Figure 11: Overhead view of the Honda's top plane damage.

Figure 11 depicts an overhead view of the Honda and the significant longitudinal deformation sustained by the windshield header, roof, and sunroof opening. This deformation produced significant intrusion, which is discussed in the Interior Damage section below. In the deformed state, a U-shaped damage pattern was centered in an area where the windshield header was engaged against the headrest of the driver's seat position. The total depth of this longitudinal crush was estimated to be approximately 51 cm (20 in).

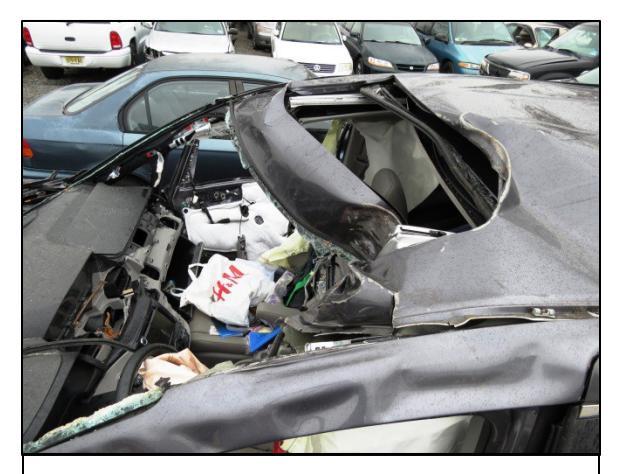
SCI analysis determined that this damage pattern (Figure 12) was the result of direct contact and engagement with a large diameter tree and most likely was associated with Event 4. Specifically,

at least one of the large diameter trees struck by the Honda's front plane and sheared at or near the height of the initial contact (bumper beam height). The sheared upper section of the tree subsequently contacted and deformed the windshield header/roof structure as the Honda maintained its forward momentum. The remainder of the damage to the top plane of the Honda consisted of minor deformation, induced buckling, and surface scratches/abrasions that were attributable to the multiple swiping impacts with tree branches and the rollover.

Figure 12: Deformation pattern to the Honda's windshield header and roof structure associated with engagement of the vehicle with a sheared section of large diameter tree.

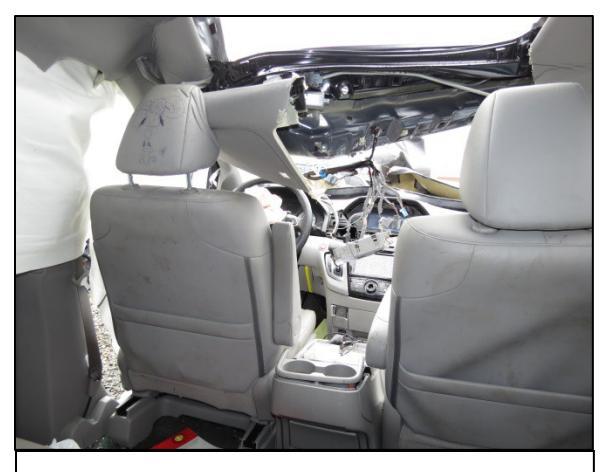
Damage to the interior of the Honda consisted of component intrusion, occupant contact, supplemental restraint system deployment, and post-crash activities. The intrusions were associated with the numerous impacts on the front, left, and right planes with multiple large and small diameter trees. A focal area of intrusion was observed to the windshield header, associative to contact and engagement with a sheared section of at least one large diameter tree. In its damaged state, the interior aspect of the windshield header was engaged against the face of the driver's adjustable head restraint. It is certain that the trees that produced this damage also fractured and penetrated the windshield glazing, and undoubtedly also contacted the driver's head and face. **Figure 13** depicts the intruded windshield header. The maximum intruded depth measured 53 cm (21 in) longitudinally. The only other measurable intrusion in the Honda was the 13 cm (5.1 in) lateral intrusion of the right B- pillar near floor level. The deformed pillar was engaged against the rear aspect of the back of the front right seat and seat track.

Figure 13: Intruded windshield header engaged against the driver's adjustable head restraint in the Honda.

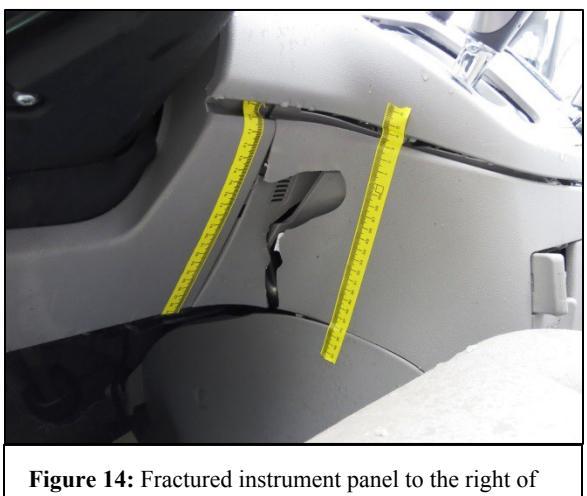
Figure 14: Fractured instrument panel to the right of the steering column from the Honda driver's right knee.

Occupant contact was visible in the front row, attributable to the driver's kinematics. There was a large fracture and indentation to the right aspect of the left lower instrument panel/left aspect of the center instrument stack (Figure 14). This contact resulted from loading by the driver's right knee during the multiple front plane impacts at the beginning of the crash sequence. The driver also certainly contacted the windshield header with her head and face as it intruded. However, there was no visible contact to the header, due largely in part to its engagement against the head restraint that prohibited thorough inspection. It was likely that the driver contacted the center stack, roof, right door components, and several of the deployed air bags during the multiple event and rollover crash.

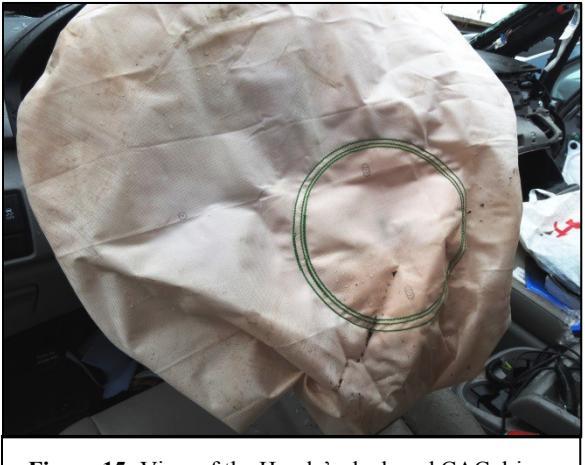
The driver's CAC frontal air bag (**Figure 15**) deployed from the module without damage or occupant contact to the module cover flaps. In its deflated state, the air bag measured 64 cm (25.2 in) in overall diameter. There was a 16 cm (6.3 in) diameter center stitch pattern, to which internal tethers were affixed. Small 4 cm (1.6 in) diameter vents were located on the rear aspect of the air bag at the 10 and 2 o'clock positions. There was no discernable occupant contact or crash-related damage to the driver's CAC frontal air bag. However, despite the lack of physical evidence, the driver certainly contacted the air bag during the crash sequence.

Figure 15: View of the Honda's deployed CAC driver air bag at the time of the SCI vehicle inspection.

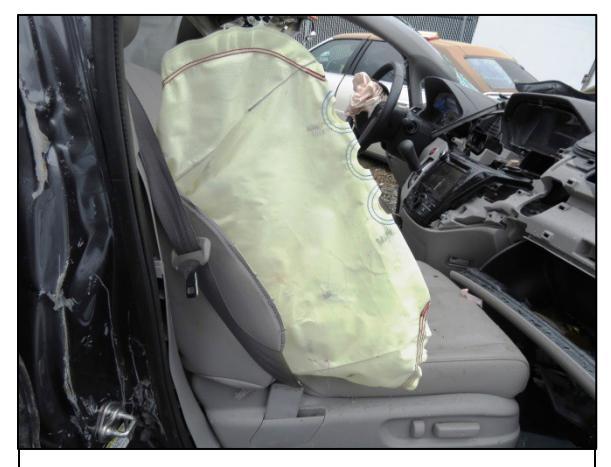
Figure 16: Deployed front row right seat-mounted side impact air bag in the Honda.

The front row right seat-mounted side impact air bag deployed through 56 cm (22.0 in) of stitching on the leading outboard aspect of the seatback (**Figure 16**). It was oval in overall shape, and measured approximately 58 cm (22.8 in) in overall height and 30 cm (11.8 in) in overall width. There were three 3 cm (1.2 in) diameter vents on the leading edge of the air bag. There was no discernable occupant contact or crash-related damage to the front row right side impact air bag.

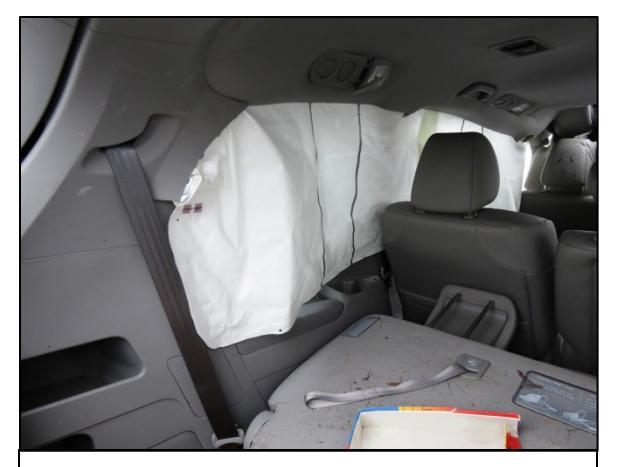
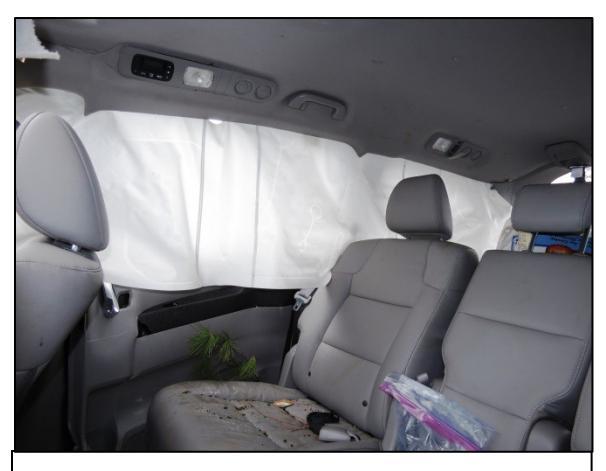
The IC air bags deployed from the roof side rails through the edge of the headliner and provided protection for all outboard positions of the Honda. In their deflated states, the IC air bags measured 256 cm (100.8 in) in overall length. They were affixed to their respective upper A-pillars by a 15 cm (5.9 in) fabric tether. A similar 5 cm (2.0 in) tether was located at the D-pillars. Vertical coverage of the IC air bags measured 60 cm (23.6 in) at the front row positions, 58 cm (22.8 in) at the B-pillars, 56 cm (22.0 in) at the second row positions, 52 cm (20.5 in) at the C-pillars, and 50 cm (19.7 in) at the third row positions.

Figure 17: View of the Honda's deployed left IC air bag for the third and second row seat positions.

Figure 18: Deployed right IC air bag for the second row position in the Honda.

It should be noted that the left IC air bag had been cut post-crash from the A-pillar tether up and along the roof side rail to the front row (driver's position). Similarly, the right IC air bag had been cut from the A-pillar tether to the B-pillar, and the complete cut section was missing from the vehicle. There was no discernable occupant contact to any of the remaining portion of either of the Honda's IC air bags. **Figure 17** depicts the left IC air bag, while **Figure 18** depicts the right IC air bag.

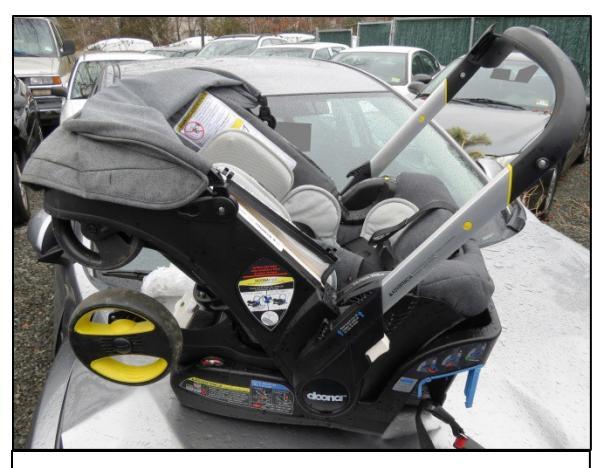
The CRS was found unsecured in the second row of the Honda at the time of the SCI vehicle in-

Figure 20: The Doona Infant CRS at the time of the SCI inspection.

spection. The fabric of the CRS was removed and the CRS shell was inspected for crash-related loading evidence and damage; none was detected. The harness straps were adjusted to their middle slot adjustment position, and the lower buckle strap was routed through its path. An inspection of the harness revealed historical use. The webbing was gathered in the belt path of the retainer clip (**Figure 21**). Both harness straps were cut and the latch plates remained engaged in the buckle of the CRS (**Figure 22**). This evidence indicated that the 5-month-old child was restrained by the integral harness of the CRS at the time of the crash.

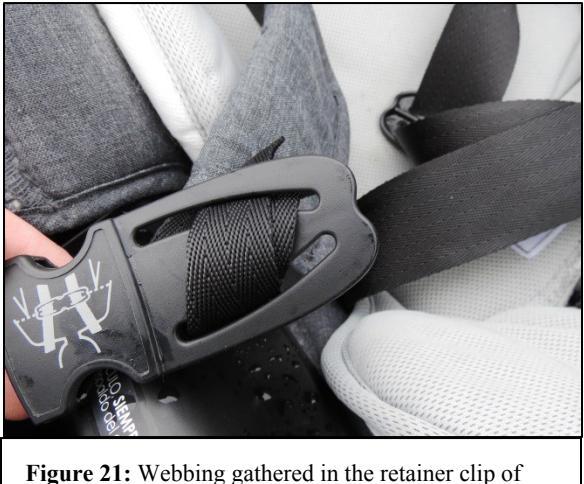
Figure 21: Webbing gathered in the retainer clip of the Doona Infant CRS.

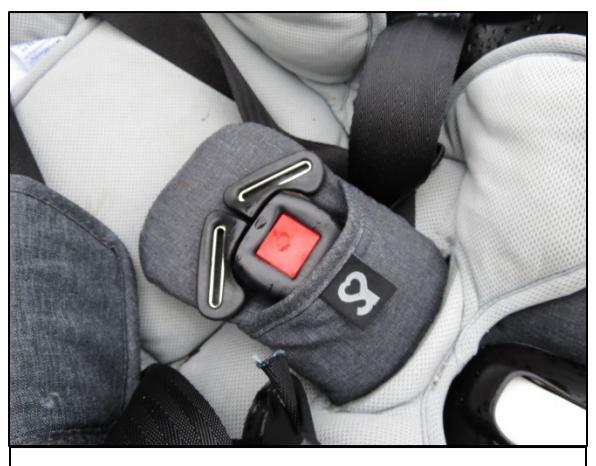
Figure 22: Latch plates of the CRS harness' engaged in the buckle at the time of the SCI inspection.

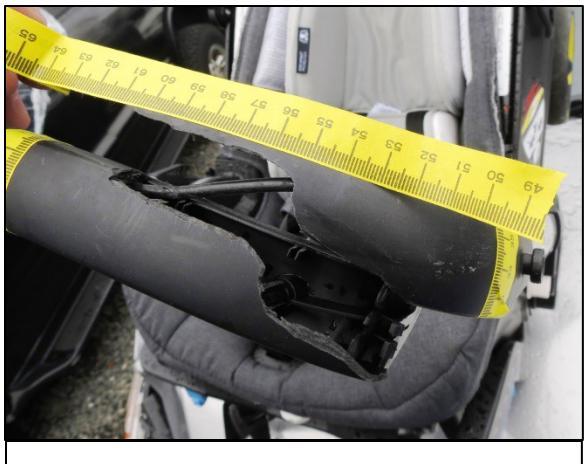
Positioning the CRS in the Honda's second row revealed that the LATCH equipment appeared to be adjusted to the appropriate length to achieve securement of the CRS in the vehicle when used. However, there was no evidence that the LATCH equipment was in use at the time of the crash. The lack of securement of the CRS in the vehicle permitted its displacement about the vehicle's interior during the multiple events of the crash. The folding stroller/carry handle was observed to be folded open in the carry position at the time of inspection. A fracture of the handle measuring 12 cm (4.7 in) in length was observed to the top left corner of the handle (**Figure 23**). It was determined that this damage most likely occurred

Figure 23: Fracture to the handle of the Doona CRS.

during the final stages of the crash as the CRS was directed toward the right side of the vehicle as the Honda completed its rollover sequence. The CRS was found post-crash by a witness to the crash who stopped to render aid. This witness found the CRS upside down in the second row right area of the Honda, on top of the deployed right IC air bag. There was no other remarkable damage to the CRS or its base.

It likely was not until the rollover sequence that the CRS became displaced laterally toward the right plane as the vehicle came to final rest. The CRS contacted the right roof side rail and deployed IC air bag. This fractured the handle of the CRS, but the infant remained protected by the shell of the CRS and secured in it. She probably experienced minor contact with the roof side rail, which produced a facial contusion. There was no evidence of this contact discernable at the time of the SCI inspection. The first arriving witness to the vehicle post-crash heard the cries of the infant and found the CRS lying unsecured against the right roof side rail surface of the Honda, face down. This witness righted the infant CRS, cut the harness straps, and subsequently removed the infant entirely from the CRS and vehicle. Once at the crash scene, EMS personnel assumed care of the infant and transported her by ambulance to a local hospital. She was examined and released in hours of the crash. Although there were no injuries to the child documented by her medical records, law enforcement indicated that the child had sustained a minor facial contusion. As indicated, the facial contusion probably resulted from contact with right plane components during the rollover sequence.

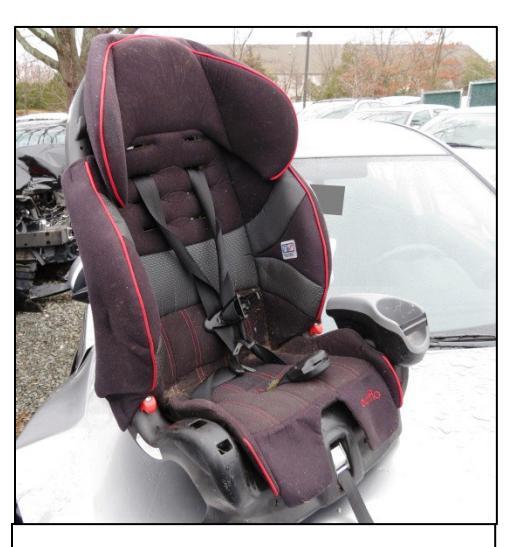
A second CRS was also found in the Honda at the time of the SCI vehicle inspection. This CRS was an Evenflo Maestro harnessed booster CRS, manufactured in the United States on April 29, 2014. The Evenflo booster CRS (Figure 24) was identified by the model number 31021270C. It was equipped with the LATCH system and was designed for use in a forward-facing orientation with a harness for children weighing 10 to 22.6 kg (22 to 50 lb) and whose height was 71 to 127 cm (28 to 50 in). Once the child exceeded the weight threshold, it could be used as a booster CRS for children up to 45 kg (100 lb). Labeling on the booster CRS stated that it expires in April 2020. As of the date of this technical report, there was one active recall concerning this specific Evenflo Maestro CRS. The recall was identified by the NHTSA number 14C003000 and concerned difficulty in releasing the buckle of the harness system, such that the latch could become stuck in the buckle and unable to be released. The CRS was not believed to have been ser-

Figure 24: Evenflo Maestro harnessed booster CRS found in the Honda at the time of the SCI vehicle inspection. Note that this CRS was not occupied at the time of the crash.

viced for this recall. However, there was no damage to the harnessed booster CRS, and it was not occupied at the time of the crash. Due to the fatal outcome of the driver, the specific pre-crash positioning of the harnessed booster CRS and its level of securement in the Honda remains unknown.
