U.S. Department  
of Transportation

**National Highway  
Traffic Safety  
Administration**

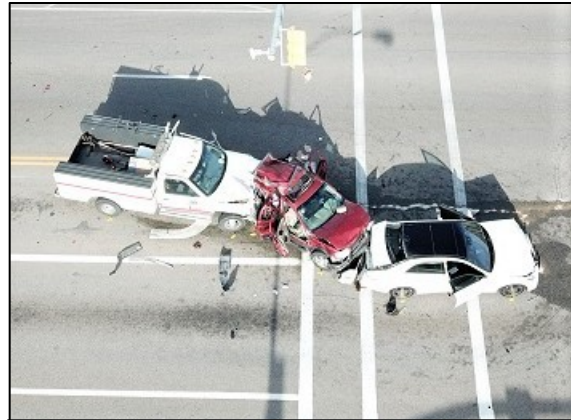
**Figure 3.** Final rest overhead view looking east (police photo).

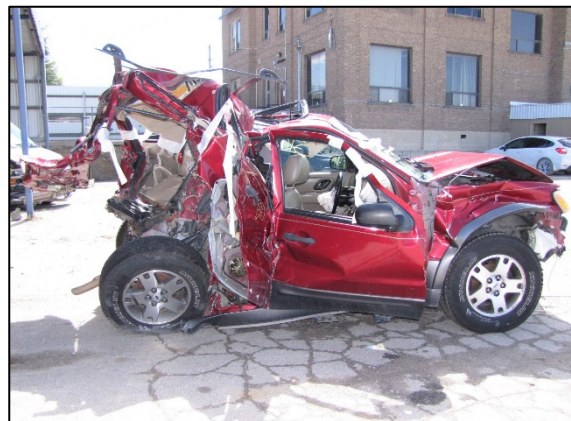
**Figure 4.** Right side view, the 2003 Ford Escape.

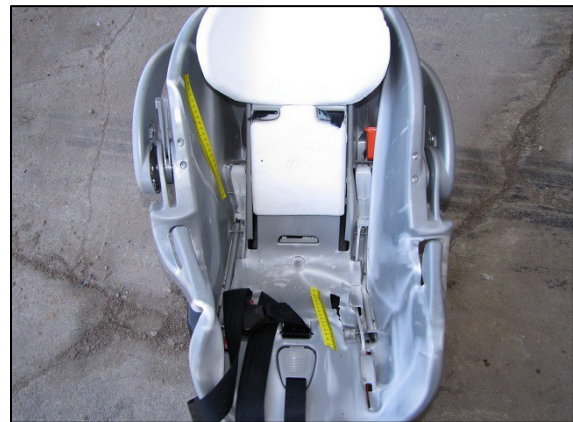
**Figure 7.** Baby Trend Flex-Loc ISS shell with damage.

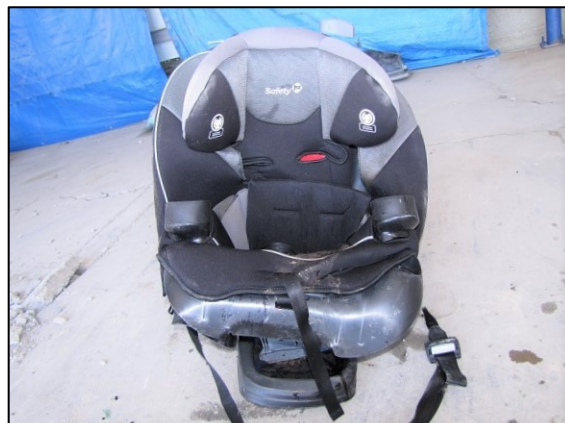
**Figure 8.** Safety 1st Everfit CRS.

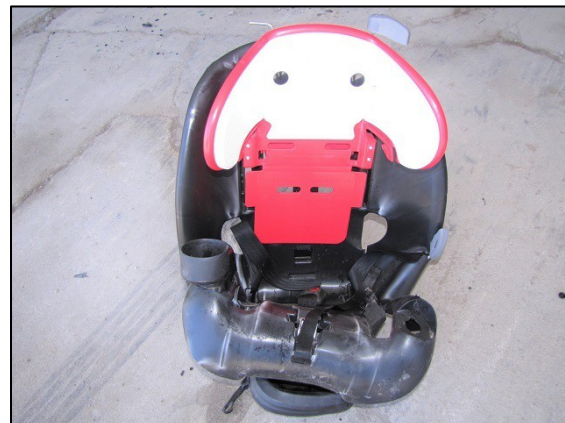
**Figure 9.** Safety 1st Everfit CRS shell with damage.

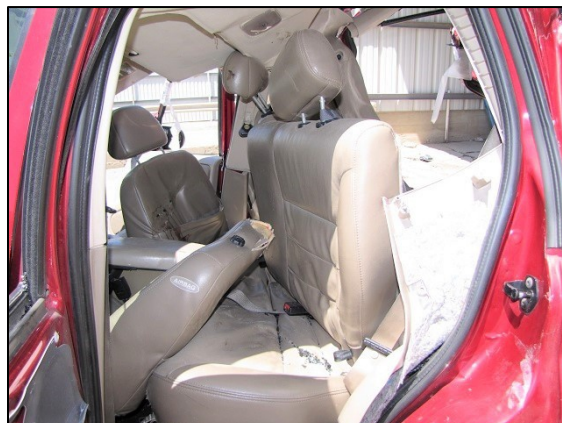
**Figure 10.** Interior second-row view from the driver's side.
