U.S. Department
of Transportation

**National Highway
Traffic Safety
Administration**

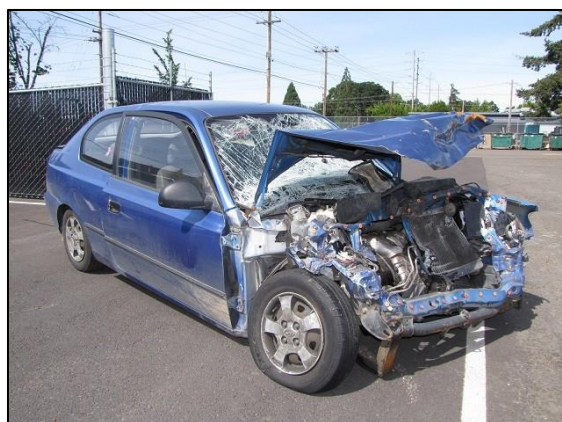
Figure 1. The 2002 Hyundai Accent.

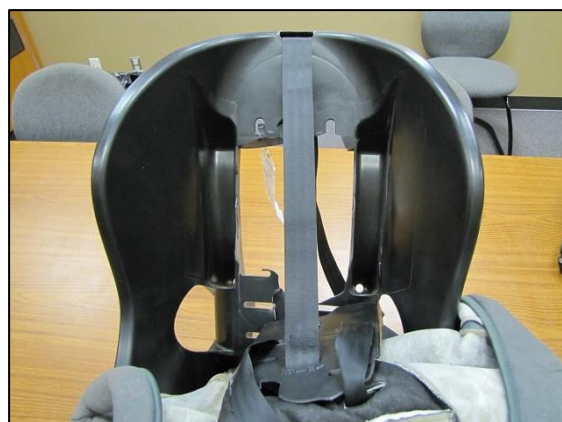
Figure 2. Cosco Scenera Next CRS shell back support without padding.

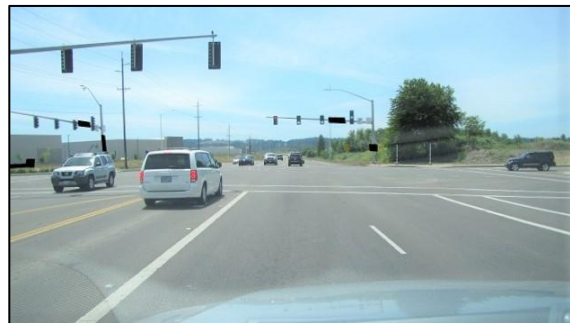
Figure 3. Crash site, the 2002 Hyundai Accent southbound approaching.

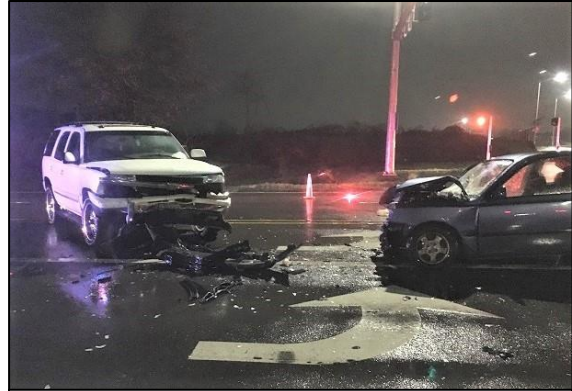
Figure 4. Post-crash final rest view, looking east (police photo).

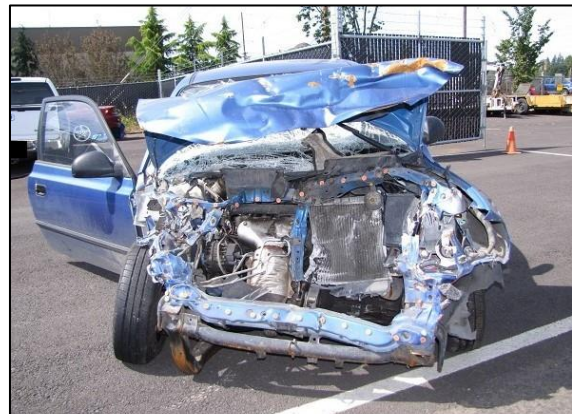
Figure 5. Front-plane damage, the 2002 Hyundai Accent.

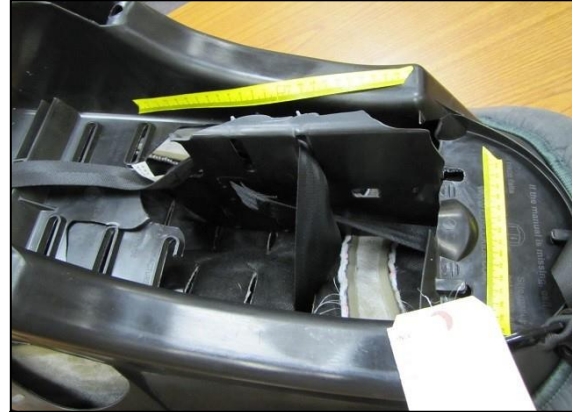
Figure 6. Fractures, back support of the CRS.

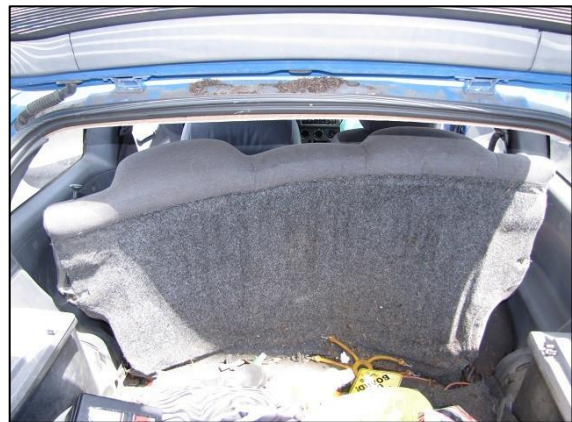
Figure 7. Second-row seat back, the 2002 Hyundai Accent.

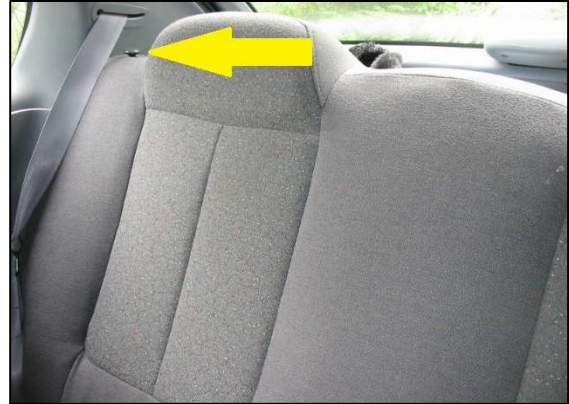
Figure 8. Exemplar second-row seat, the 2002 Hyundai Accent. (Arrow points to right-seat back latch.)

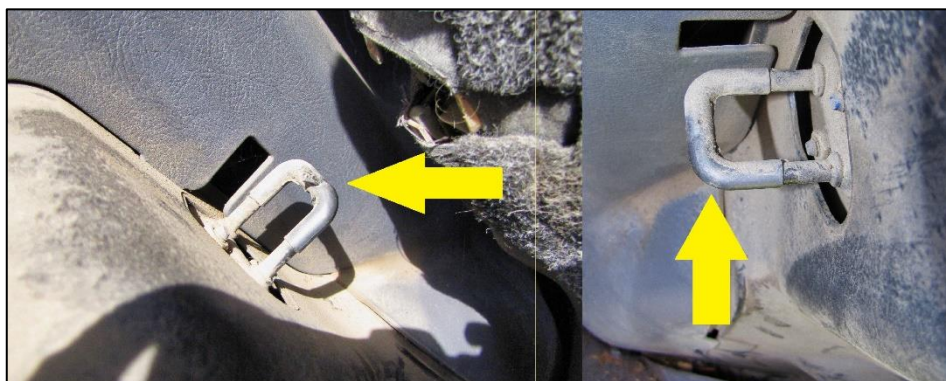
Figure 9. Left- and right-rear seat latch posts for the second-row seat, the 2002 Hyundai Accent.

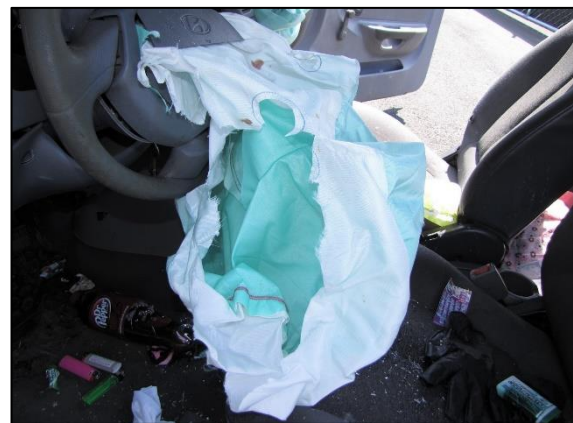
Figure 12. Driver's air bag, the 2002 Hyundai Accent.

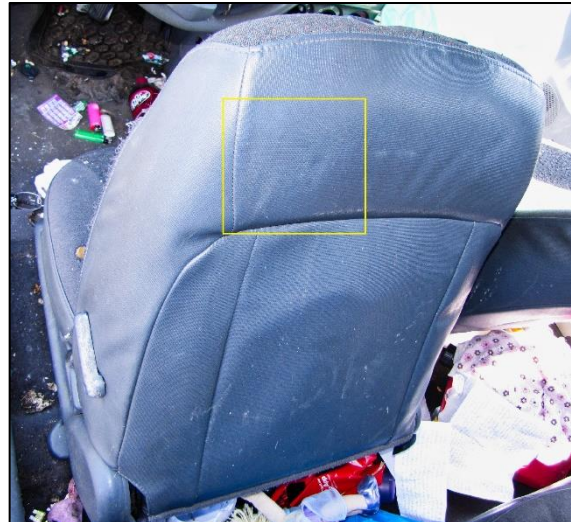
Figure 13. Driver's seat back, 2002 Hyundai Accent.

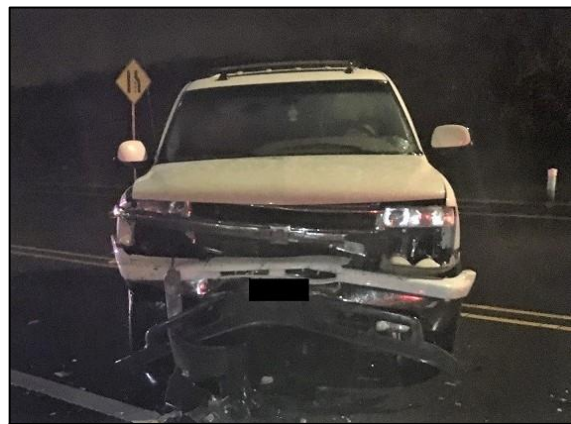
Figure 14. Front-plane damage, the 2005 Chevrolet Tahoe (police photo).
